DONGOLA

FIELDWORK
CONSERVATION
AND SITE MANAGEMENT

PCMA Excavation Series 5

QATAR-SUDAN ARCHAEOLOGICAL PROJECT (QSAP)
NUBIAN ARCHAEOLOGICAL DEVELOPMENT ORGANIZATION

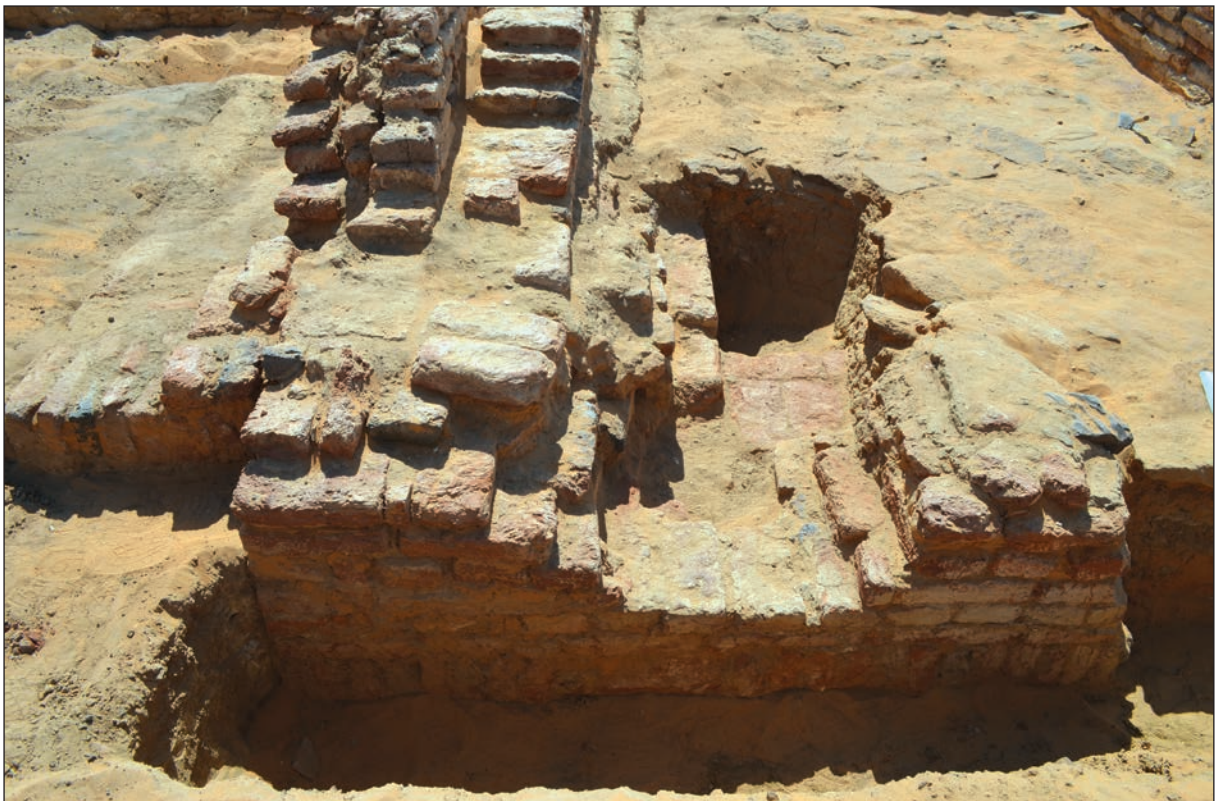
Fig. 1.3. Church foundations: northeastern corner, view from the north

According to its original design, the Monastery Church was intended to have elongated proportions. The planned size of the building is indicated by the foundation layout that survived in the eastern, ultimately undeveloped, part of the church. The planned size of the structure was 31 m by 14 m and the original northeastern corner of the building is preserved at foundation level [Fig. 1.3].

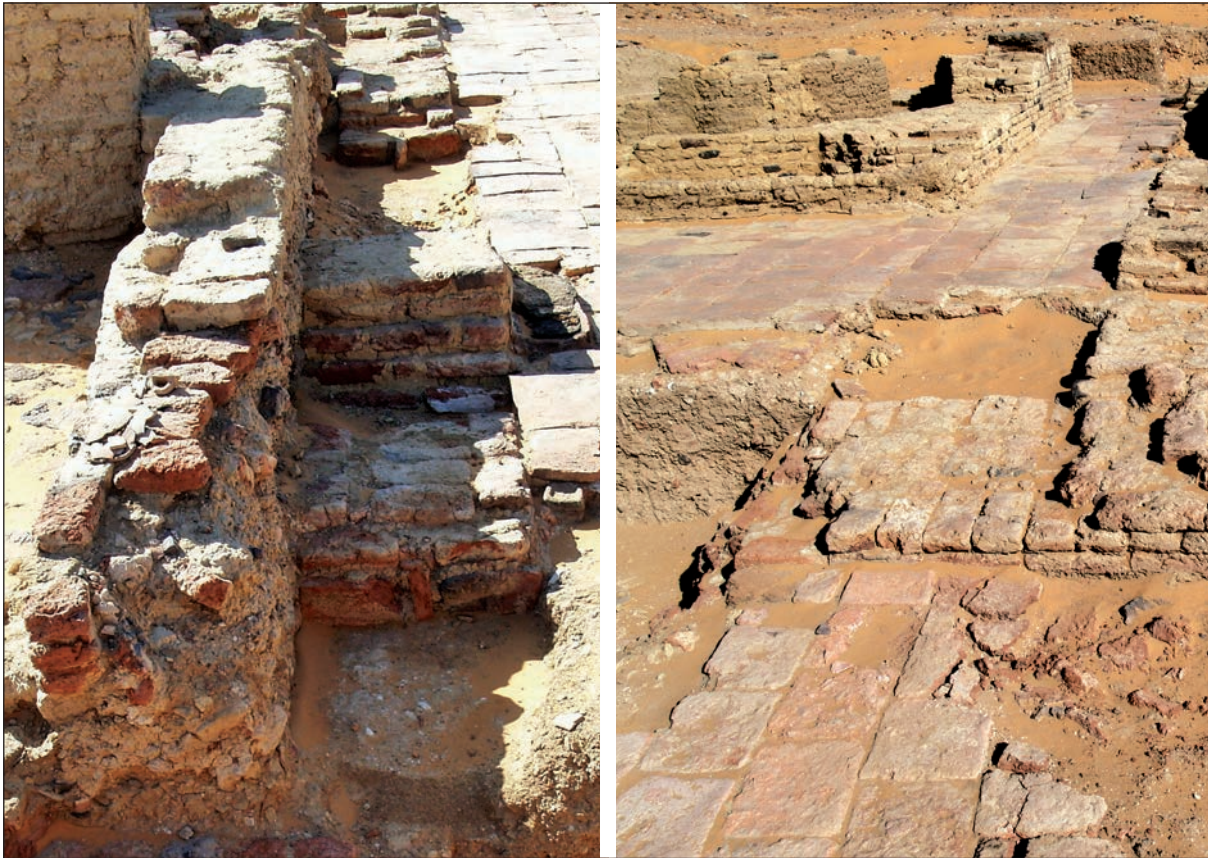
Fig. 1.4. Church foundations: left, state of preservation of the east wall of the church; right, eastern part of the south outer wall of the church

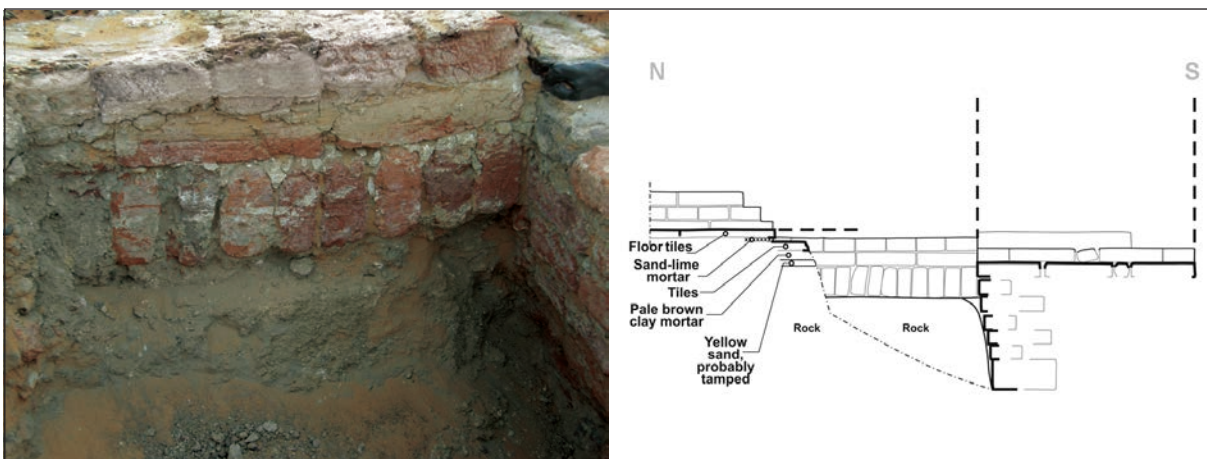
Fig. 1.5. Foundations of the south and east walls in the southeastern corner of the diakonikon

It is uncertain whether the eastern section of the south wall of the building was destroyed or simply never built. At the current stage of research one cannot rule out the possibility that the southeastern part of the building was razed along with some of its foundations. The originally planned eastern part of the church was at a later stage adapted to other functions, including funerary purposes. Nothing suggests, however, that construction of this eastern part of the church was continued above foundation level. It is probable that the original version of the project was abandoned while the building of the church was still in progress, and the logical consequence was the reduction of the building's length to 27 m. The originally planned eastern part was never built. The internal partition wall behind the apse thus became the external wall of the building. This wall is preserved almost exclusively at foundation level, up to the level of internal flooring. It is impossible to establish how its external face was finished, as no plaster has been preserved [Figs 1.2 top; 1.5].

walls. The north wall was founded 1.15 m below the level of the floor in the naos, the south wall 0.90 m, and the thinner east wall behind the apse 0.57 m below this level [see *Fig. 1.5*]. The foundation level of the west wall has not been established.

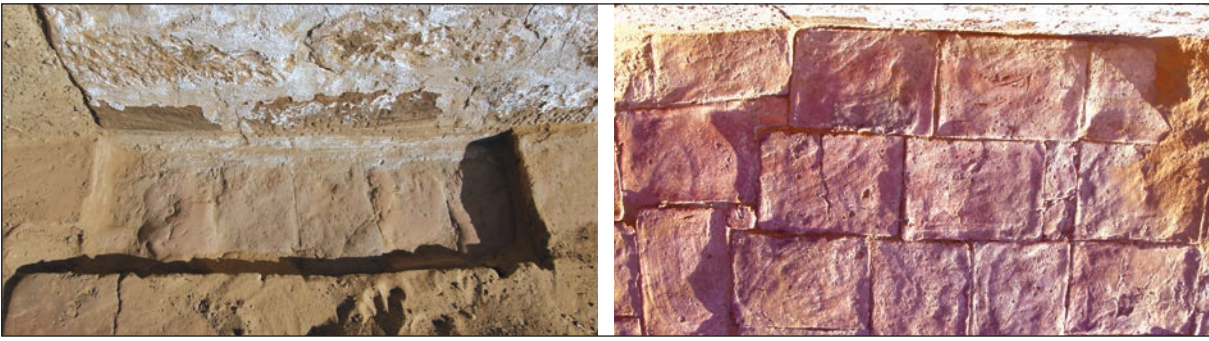
Fig. 1.7. Southern side of the southwestern pillar in the church naos: left, earlier pavement seen in test under ceramic tile floor; right, later ceramic tile floor abutting the face of the pillar

In the 2012 season, trench 10.01 was excavated in order to determine the relationship of the stone pillars to the floor and to the footing. The size of the trench was 1.00 m by 0.30 m [Fig. 1.7]. Two floor tiles were removed by the western edge of the southern face of the southwestern pillar. The floor tiles, 0.50 m by 0.30 m each, lay

The flooring in the central part of the sanctuary was re-laid: a brick floor was introduced in place of the old ceramic-tile floor [see Fig. 1.7 right]. In a considerable part of the sanctuary, the new floor followed no regular pattern and was covered with a smoothed layer of lime plaster with an admixture of gravel. The new flooring in the sanctuary was in all likelihood associated with the interment of burials in this area (Gazda 2005: 290–292). The original floor remained *in situ* in the lateral parts of the

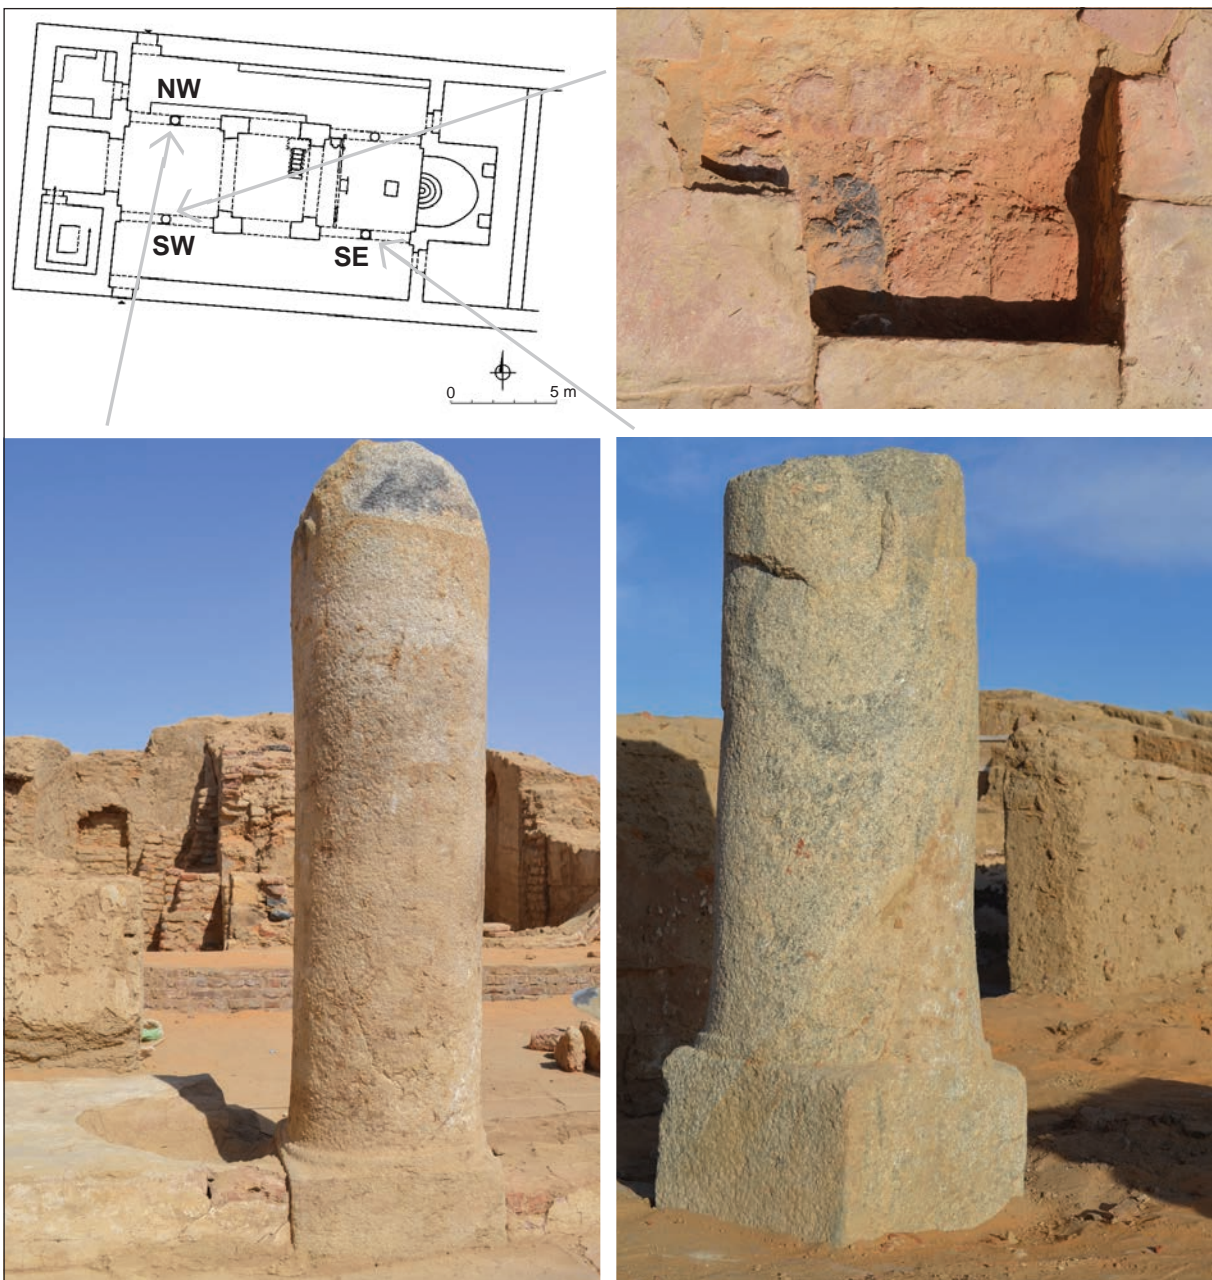
Fig. 1.8. Columns in the church naos: top right, outline of lost southwestern column; bottom left, northwestern column; bottom right, southeastern column

The same continuous footing on which the stone pillars were founded also supported four granite columns standing to the east and west of the central tower. Two columns, the southeastern and the northwestern one, are preserved *in situ*. The other two were dismantled, but it is possible to establish their location by investigating the layout of the floor tiles that abutted their bases [Fig. 1.8 top right]. Each of the two preserved columns was made of a monolithic block of gray granite carved to form a shaft and a base. The upper parts of shafts of both columns were destroyed. The northwestern column, over 1.82 m in height, had a base measuring 0.50 m by 0.50 m and 0.30 m high [Fig. 1.8 bottom left]. The southeastern column (over 1.45 m high, with a square base 0.50 m to the side and 0.38 m high) was overturned when the church had already been partly buried and destroyed [Fig. 1.8 bottom right].

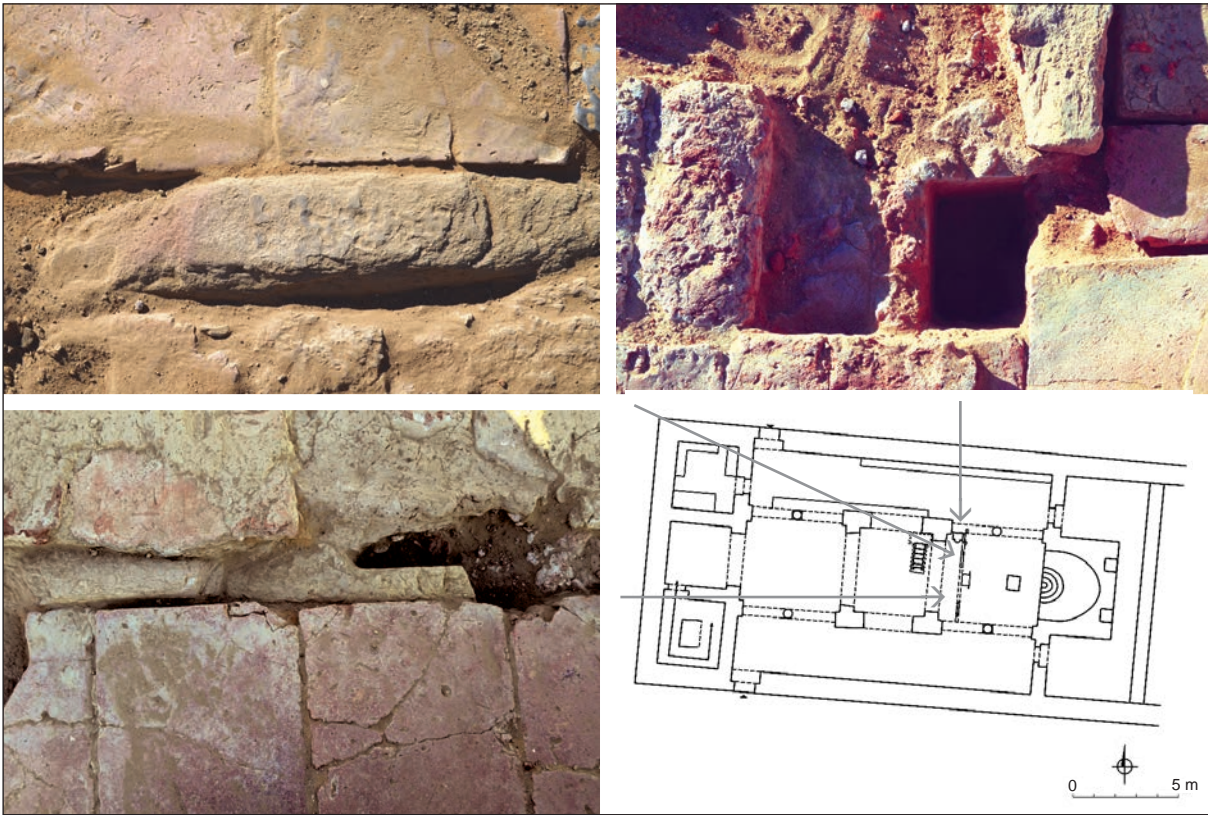
Fig. 1.9. Evidence for the location of the original sanctuary: top and bottom left, broken slabs of the altar screen between the flooring tiles; top right, outline of a removed altar screen post in the pavement

eastern part of the nave, in front of the apse filled by the synthronon. At a later stage, this space was remodeled and destroyed by burial pits (Gazda 2005: 290–292). The original location of the sanctuary was established thanks to fragments of broken slabs from the original altar screen preserved below the flooring [Fig. 1.9 left].

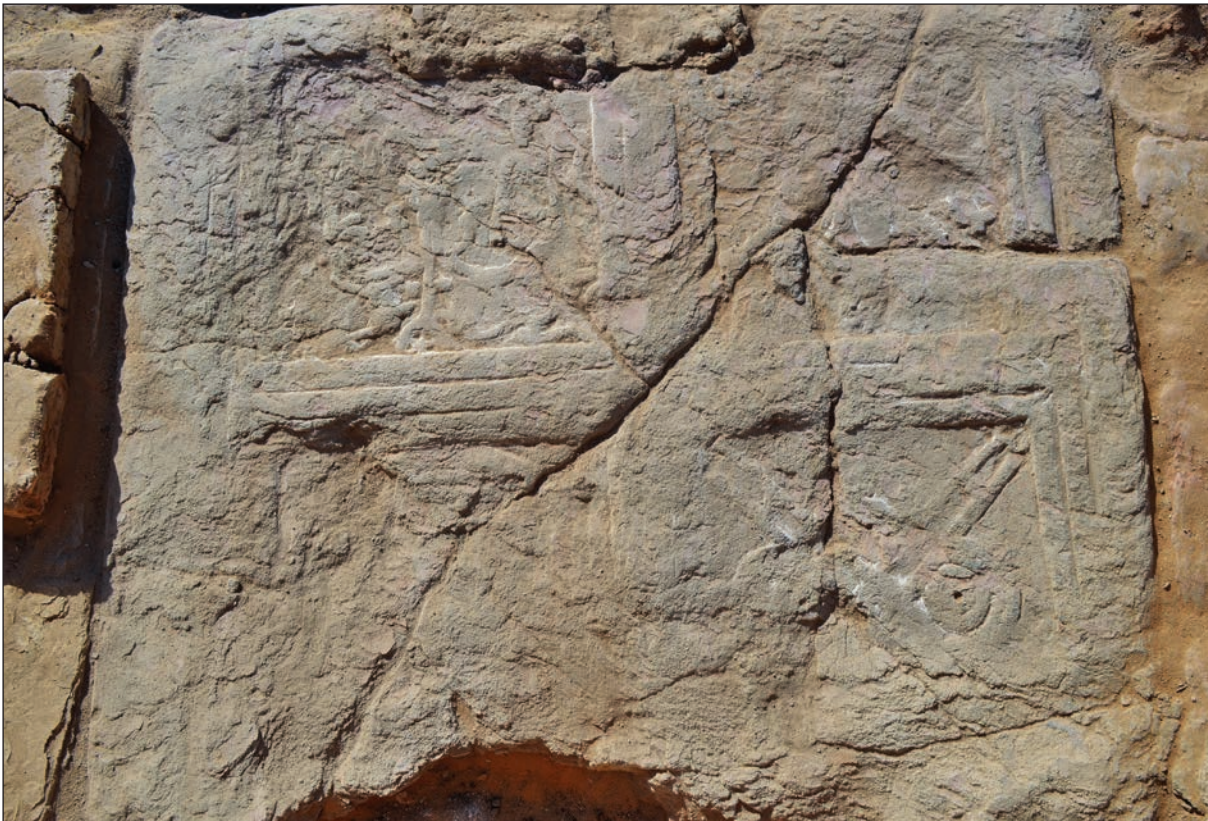
Fig. 1.10. Sandstone slab from the altar screen

One of the sandstone altar screen slabs (dimensions: H. 97 cm; L. 110 cm; Th. 12.5 cm) was uncovered lying in front of the west screen wall, in the naos of the church [Fig. 1.10]. The surface of the slab is badly damaged, with cracks and chips in the upper and lower parts. Only one side of the slab was studied, since raising it could have led to its complete destruction. Within a border 15 cm wide were two bands, each 10 cm wide, one horizontal and the other vertical, dividing the space on the slab into four fields decorated in shallow relief. The decoration is very eroded and hardly discernible. The motifs in the two lower(?) fields were geometrical, with diagonal lines intersecting in the middle and circular elements inscribed into the resulting triangles. Decoration in the two upper(?) fields was floral with symbolic elements including a small cross.

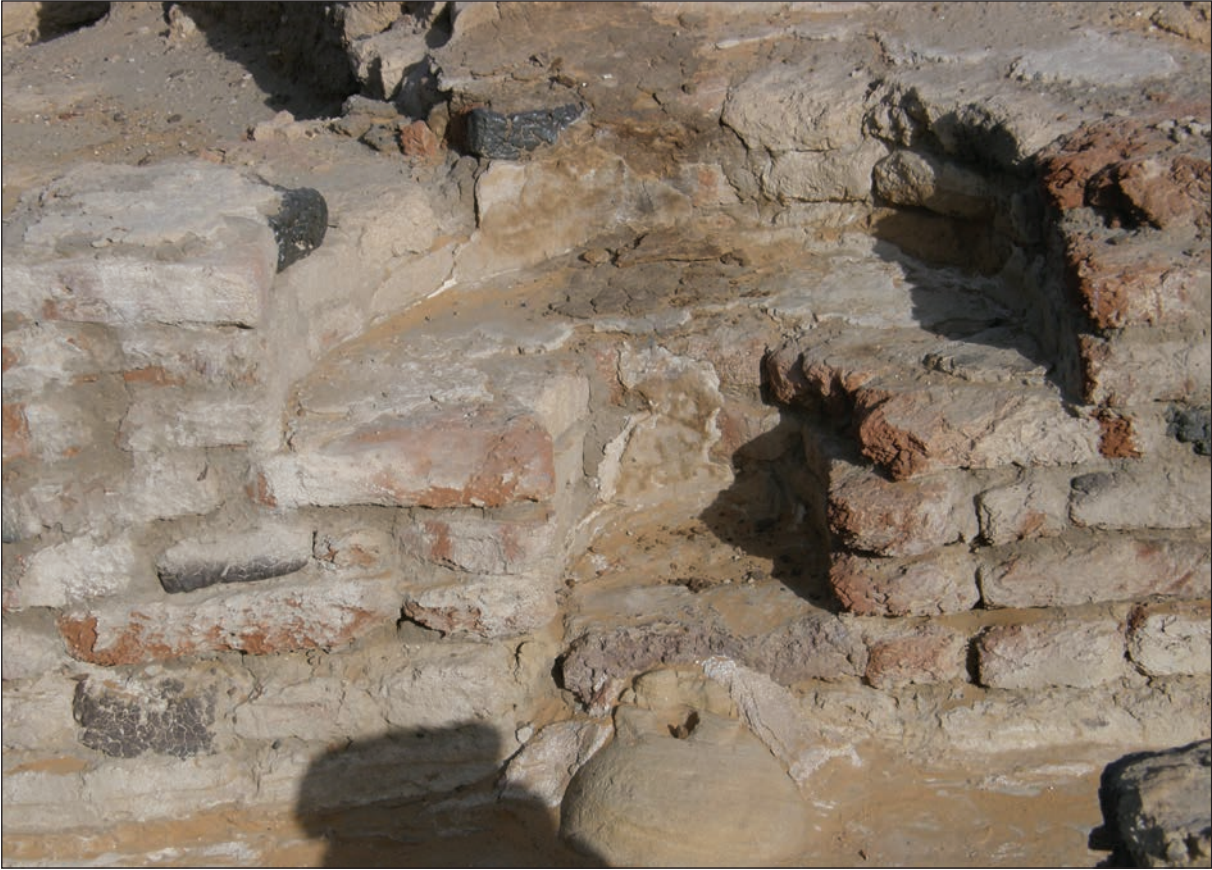
Fig. 1.11. Central part of the synthronon, frontal view from the west

The apse, 3.60 m in width and 3.00 m in diameter, was flanked on the front by two pilasters (W. 0.70 m; Th. 0.20 m), which presumably supported the ceiling beams of the side aisles [see Fig. 1.2 bottom]. The inside of the apse was completely filled by the synthronon, only the central part of which survives [Fig. 1.11].

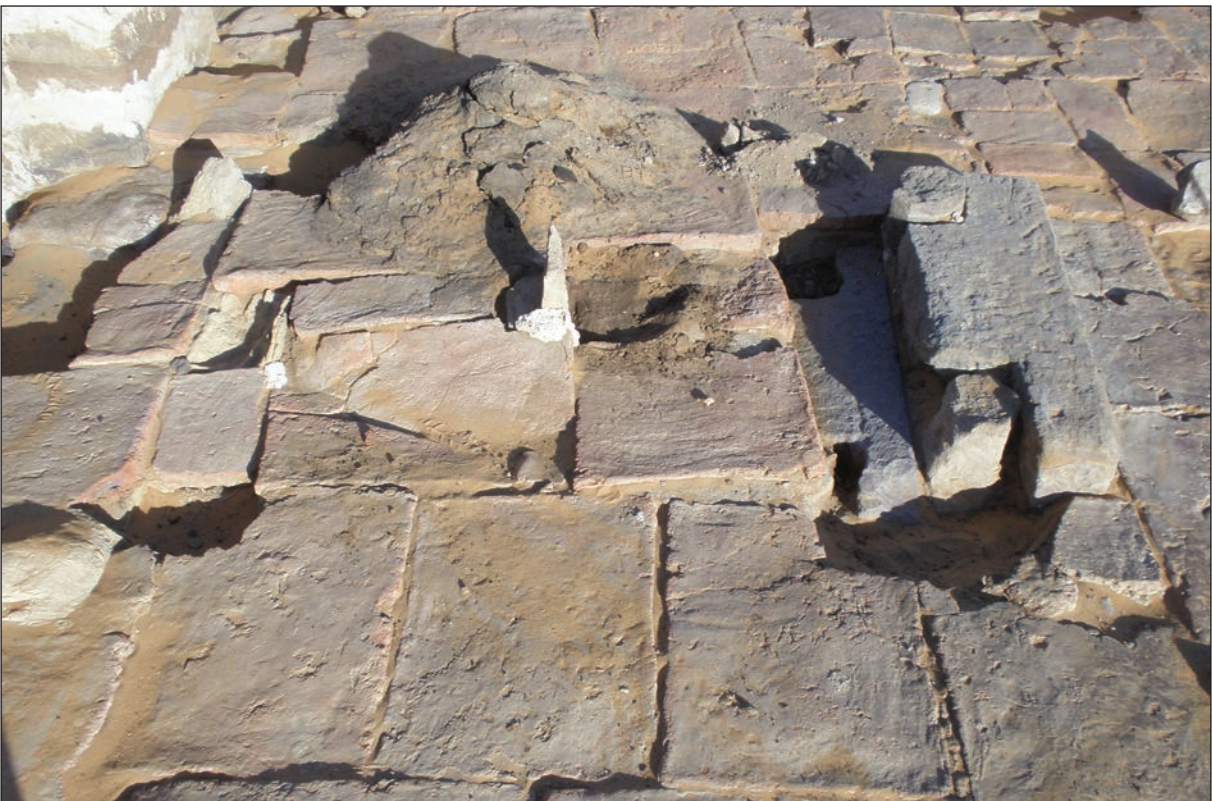
Fig. 1.12. Relics of the pulpit preserved at floor level, view from the west

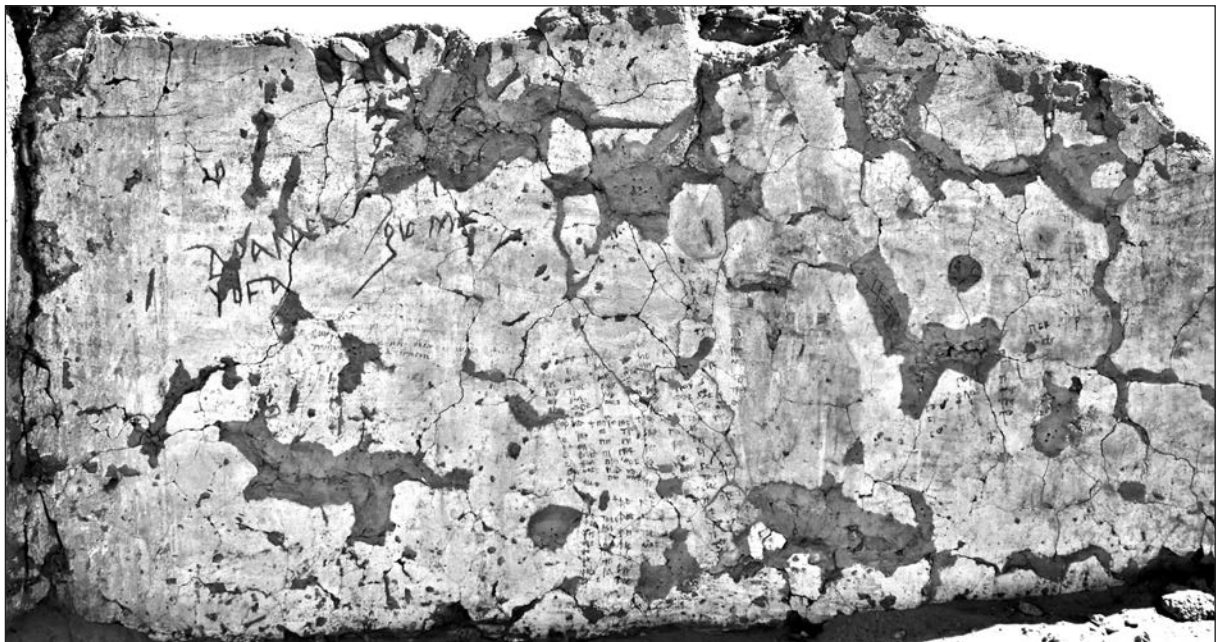
Fig. 1.14. Representation of Christ and educational inscriptions in Greek on the altar screen closing the southern aisle of the Monastery Church after structural changes, view from the west

The partition wall delimiting the sanctuary was built of large sun-dried bricks (dimensions 35–36 cm by 18 cm by 8 cm) and was founded on the floor. Its maximum preserved height is 1.07 m, but there is no indication of its original height. The walls, about 0.40 m in width, were plastered and covered with paintings, which survived in fragments on the western face: in the nave on both sides of the entrance, and in the southern aisle (Martens-Czarnecka 2011: Cat. Nos 142, 143, and 144). Numerous Greek inscriptions, most of them school exercises, survived next to a painting of Christ on the western face of the wall in the southern aisle [Fig. 1.14].

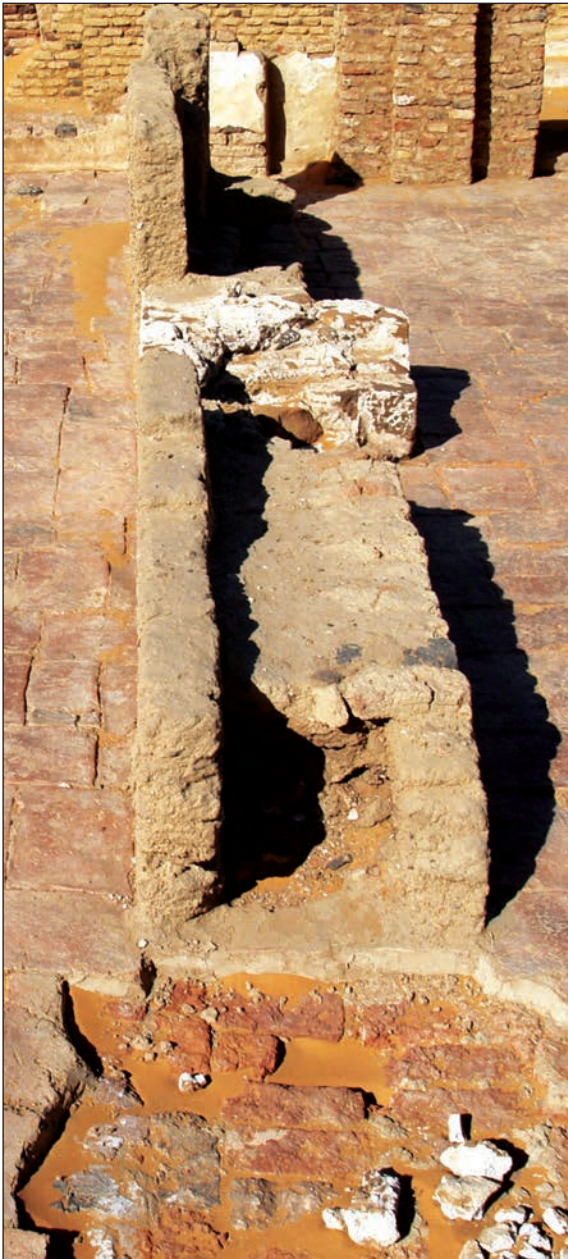
Fig. 1.15. Wall separating the nave (on the right) from the southern aisle, view from the east

The mud-brick wall between the southwestern and southeastern pillars was built as two parallel walls, each 0.18 wide, the space between them filled with rubble [Fig. 1.15]. Up to a height of 0.48 m the entire wall was 0.82 m wide, but above this level only the south facing wall is preserved (up to about 0.70 m in height). Thus, on the southern face, the wall separated the southern aisle from the nave, while on the northern face, it formed a bench, 0.64 m wide and 0.48 m high. Currently the bench is topped with red bricks laid crosswise on the upper surface.

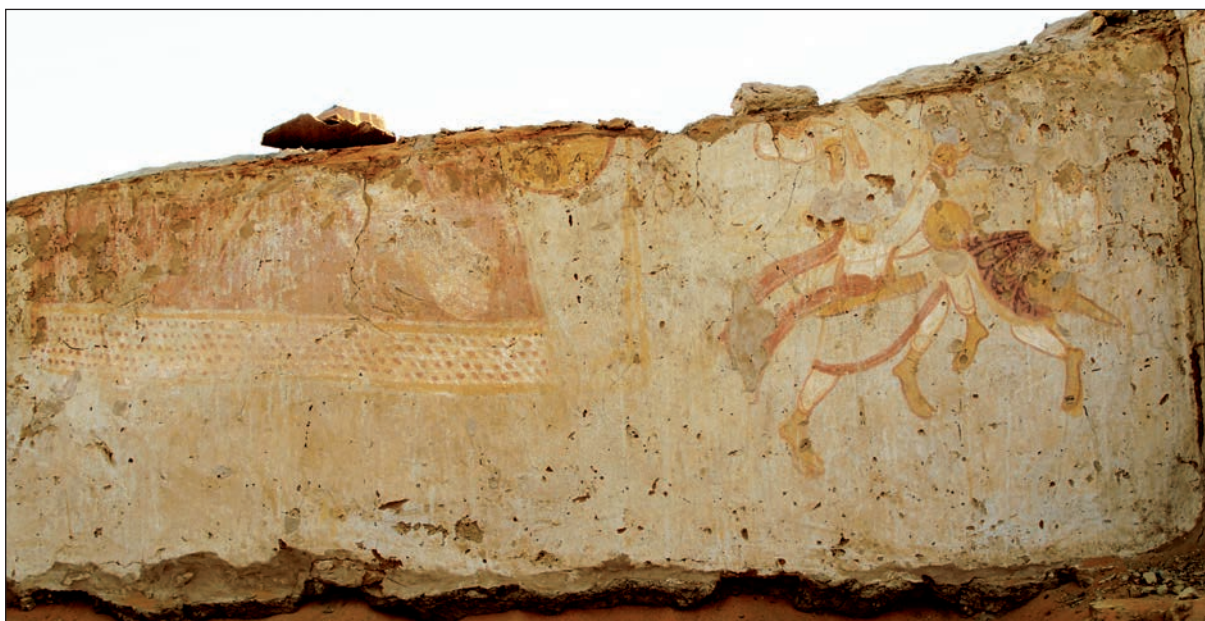
Fig. 2.1. Part of the mural showing the Nativity on a partition wall selected for dismantlement

different spaces if the pieces under conservation prove impossible to secure *in situ* due to their location on isolated walls (as was the case in the Monastery Church in Old Dongola) and when building a shelter over the whole structure is not economically viable [Fig. 2.1].

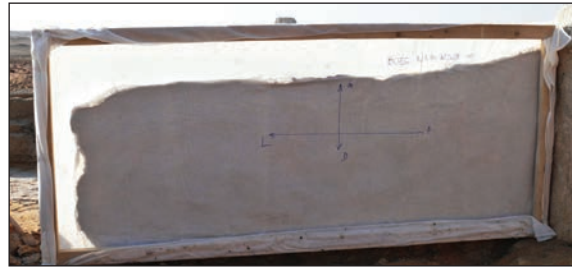
Fig. 2.2. Markings on a faced painting ready for transfer to a new support

It proved useful to mark the vertical and the horizontal axes of the faced paintings, as well as the top and bottom edges [Fig. 2.2]. Such marks facilitate the correct attachment of paintings to their new support. The lack of these indications may lead to errors during re-mounting.

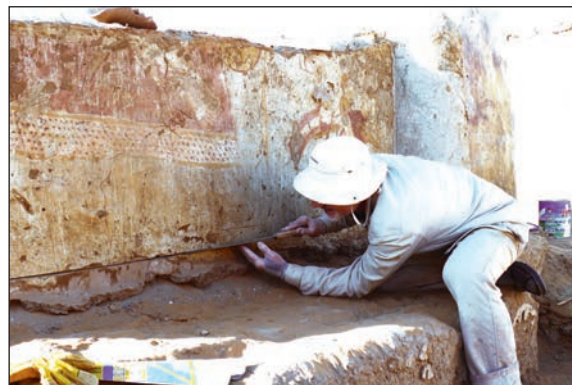
Fig. 2.3. Cutting the plaster along the lower edge of the painting selected for transfer, before attachment of the facing

The walls that carried the paintings came from late construction phases of the Monastery Church and were selected for dismantlement. Thus, it was possible to detach the faced and trussed murals gradually by removing consecutive bricks one by one, starting from the top [Figs 2.3, 2.4]. After dismantlement of the wall, the painting remained attached to the truss.

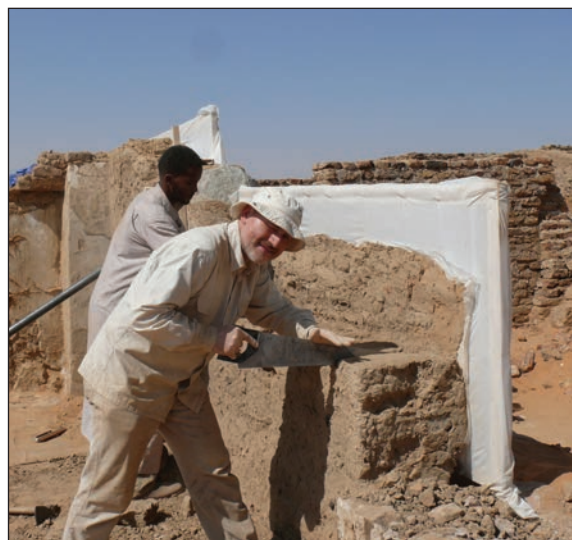
Fig. 2.4. Dismantlement of the wall during transfer of the Nativity scene

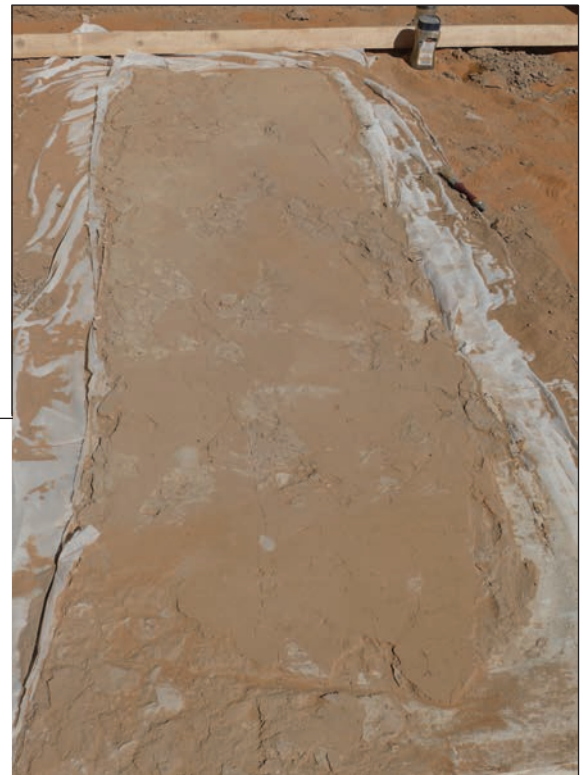
Fig. 2.5. Back of the painting: left, immediately after detachment from the wall; right, the same painting after the back surface was evened out

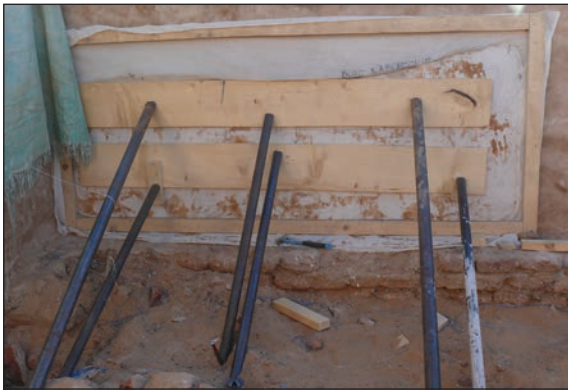
Fig. 2.6. Pressure on the transferred mural with the Nativity scene as it is mounted in a new location

The process of re-attaching the paintings was significantly facilitated by the fact that the plaster fragments had been fixed to wooden trusses and bore indications as to their vertical and horizontal axes. The position in which each painting was to be attached to the wall could thus be easily determined. In the places of attachment, the surfaces of the newly plastered walls were scratched and daubed with injection fluid. Lime-sand mortar with an admixture of polyvinyl acetate was applied to obtain a ribbed surface similar to the effect of using a tile trowel with serrated edges. Then, the backs of the paintings were moistened with injection fluid and quickly attached to the fresh mortar. To prevent the pieces from shifting, they were suspended from nails hammered into the walls under the upper boards of the trusses. The faces were held in place with boards, which, in turn, were supported with stanchions [Fig. 2.6]. The trusses could be removed after one day, and the mesh could be attached to the walls with nails. The lower and side edges of the attached plaster were lined with putty. Despite attempts, it was impossible to attach the plaster evenly to the whole surface. Therefore, liquid lime-sand mortar was poured in along the upper edge to

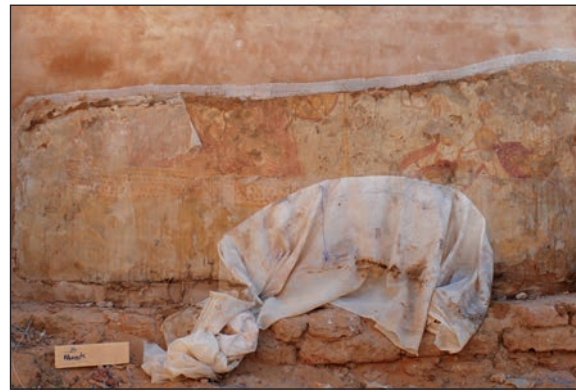
Fig. 2.7. Removal of the facing from the transferred Nativity mural

Facing removal is the stage of transfer works that permits assessment of results. Detachment of a facing attached with animal glue requires use of hot water. Warm water is inadequate, as the layers of paint are in danger of becoming excessively damp. Experience has shown that the best method is to apply hot compresses to the facing and to carefully peel off the layers of tissue and textile parallel to the painting as they start to become detached [Fig. 2.7].

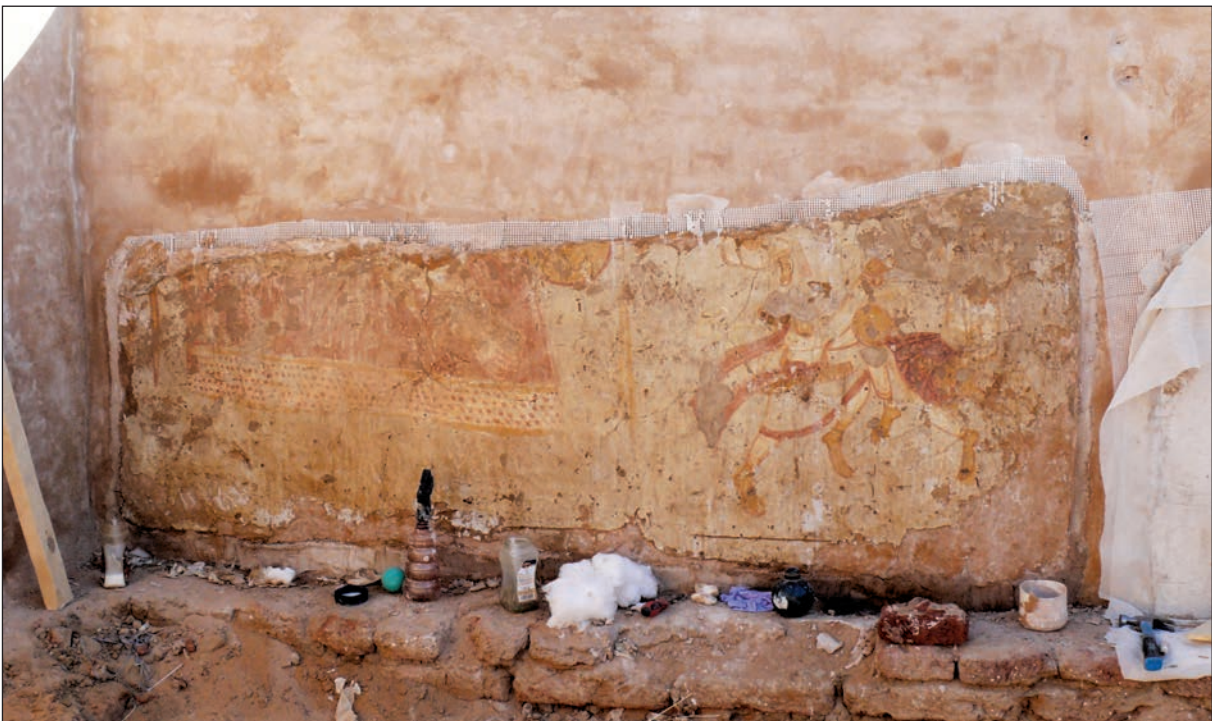
Fig. 2.8. Transferred Nativity mural after removal of the facing

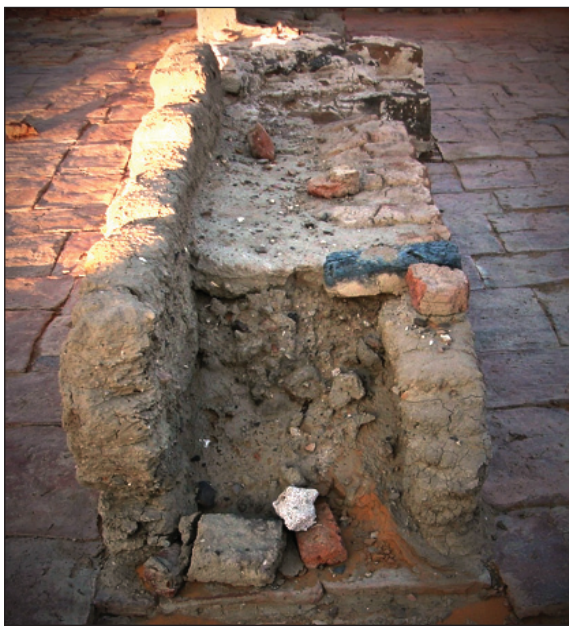
Fig. 3.2. Secondary structure between the southern pillars of the church, seen from the east (see also Fig. 1.15)

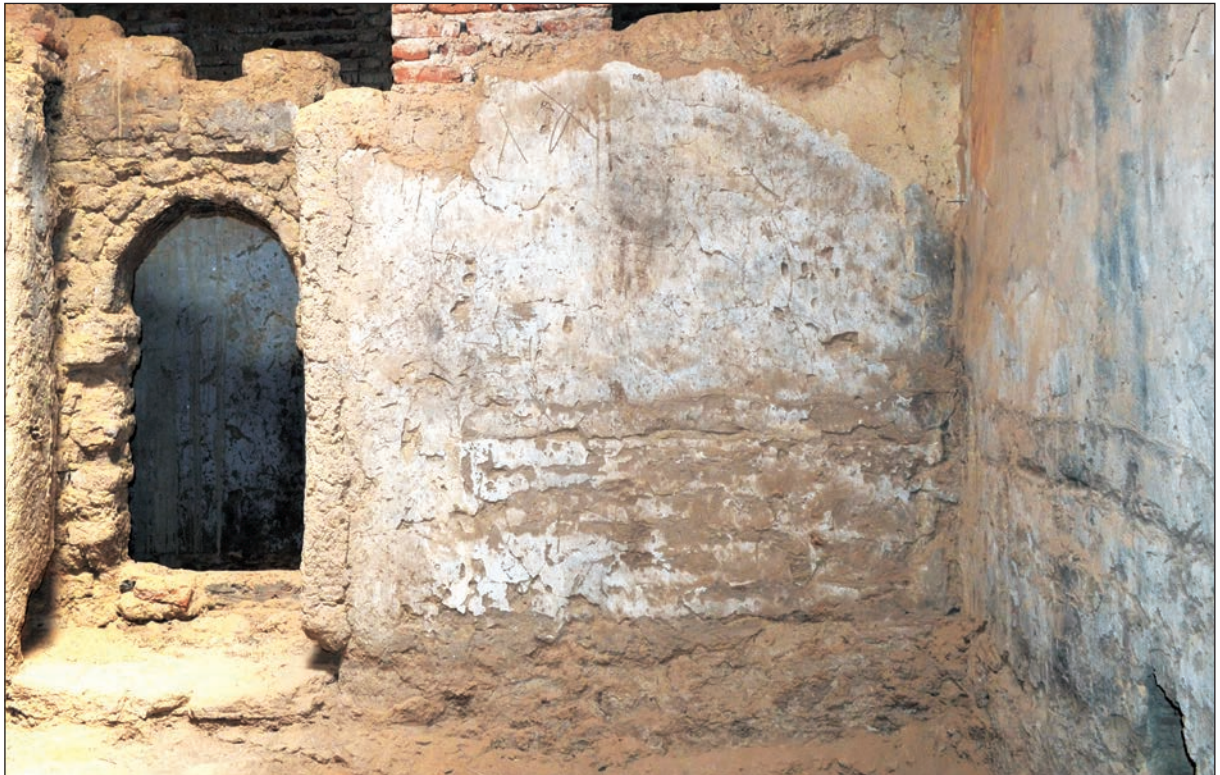
Fig. 4.6. North wall of room B.I.NE.2 with the entrance to room B.I.NE.1. The eastern side of the entrance was remodeled at a later stage

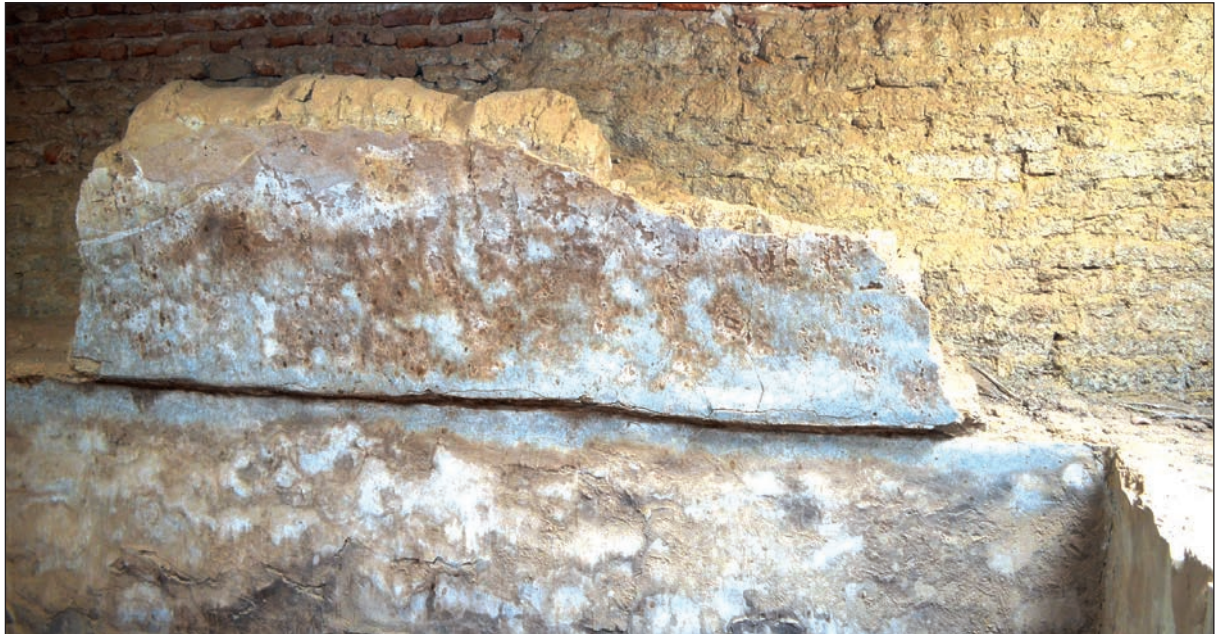
Fig. 4.7. East wall of room B.I.NE.2 with a fragmentarily preserved barrel vault

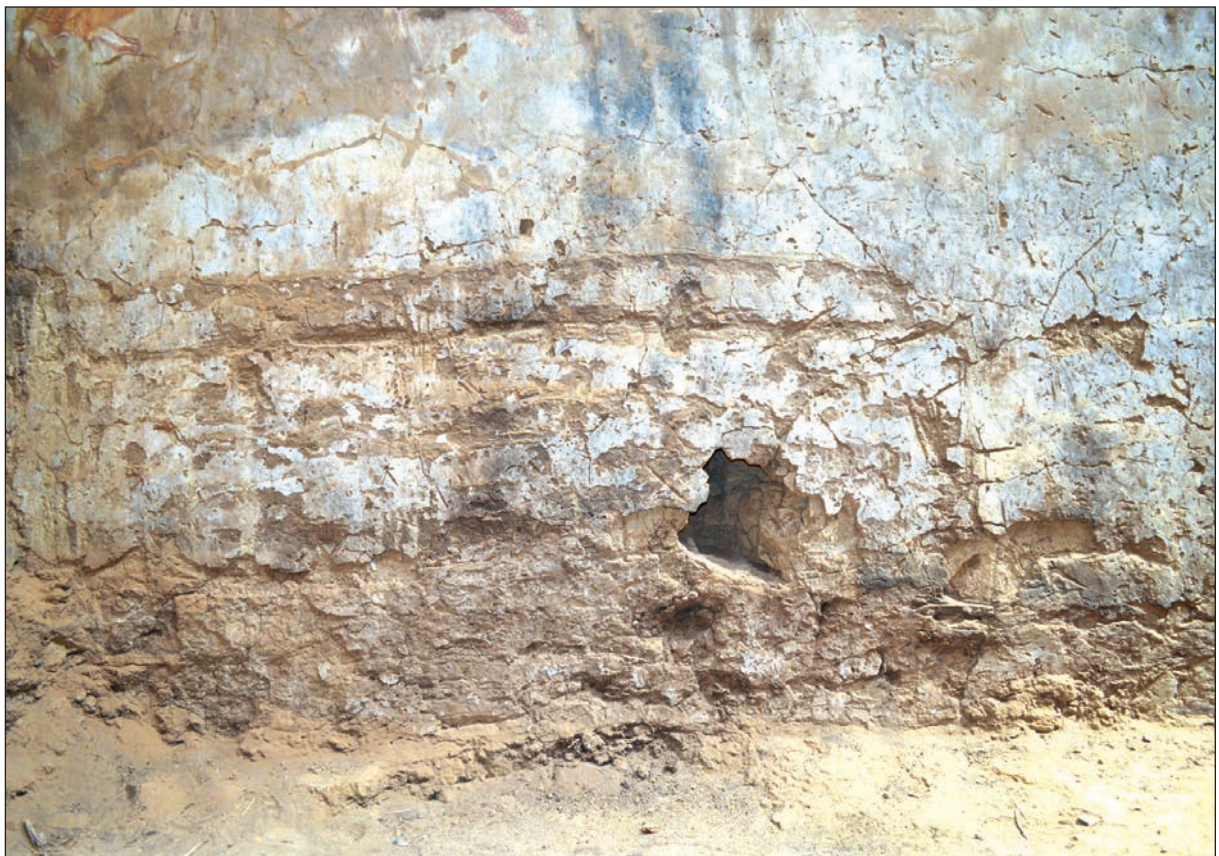
Fig. 4.8. Northeastern corner of room B.I.NE.2 with traces of a dismantled feature (walls of a basin?)

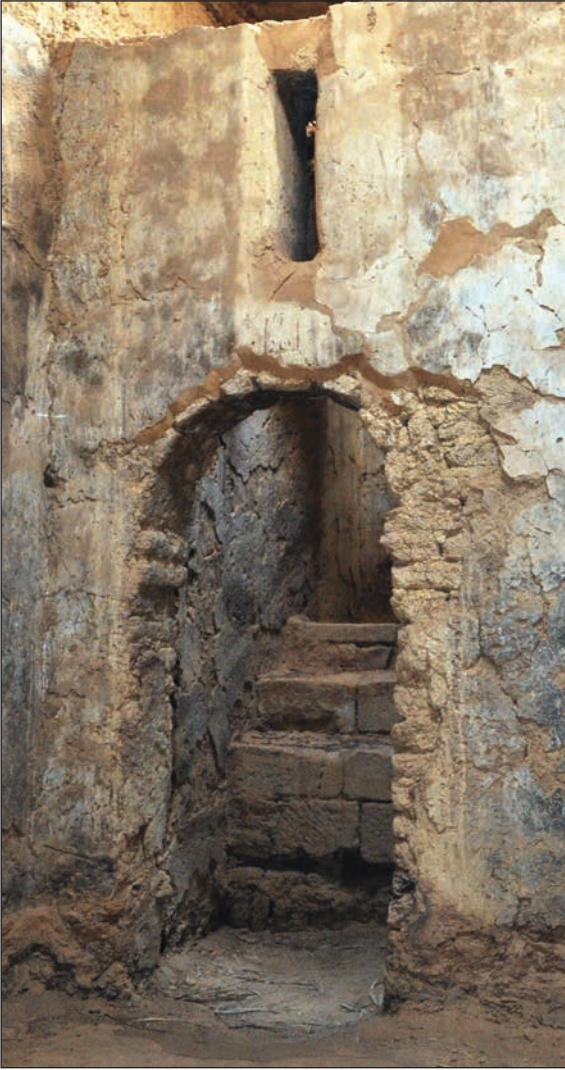
Fig. 4.9. Entrance from room B.I.NE.2 to staircase B.I.NE.3

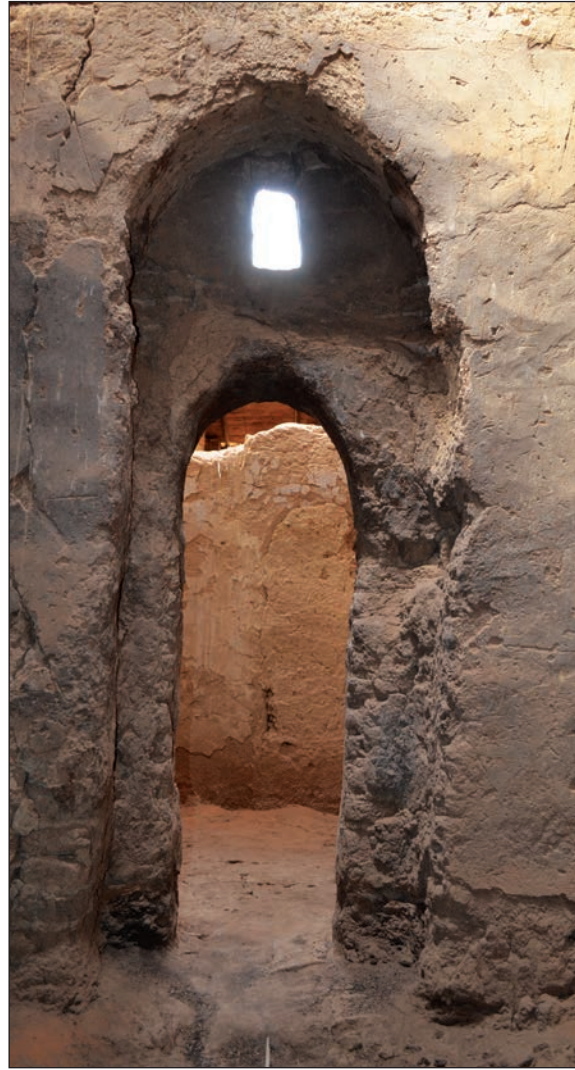
Fig. 4.10. Doorway leading from room B.I.SW.3 to B.I.SW.2

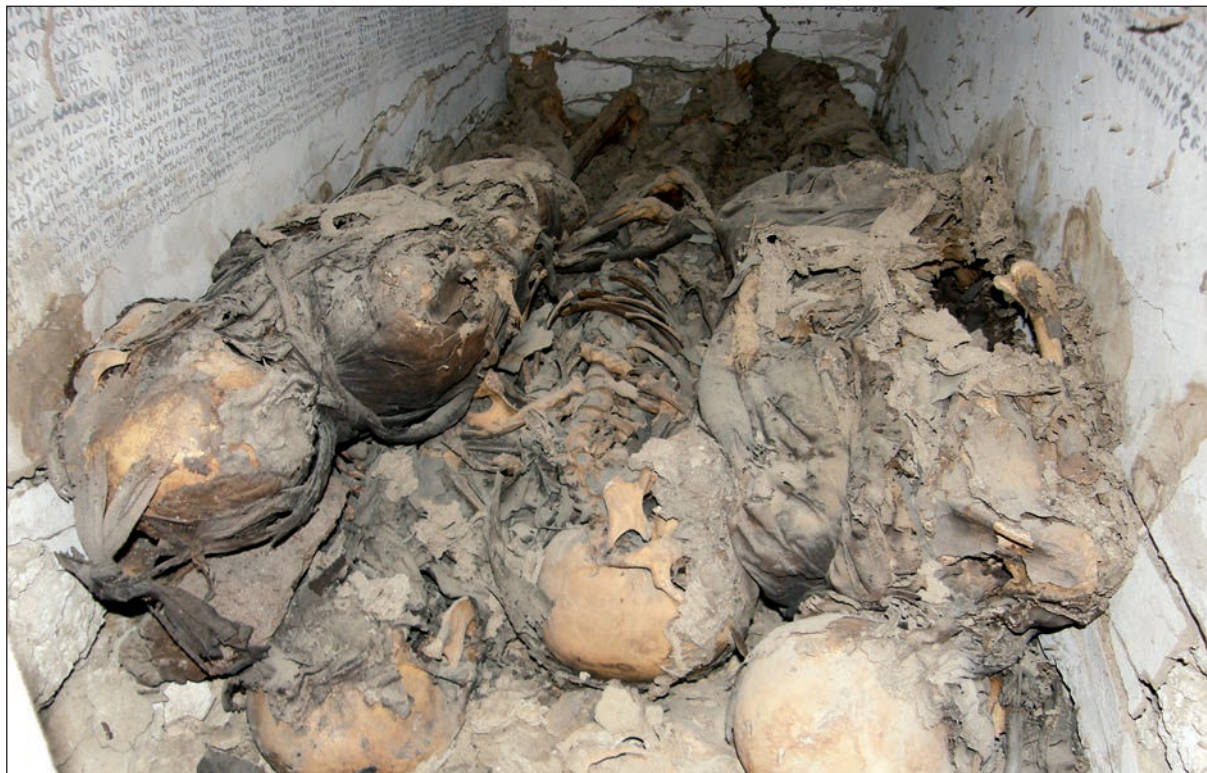
Fig. 4.14. Interior of the crypt of Georgios with seven burials in the uppermost layer, state in 2009 after the crypt was reopened

The crypt is partly cut in the bedrock, and its upper part is constructed of brick. It consists of a burial chamber and of a shaft located on the western side [Fig. 4.13]. The burial chamber, measuring 2.08 m by 0.80–0.86 m and reaching a height of 1.20 m, has a brick vault. Its carefully plastered internal walls are covered with texts in Greek and Coptic (Łajtar and van der Vliet 2017). The burial shaft measuring 0.80 m by 0.80 m, with three steps descending from west to east, gave access to the chamber, which had a rectangular opening in the west wall. The opening measured 33 cm by 38 cm and was topped with a stone lintel. In addition to Georgios, the crypt contained the bodies of six other men, who had died at an advanced age (Godlewski, Mahler, and Czaja-Szewczak 2012: 338–348, 353–356) [Fig. 4-14].

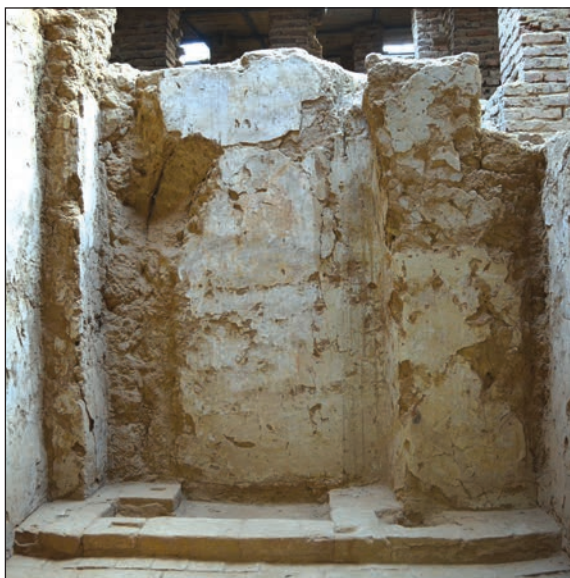
Fig. 4.15. Base of an altar in the blocked entrance to B.I.SW.2

The sanctuary of the new complex encompassed room B.I.SW.1, as well as room B.VI.1 built against the west external wall. In room SW.1, the jambs of the western entrance were cut away to broaden the doorway, and the passage to room B.I.SW.2 was blocked, forming a kind of apse. The apse held an altar whose base, built of limestone blocks, measured 0.69 m by 1.02 m. The now-lost *mensa* was supported by four stone pillars and its dimensions were presumably 1.25 m by 0.70 m. The height of the altar

is impossible to determine for lack of evidence. A lamp box was found in the entrance to the sanctuary, in its northern doorjamb. It measured 19 cm by 24 cm and was located 1.36 m above floor level. There was originally no altar screen between the naos and the sanctuary [Figs 4.12, 4.15].
