DONGOLA

FIELDWORK
CONSERVATION
AND SITE MANAGEMENT

PCMA Excavation Series 5

QATAR-SUDAN ARCHAEOLOGICAL PROJECT (QSAP)
NUBIAN ARCHAEOLOGICAL DEVELOPMENT ORGANIZATION

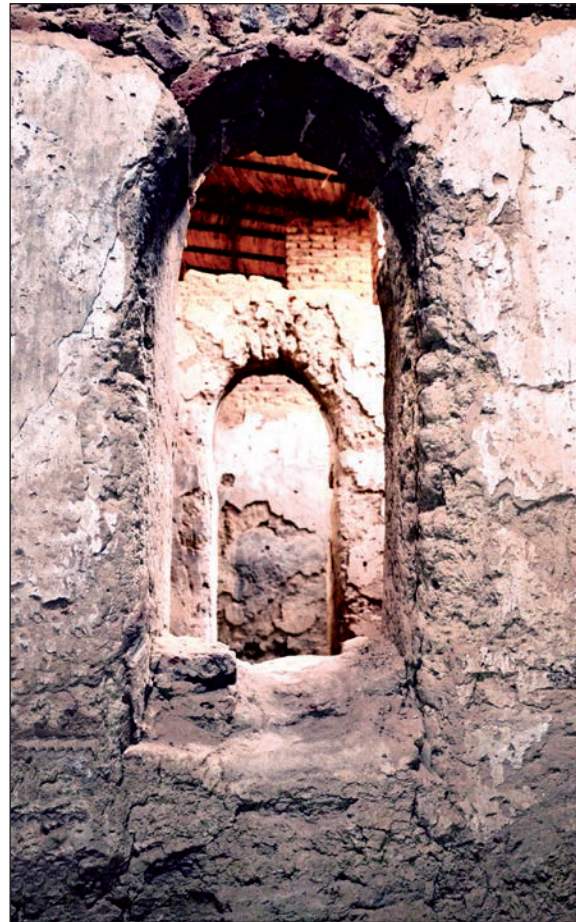
Fig. 4.18. Hacked-out passageway from B.I.NE.5 to B.I.SW.2, view from the north

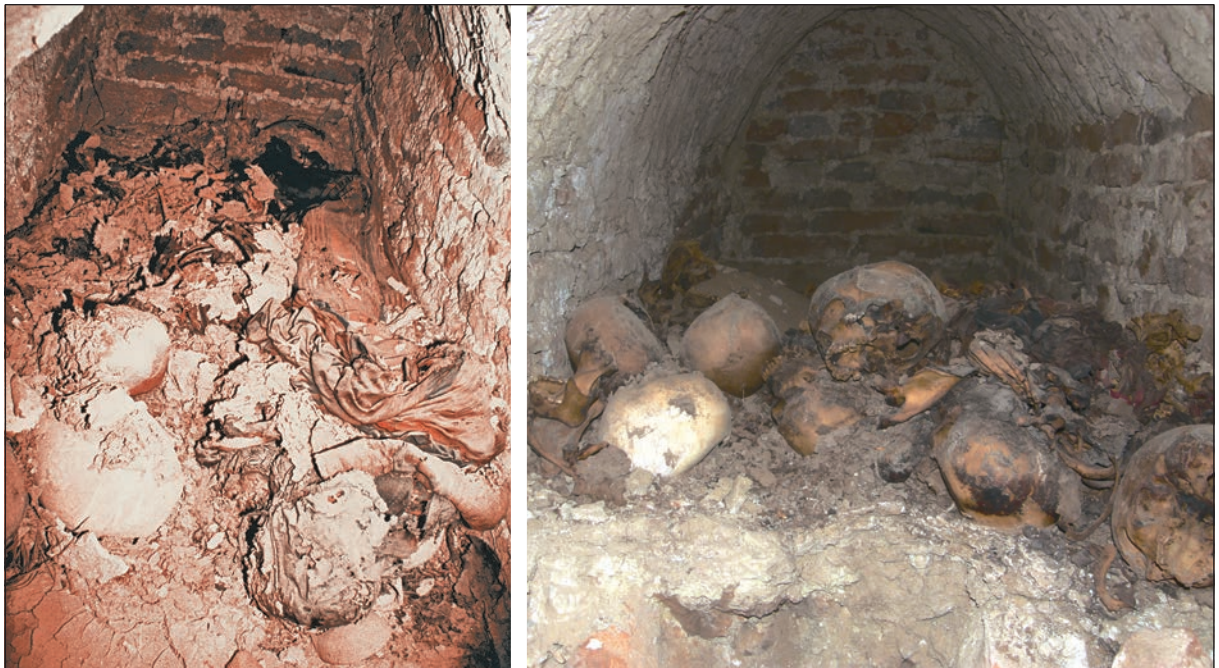
Fig. 4.21. Interior of crypt K.2: left, state in 1993; note textile on right, by the wall; right, state in 2009, after the reopening of the crypt

Two crypts (K.2 and K.3), built in a single trench measuring 2.43 m by 3.45 m, are not a structural unity, even though they were most likely contemporary. The southern crypt (K.2) was built first or may have belonged to an earlier tomb. Subsequently, on the northern side crypt K.3 was added, its southern vault spring resting on the vault of crypt K.2. Both crypts were accessed from the west by separate narrow grave shafts. The walls and vaults of the crypts, as well as their shafts, were built of baked bricks. The interiors were covered with lime plaster, but the coating fell away from the bricks most likely due to high humidity inside the crypts [Figs 4.20, 4.21]. The details of the crypts are as follows:

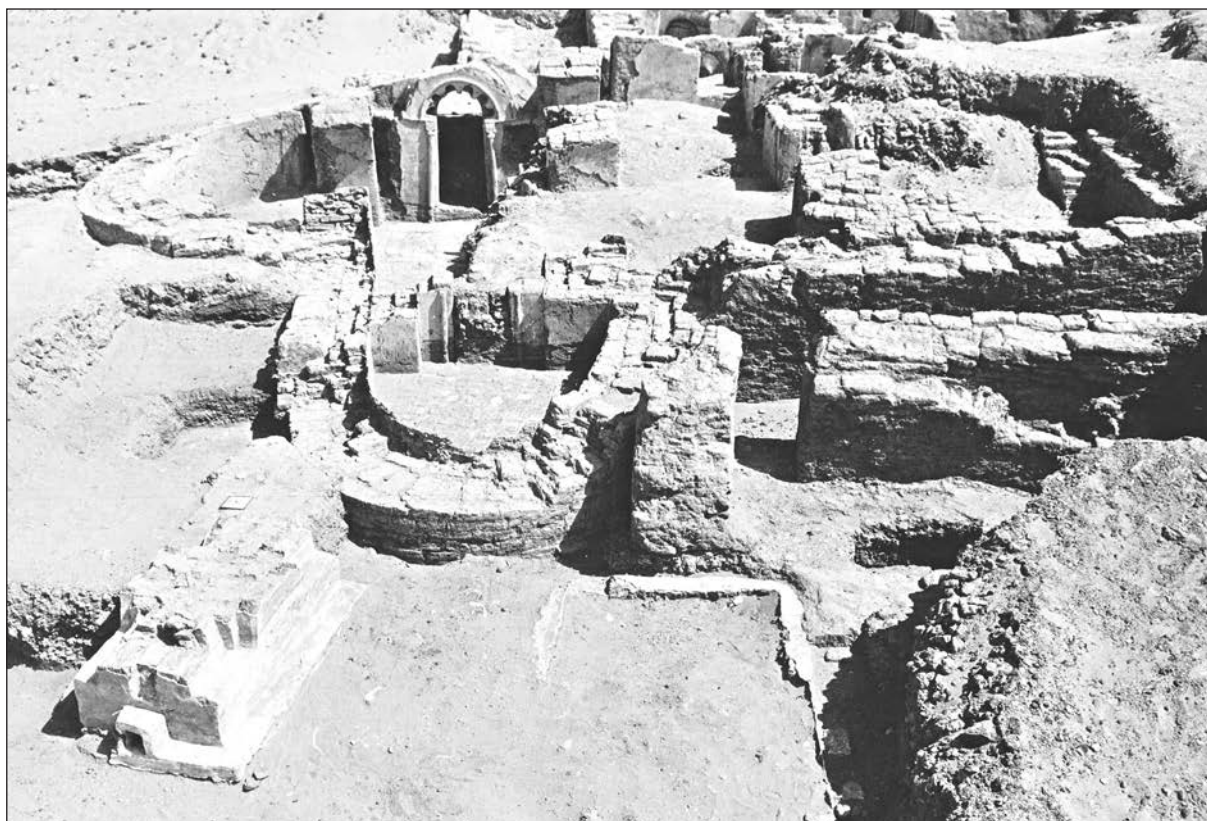
Fig. 4.22. Building H.NW.B.VII, view from the west in 1993; state of preservation of the walls

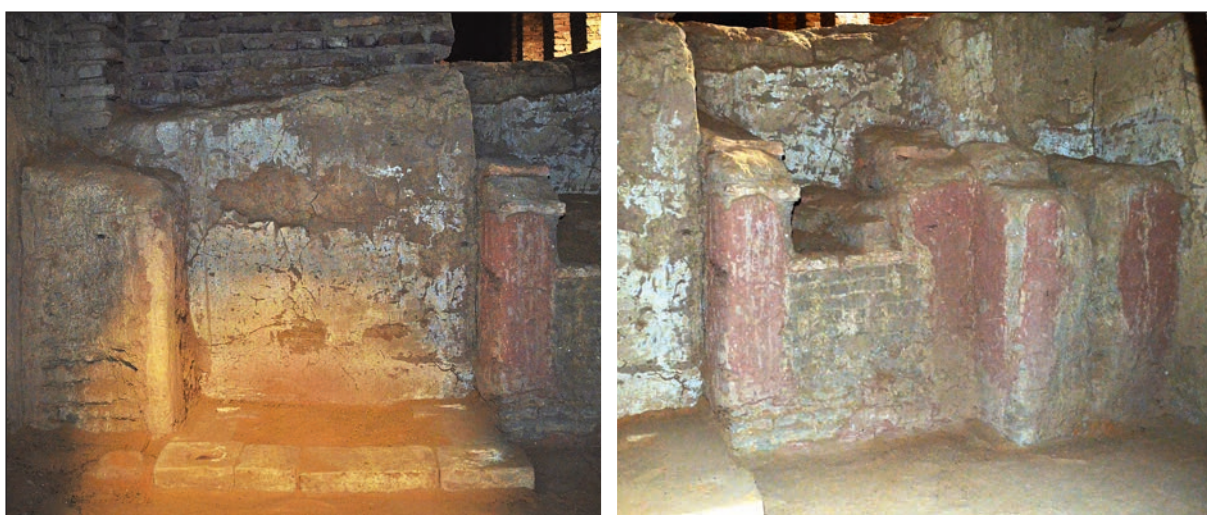
Fig. 4.23. Eastern side of the sanctuary in H.NW.B.VII: left, view of stone altar base in the northern part; right, auxiliary tables in the southern part

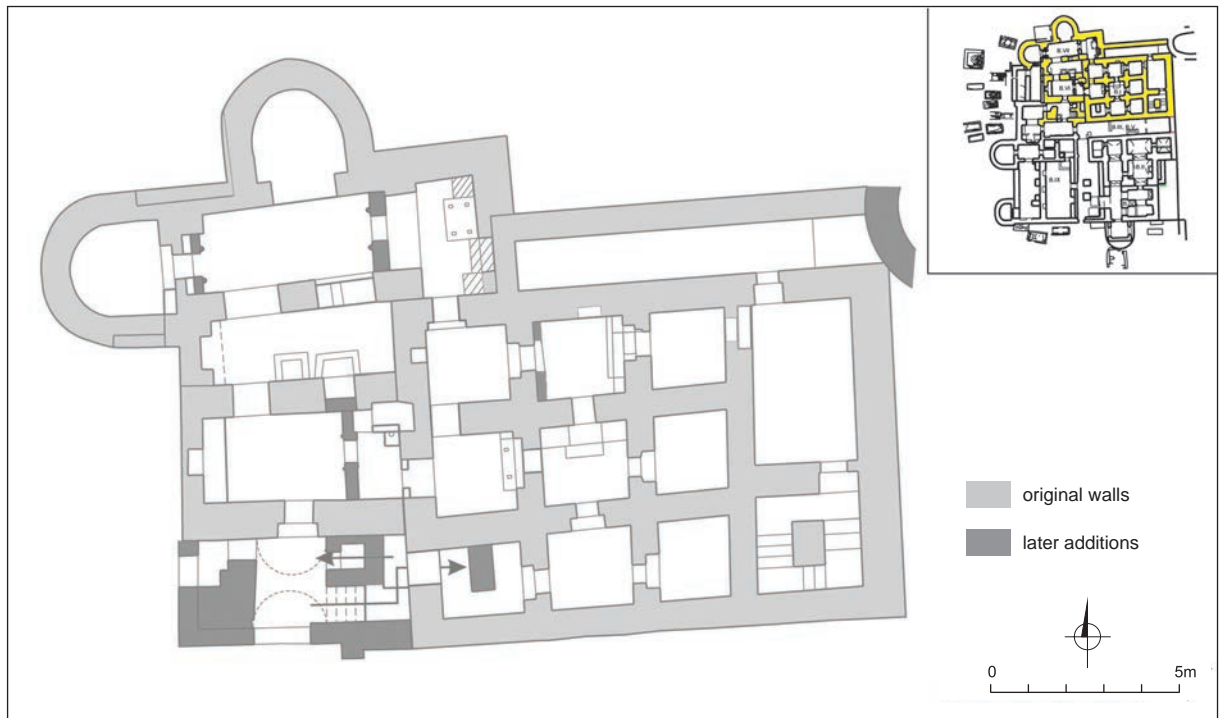
Fig. 4.24. Commemorative chapel (H.NW.B.VIII), constructed of remodelled units B.VI. B.VII and B.I; in red, later structural additions

northwestern corner. The two newly created passages allowed to connect both sanctuaries with the prothesis arranged in room B.I.NE.5 after structural changes [Fig. 4.24].

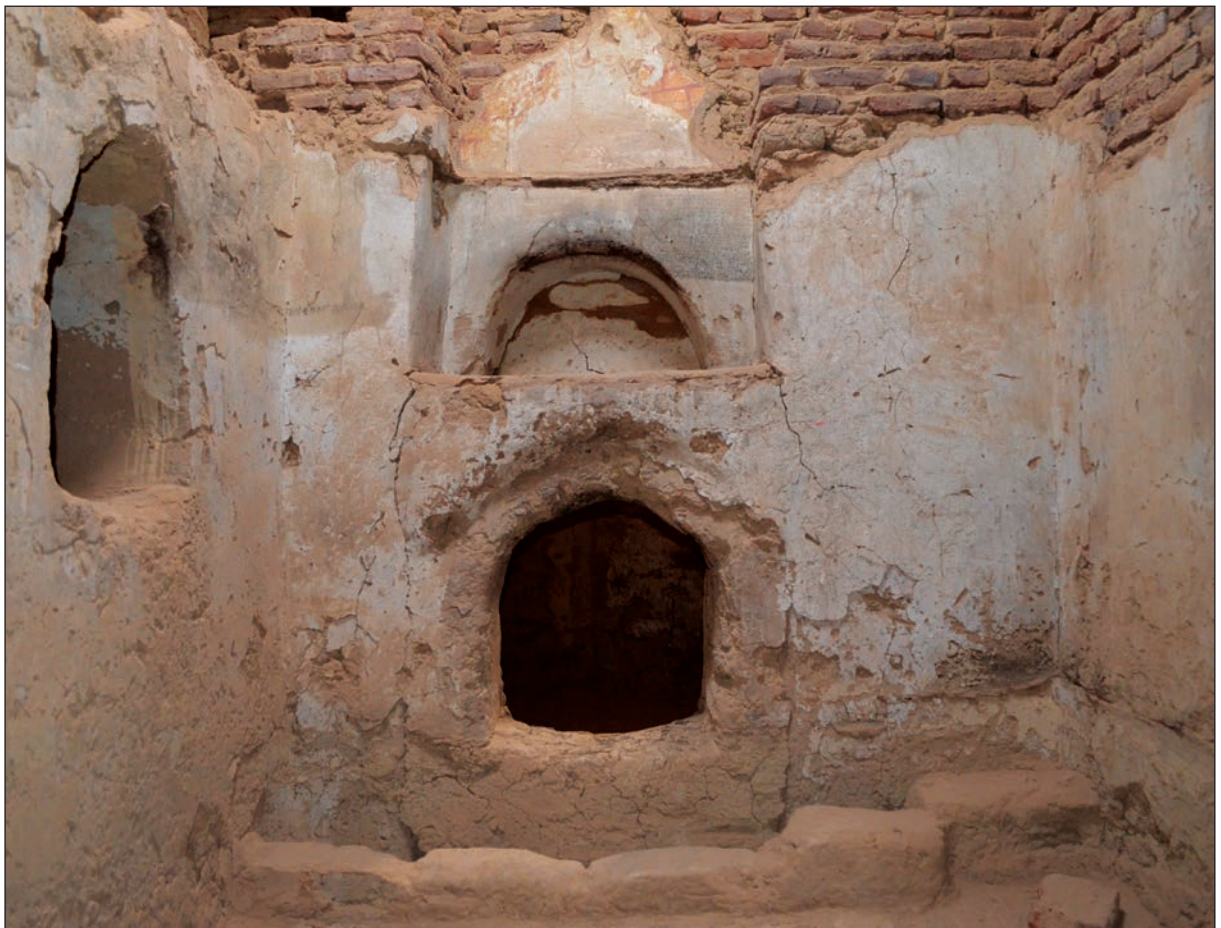
Fig. 4.25. Building B.VIII: eastern part of the prothesis, the altar viewed from the west

the wall plaster near the altar, as well as the fragmentarily preserved representation of Christ with a chalice, located above [Fig. 4.25].

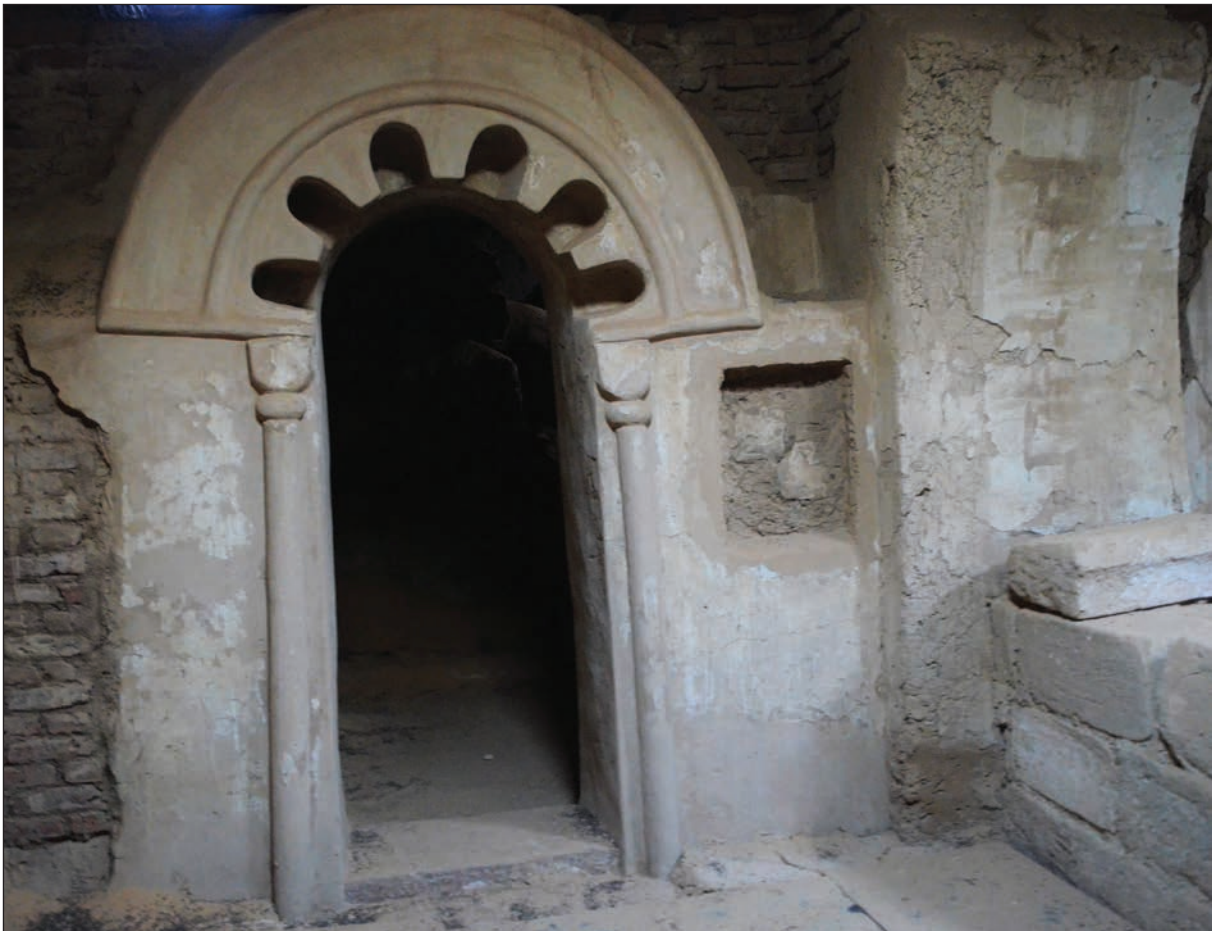
Fig. 4.27. Building B.VIII: altar screen with the entrance to the northern sanctuary

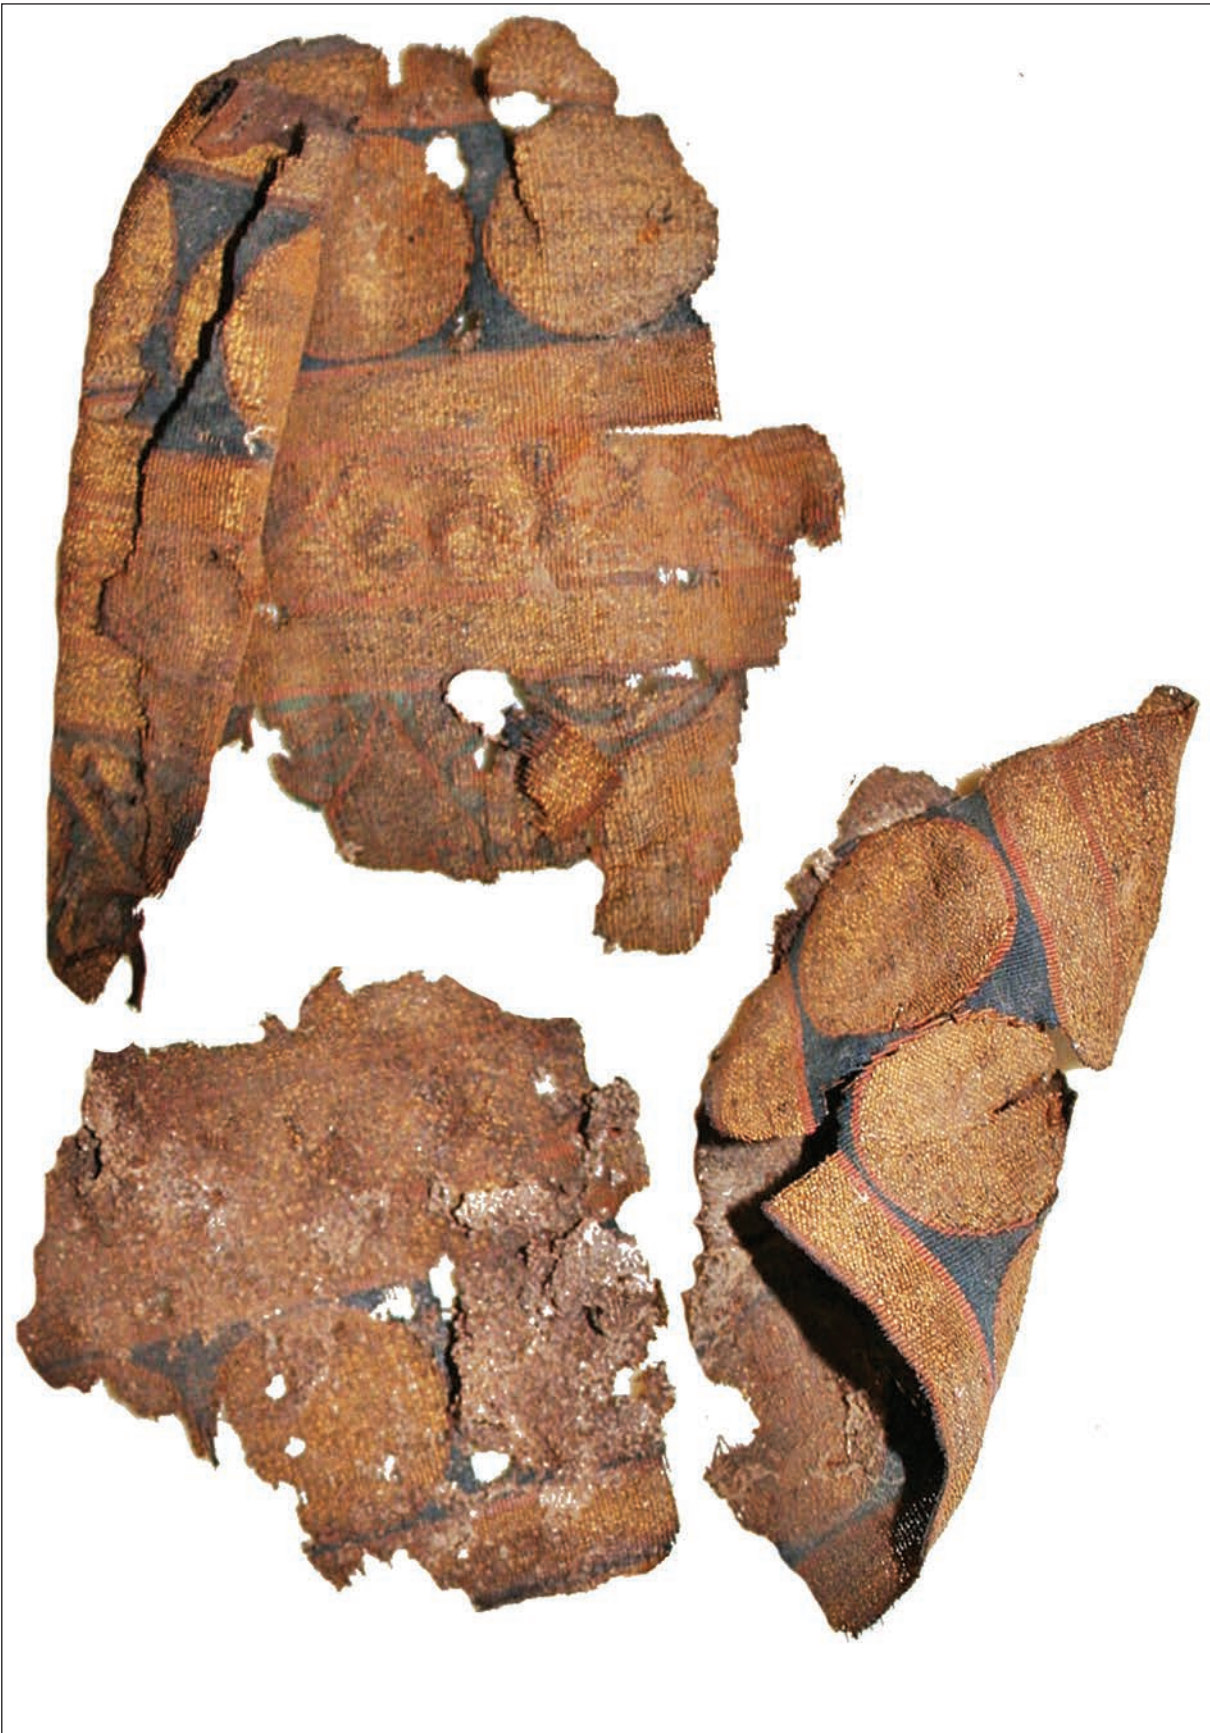
Fig. 5.2. Three fragments of the “golden textile” from crypt K.2 of the monastery on Kom H in Dongola

A remarkable object, fragments of which had already been identified and documented during the first opening of the crypts in 1990, was found in crypt K.2. Among the few textile fragments preserved in the burial vault were three pieces of silk textile with gold thread [Fig. 5.2]. Comparison of photographic documentation of the fragments recovered and documented in 1990 to the piece attributed to the same textile and excavated in crypt K.2 in 2009 gave a positive match (Godlewski, Mahler, and Czaja-Szewczak 2012). The textile found in 2009 (HDd.09.048) is the same textile as the one documented in 1990 (identical weaving technique and ornament), although it is not the same fragment.

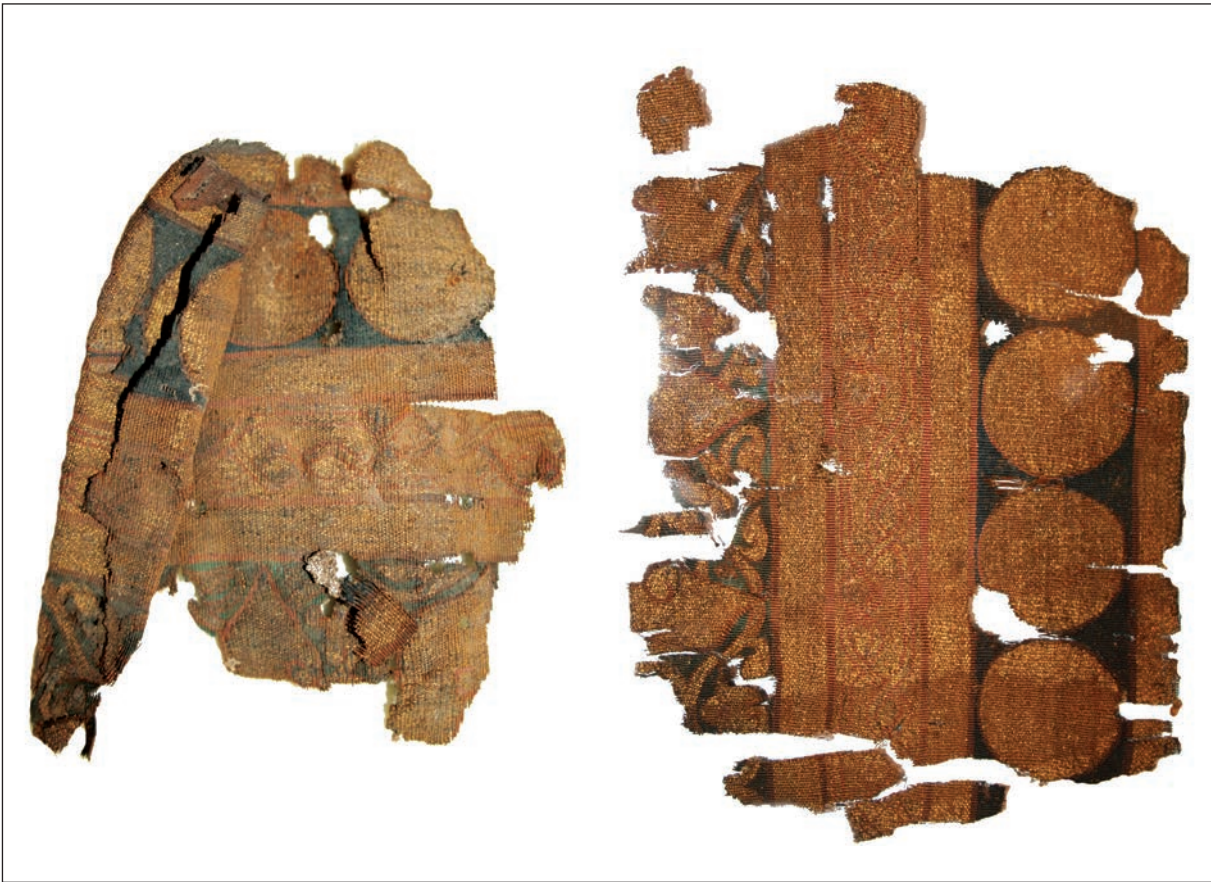
Fig. 5.7. One of the fragments of the textile: left, before conservation; right, after straightening and cleaning

The first stage of conservation consisted in cleaning the textile of surface dirt and other impurities that had penetrated into the fabric. The textile was stiff, and its fibers were very dry, brittle and prone to breakage [Fig. 5.7]. Prior to cleaning, the object was swabbed for microbiological testing. The analysis results showed no microbiological growth in progress. The cleaning

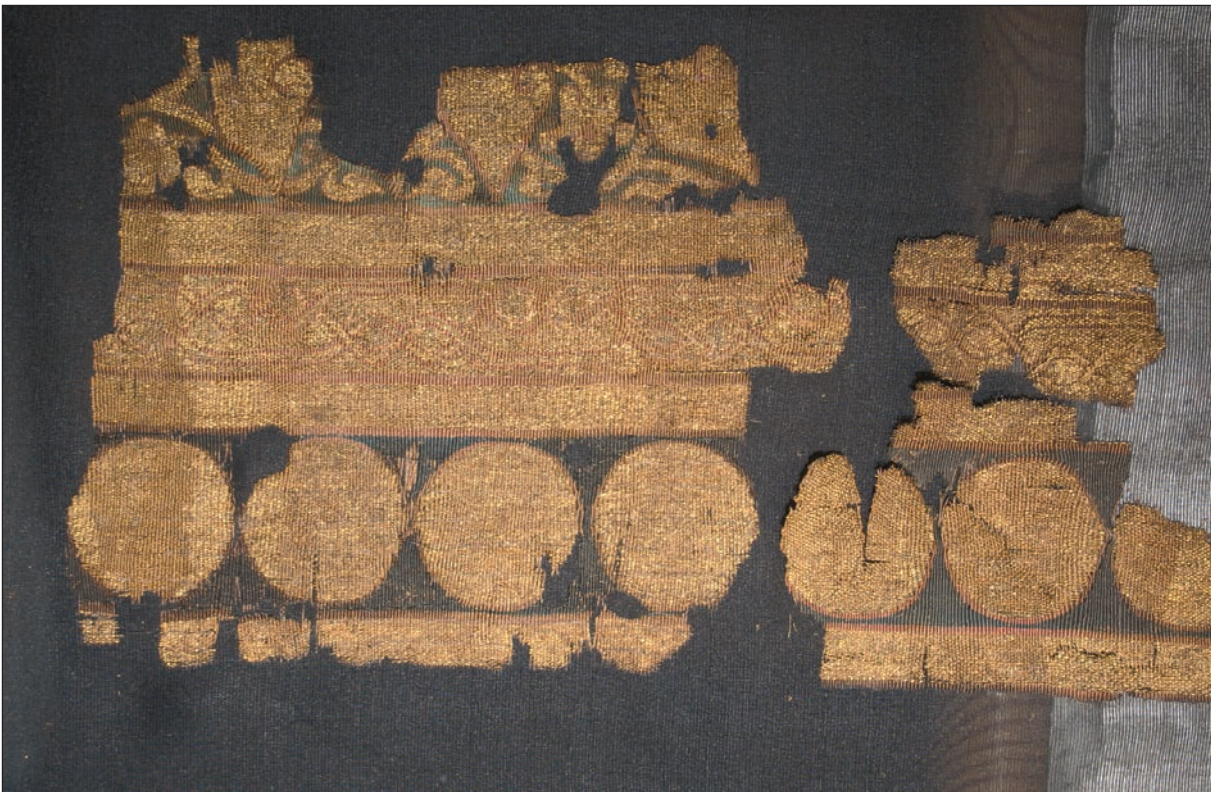
Fig. 5.8. Textile fixed with conservation stitches to a secondary silk ground

textile were first laid out on the silk plain weave [Fig. 5.5]. After arranging the fragments in such a way as to obtain continuity of the pattern, the original was secured to the support with silk yarn by tacking down the edges and surfaces with conservation stitching: self-couching stitch and laid-couching stitch [Fig. 5.8]. Once fixed to the support, the textile was stretched on a piece of acid-free cardboard. For prophylactic reasons it was decided to mount the piece in a clip frame, inserting a passe-partout to keep the glass pane away from the textile [Fig. 5.9].

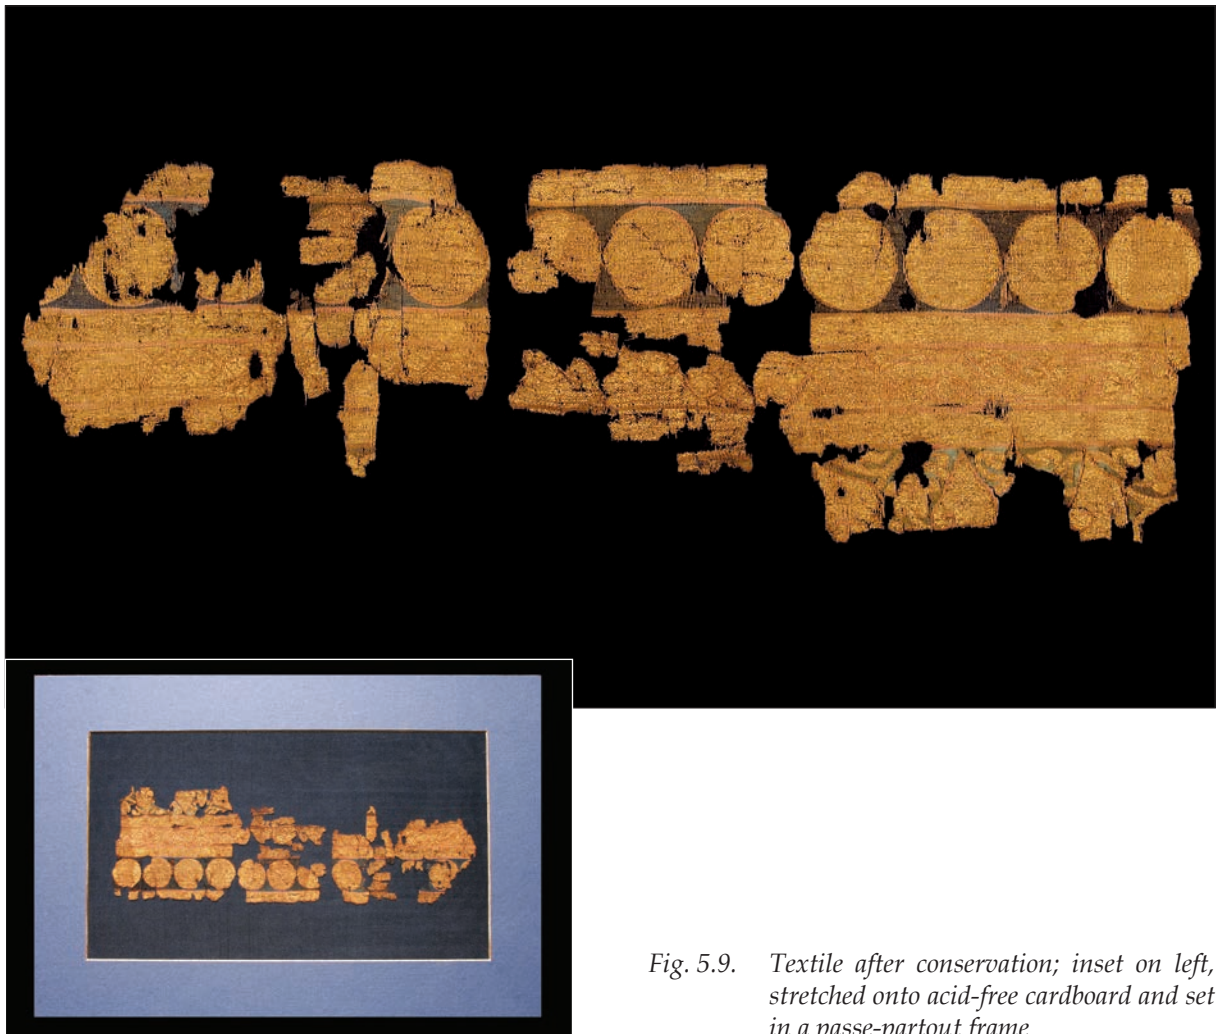
Fig. 5.9. Textile after conservation; inset on left, stretched onto acid-free cardboard and set in a passe-partout frame

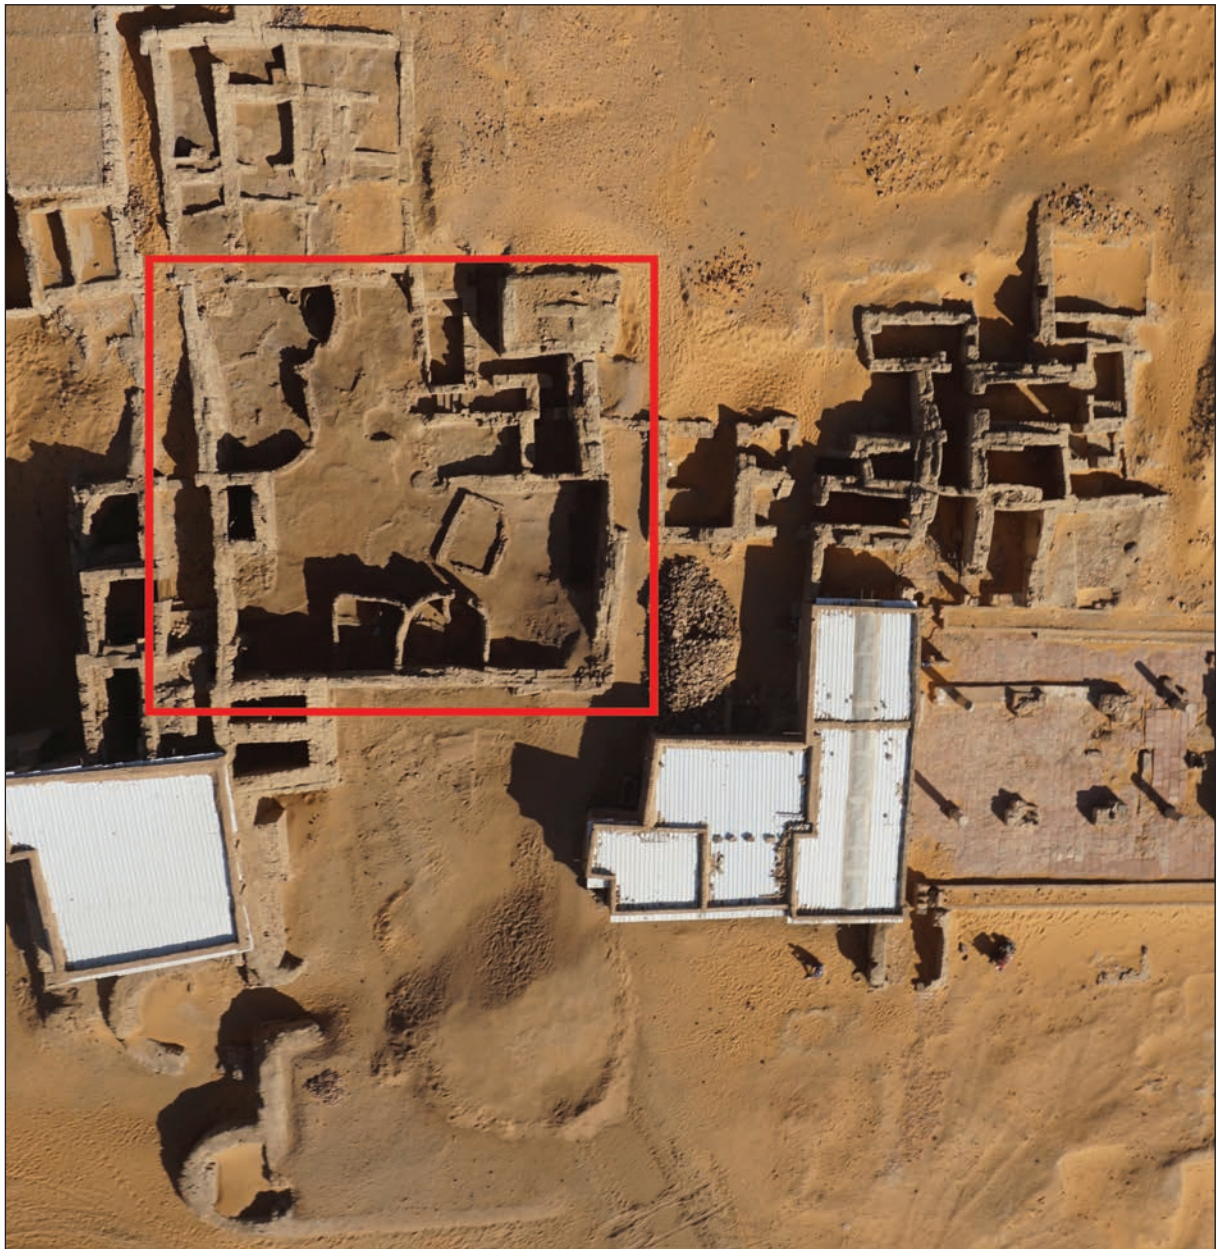
Fig. 7.3. Aerial view of the southwestern part of Kom H with the location of the investigated area

From 2014 to 2016, excavations in the Monastery on Kom H in Dongola concentrated in Courtyard A, an open area located to the northeast of the so-called Southwest Annex, or Gatehouse H.SW.B (Godlewski 2015e: 277–279) and to the south of the so-called Main Building¹ (Jakobielski 2010) [Fig. 7.3]. The area under investigation also included rooms and areas provisionally investigated by Stefan Jakobielski and referred to in previous scholarship as SW-E.14, SW-E.15 and SW-E.16 [Fig. 7.2] (Jakobielski 2010: 83, Fig. 82; Jakobielski and Martens-Czarnecka 2008: 331–334 and 326, Fig. 1). Since excavations in Courtyard A have yet to be completed, this report should be regarded as a preliminary consideration of the results obtained thus far.

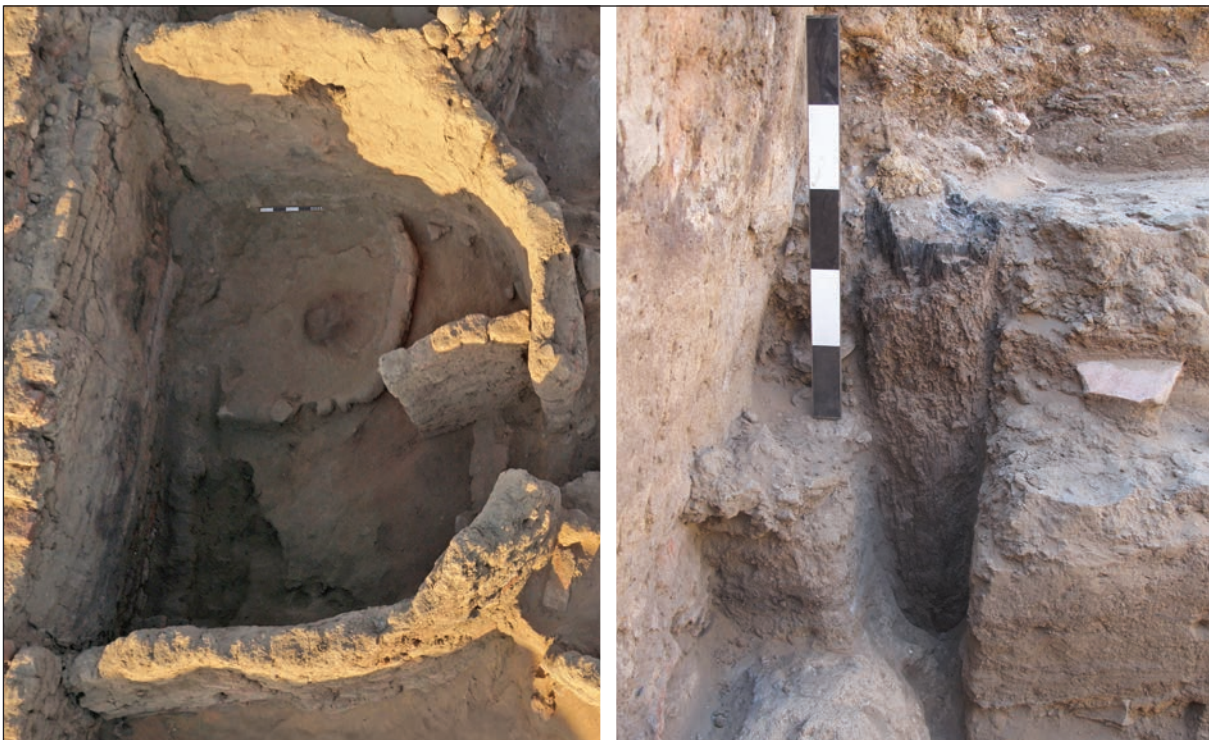
Fig. 7.6. Room 1, Phase III: left, top view looking west; right, relic of a palm-wood post supporting the roof

The earliest structure in the courtyard's open space (Phase III) was Room 1, built against the south wall of the courtyard (F8) [Fig. 7.6 left]. It was a semicircular structure measuring 2.90 m by 3.50 m, with walls preserved up to about 2 m in

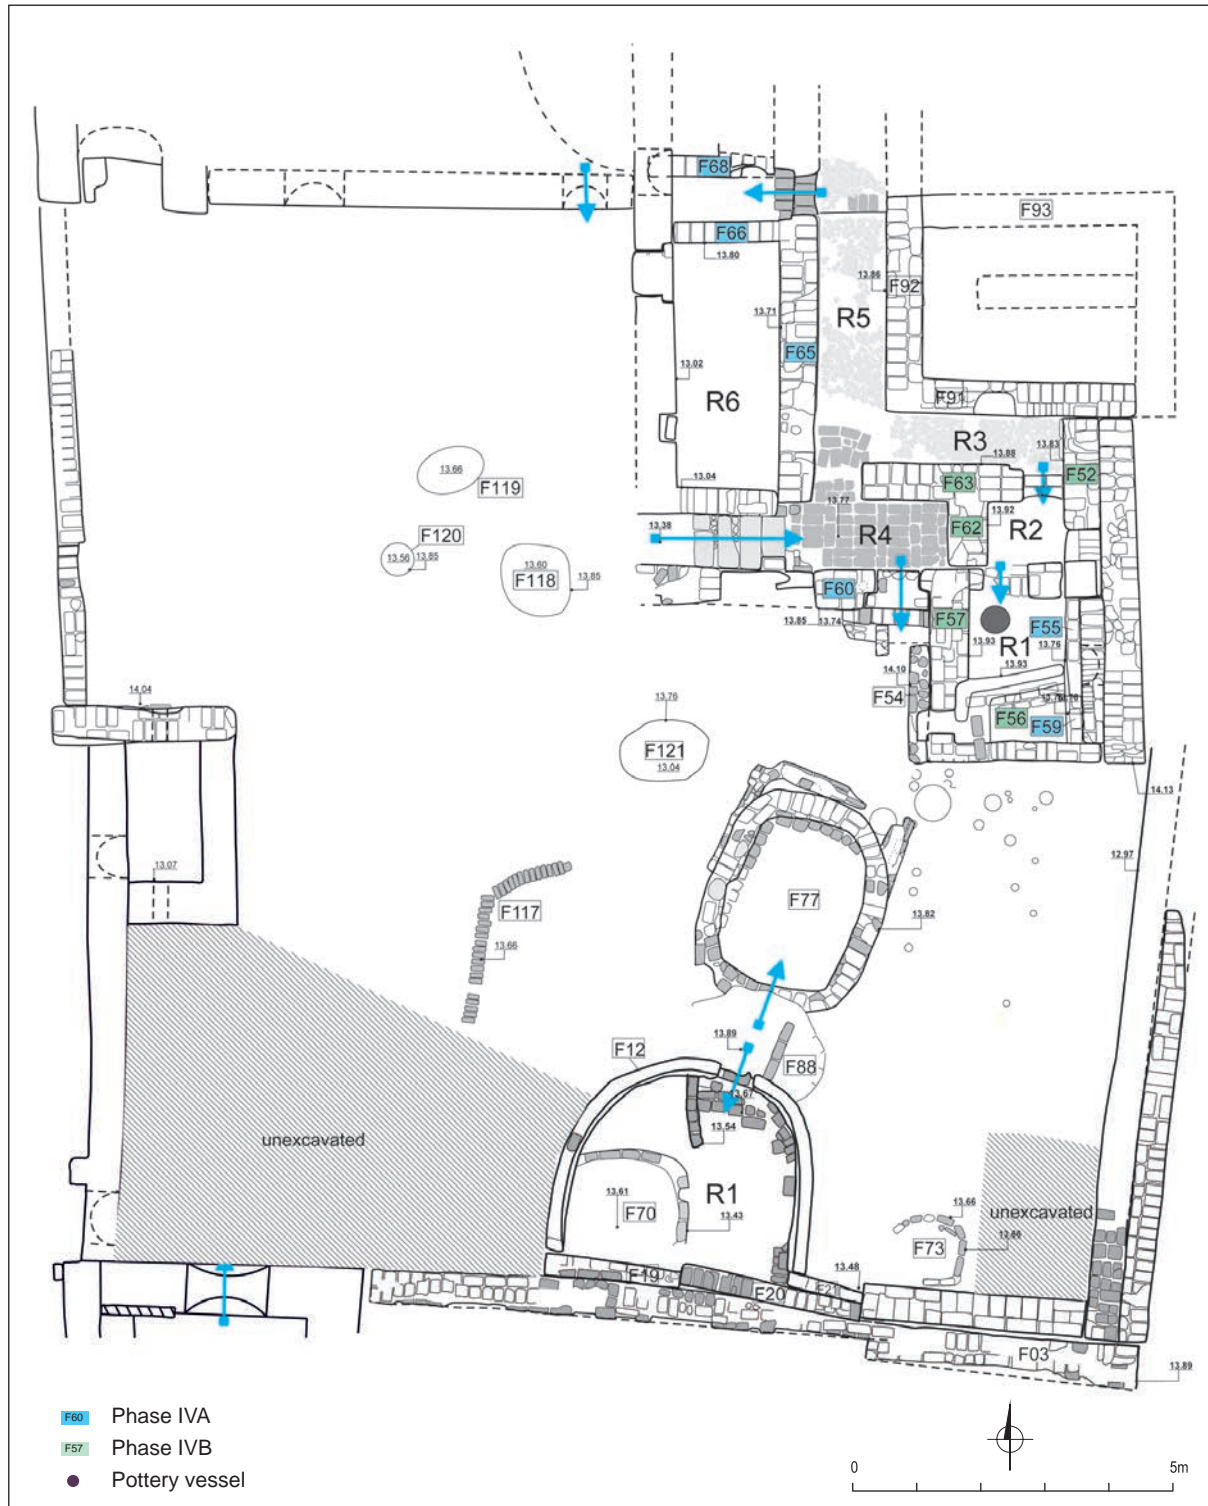
Fig. 7.7. Courtyard A in Phase IV: two episodes (A and B) of structural change

The level contemporary to the functioning of building H.B.01 in Phases IV and V was reached in most of the courtyard space [Fig. 7.7]. To the west of H.B.01, an area used for food preparation was uncovered and found to have operated consistently, with small changes, through Phases V and VI.

In Phase IVB, walls F52, F62 and F63 were built, creating Room 2 (an anteroom for Room 1) [see Fig. 7.7]. F62 was the new west wall bonded with F63, an east-west oriented wall that formed the northern boundary of the room. The east wall was the older wall F90 and its later extension to the north, F52. The bottom courses of F63 formed the threshold in the doorway to the room and abutted wall F52.

In Phase IV, new structures emerged in the southern sector of the courtyard. Oval enclosure F77 was constructed to the north of Room 1 [see *Fig. 7.7*]. Its walls, built of fragments of mud bricks and baked bricks, are preserved to a height of a maximum of 0.30 m. It is possible that the entrance to the structure was located in the south, close to Room 1, as the wall is lowest in that part and the top surface of the bricks is level with a mud walking surface to the north of the entrance to Room 1. Between the doorway and F77, to the east, there was a semicircular mud-plastered area with traces of burning (F88). A child's footprint (L. 20 cm; W. 8 cm) was preserved in its surface [*Fig. 7.9* right].

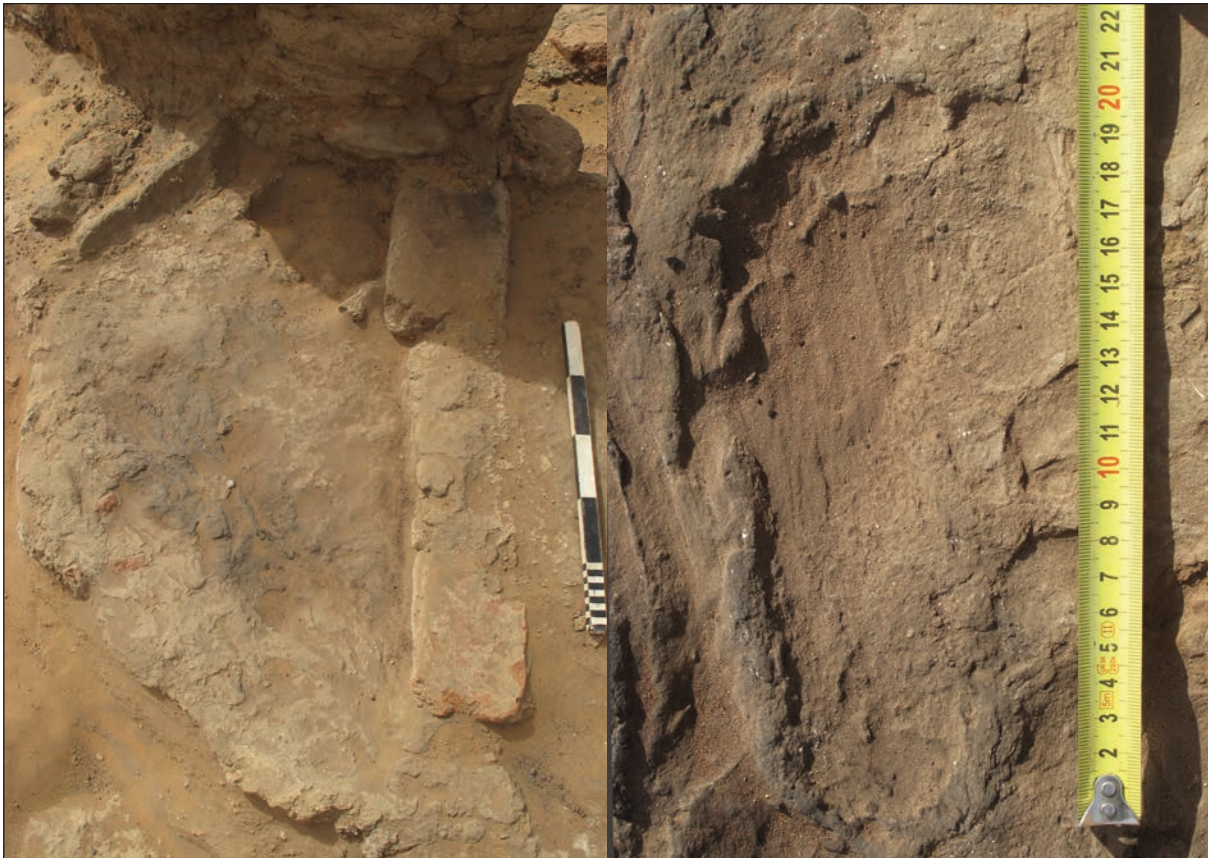
Fig. 7.9. Plastered surface F88 (left) and a footprint of a child in the mud coating (right)

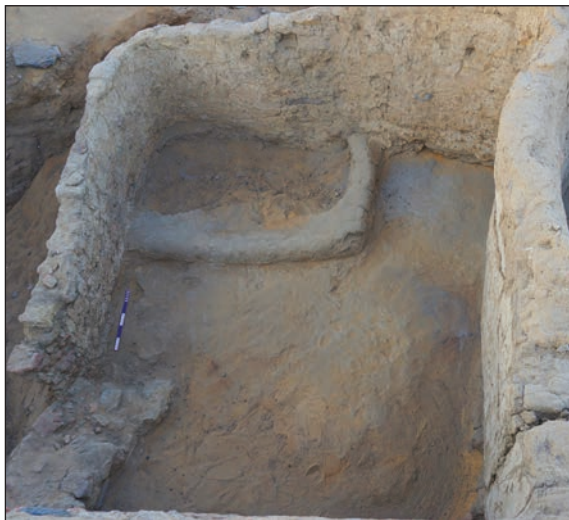
Fig. 7.10. Room 2, Phase V, aerial view looking north

easily accessible to those who entered the courtyard through the Gatehouse and it neighbored on the vaulted room SW-E.13. In its original phase, Room 2 was furnished with a low, rectangular mastaba F71 (1.27 m by 1.80 m, H. 0.20 m) located in its northwestern corner [Fig. 7.10]. A tamped walking level in Room 1 seems to correspond to the same phase. Room 2 may have replaced Room 1 in the function of a dwelling space; in this period, Room 1 is no longer roofed – the vertical palm-wood post was reduced to the walking level – and there are traces of cooking activity inside, such as burnt areas on its south and northwest walls.

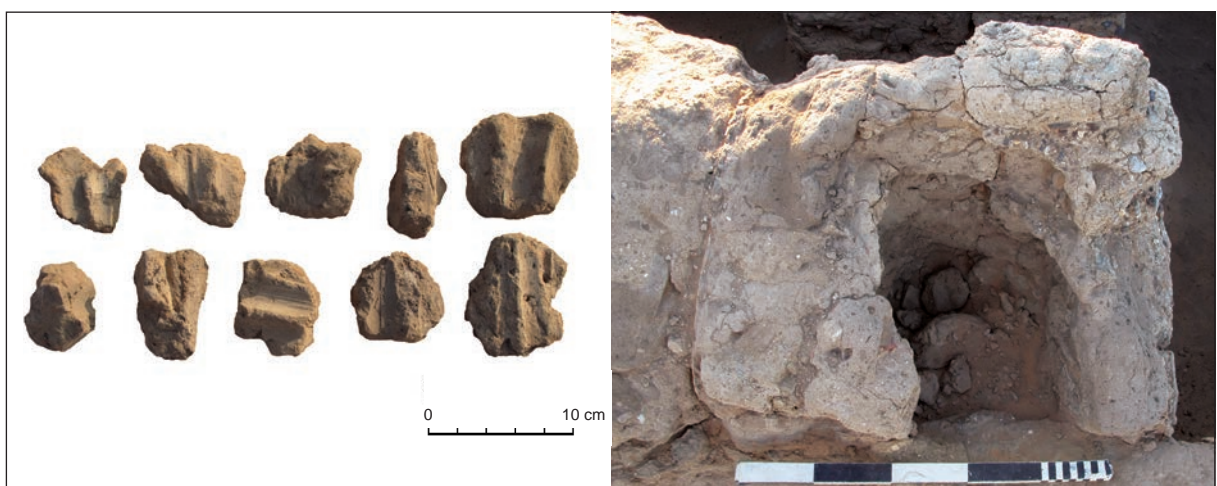
Fig. 7.12. Evidence of a flat roof over Room 5 in Phase VIIIA: left, fragments of mud ceiling with reed impressions found in SW-E.16; right, mud-brick casing for a now-lost palm-wood post

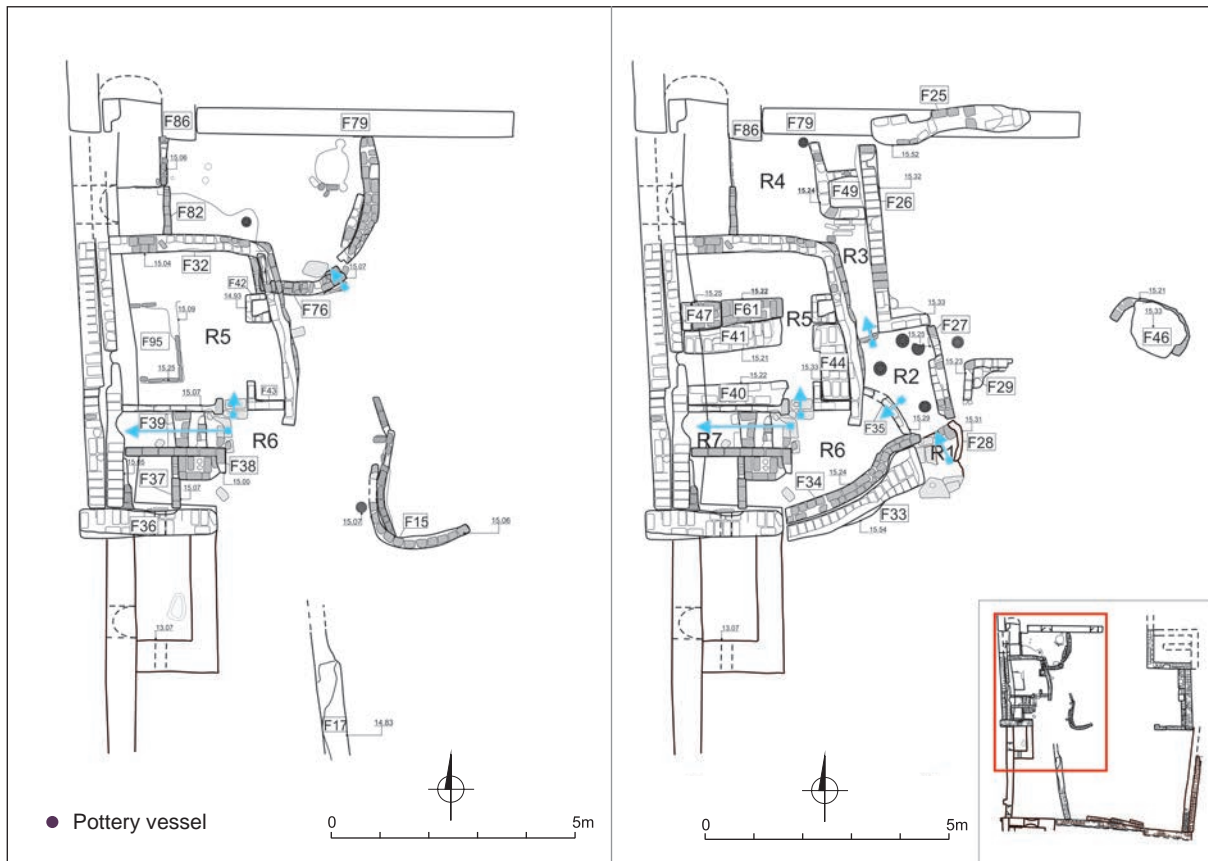
Fig. 7.13. SW-E.16 in Phases VIII: left, Phase A; right, Phase B

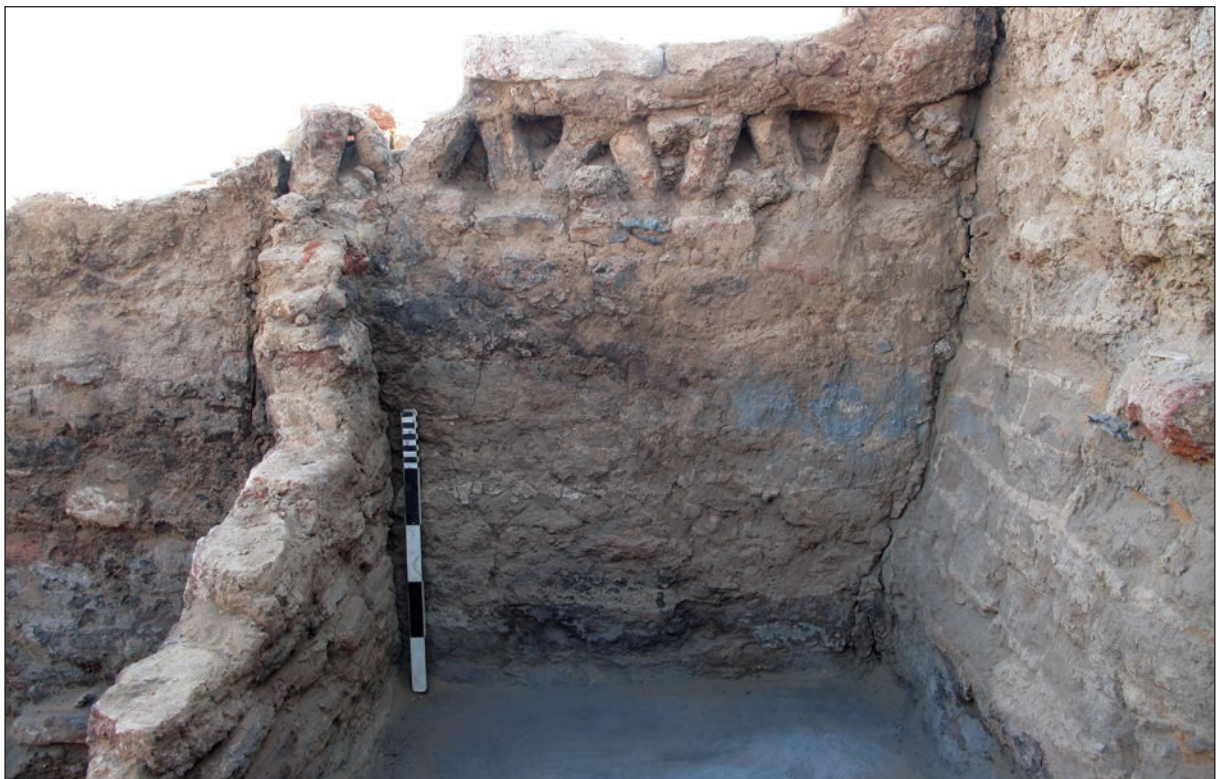
Fig. 7.14. SW-E.16: cooking space in the western part of Room 4

baked bricks adorned wall F32. It is impossible to determine if such decoration was originally present on all walls of the room or if it was limited to the cooking area [Fig. 7.14].

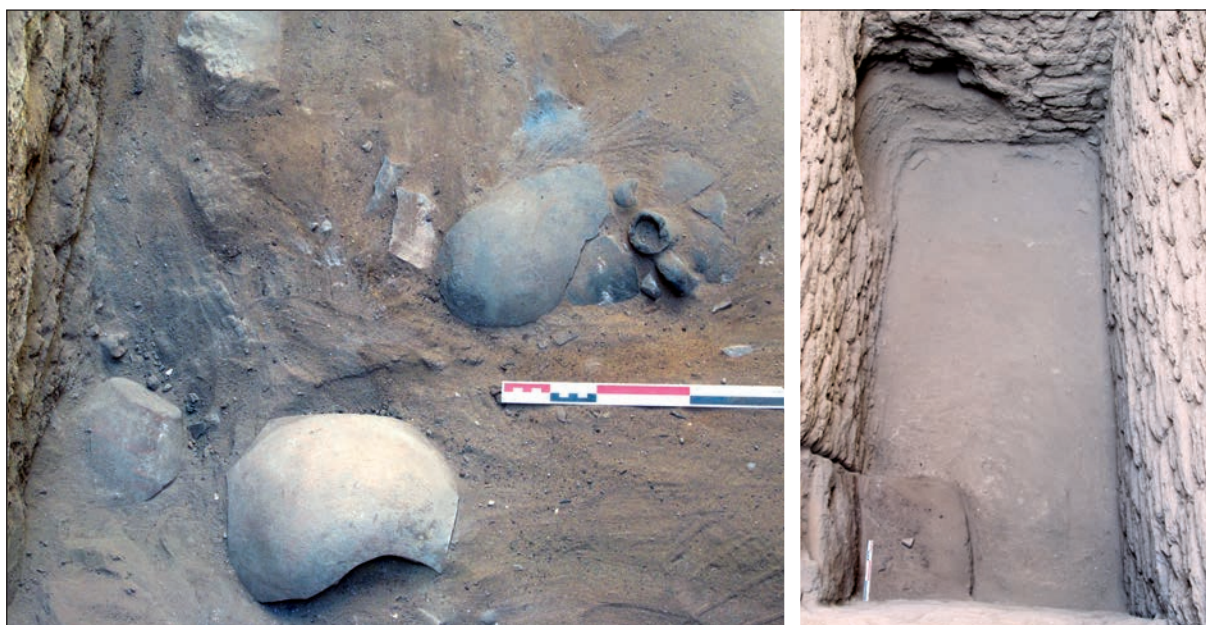
Fig. 7.15. Room SW-E.15: left, dump layer 66; right, the excavated room seen from above with a doorway in the southwestern corner and damaged northwestern corner

It seems that in Phase VIII the room was no longer in use and functioned as a garbage dump. Its upper fill was partially excavated by Jakobielski, but below an approximately one-meter layer of windblown sand original dump deposits were reached. The layers of refuse had a total thickness of approximately 2 m. They were excavated as three layers: 43, 46, and 66 [Fig. 7.15 left].
