DONGOLA

FIELDWORK
CONSERVATION
AND SITE MANAGEMENT

PCMA Excavation Series 5

QATAR-SUDAN ARCHAEOLOGICAL PROJECT (QSAP)
NUBIAN ARCHAEOLOGICAL DEVELOPMENT ORGANIZATION

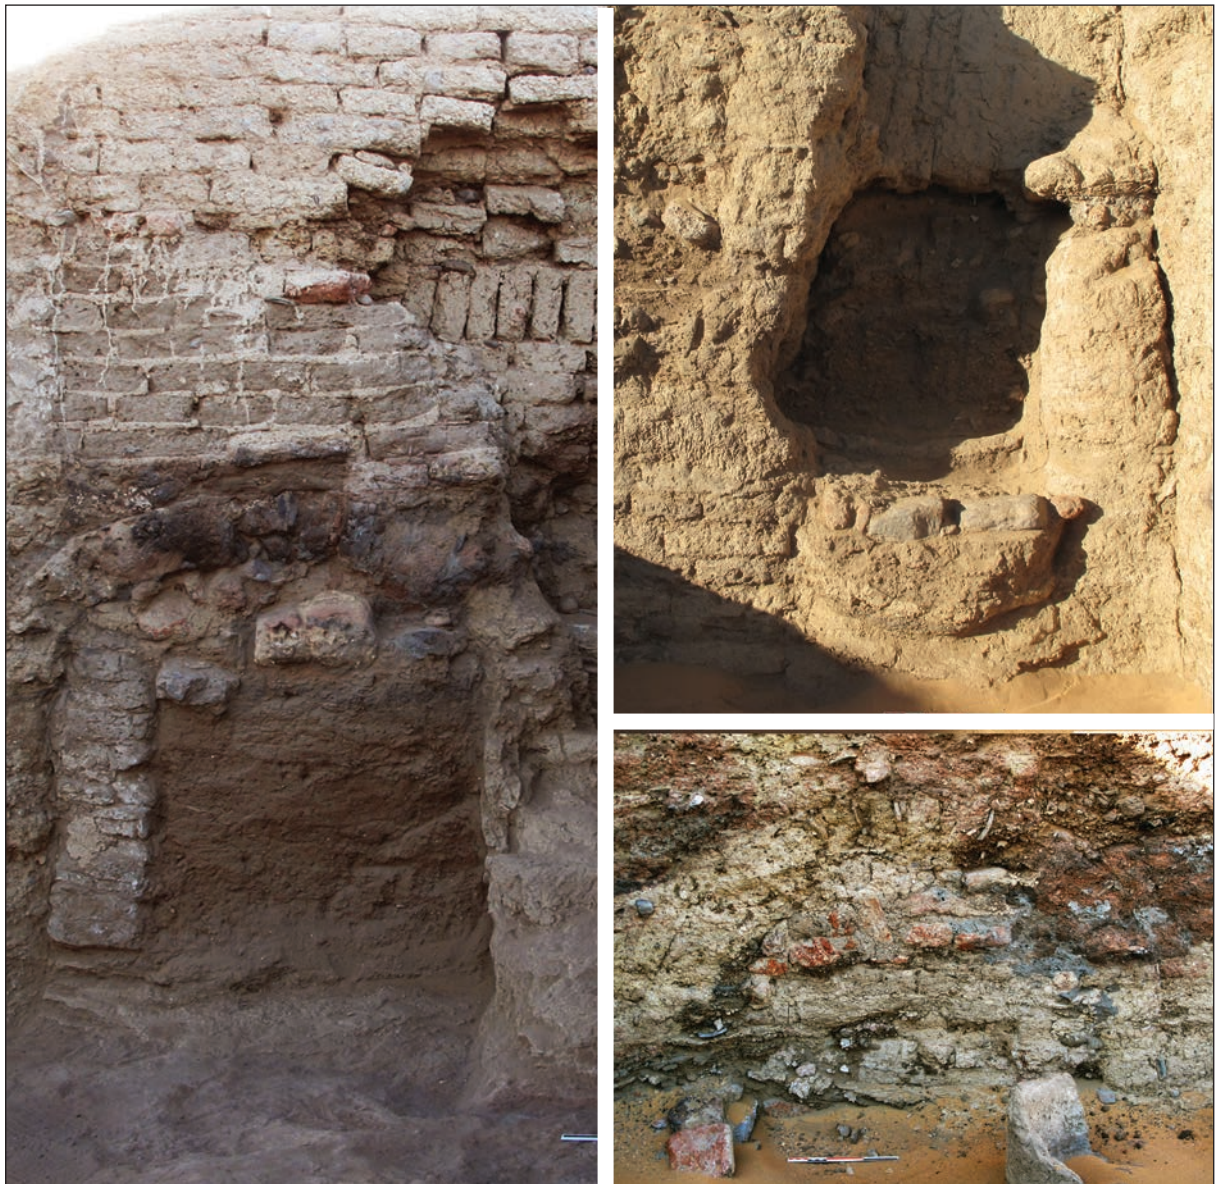
Fig. 7.16. Doorways leading to Courtyard A from the north and west: left, western doorway in wall F31, opening on the western cooking area; top and bottom right, entrances to the Main Building

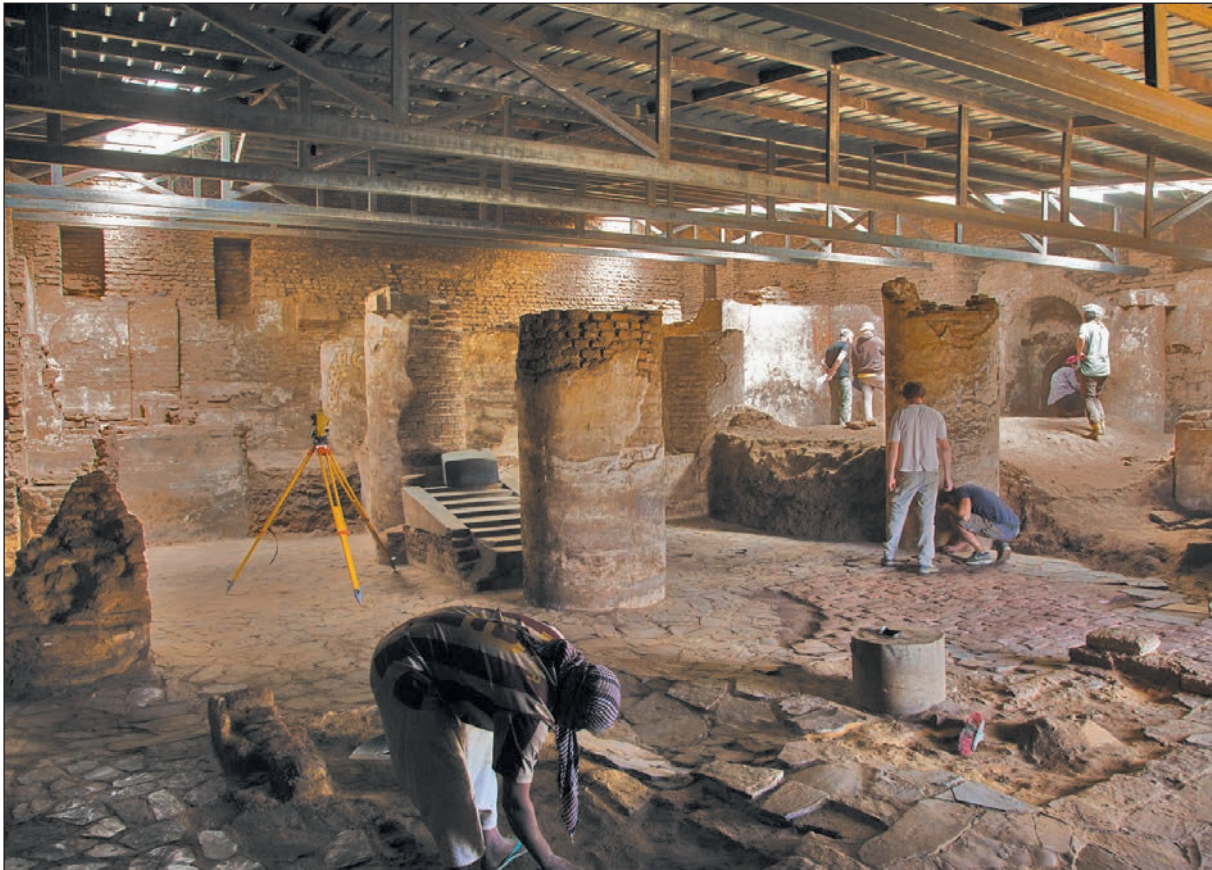
Fig. 10.3. Documentation inside the church, view from the west

The interior of the naos is articulated by four freestanding pillars, which together with cylindrical engaged pillars support the arches and vaults reaching different heights above the naos. It is without a doubt that the domed central part of the naos was the highest part of the complex [*Figs 10.3, 10.5*].

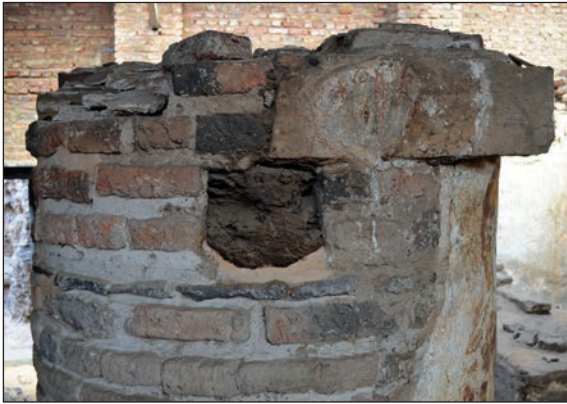
Fig. 10.4. Northeastern freestanding pillar

designed curved bricks joined with lime mortar. Their preserved upper surfaces were capped with pairs of sandstone blocks, which served as bases for arches and held beams that connected the freestanding and engaged pillars. The stone capping is preserved *in situ* only on the northeastern freestanding pillar (CNE) [Fig. 10.4], but most of the other blocks were found in the fill of the church.

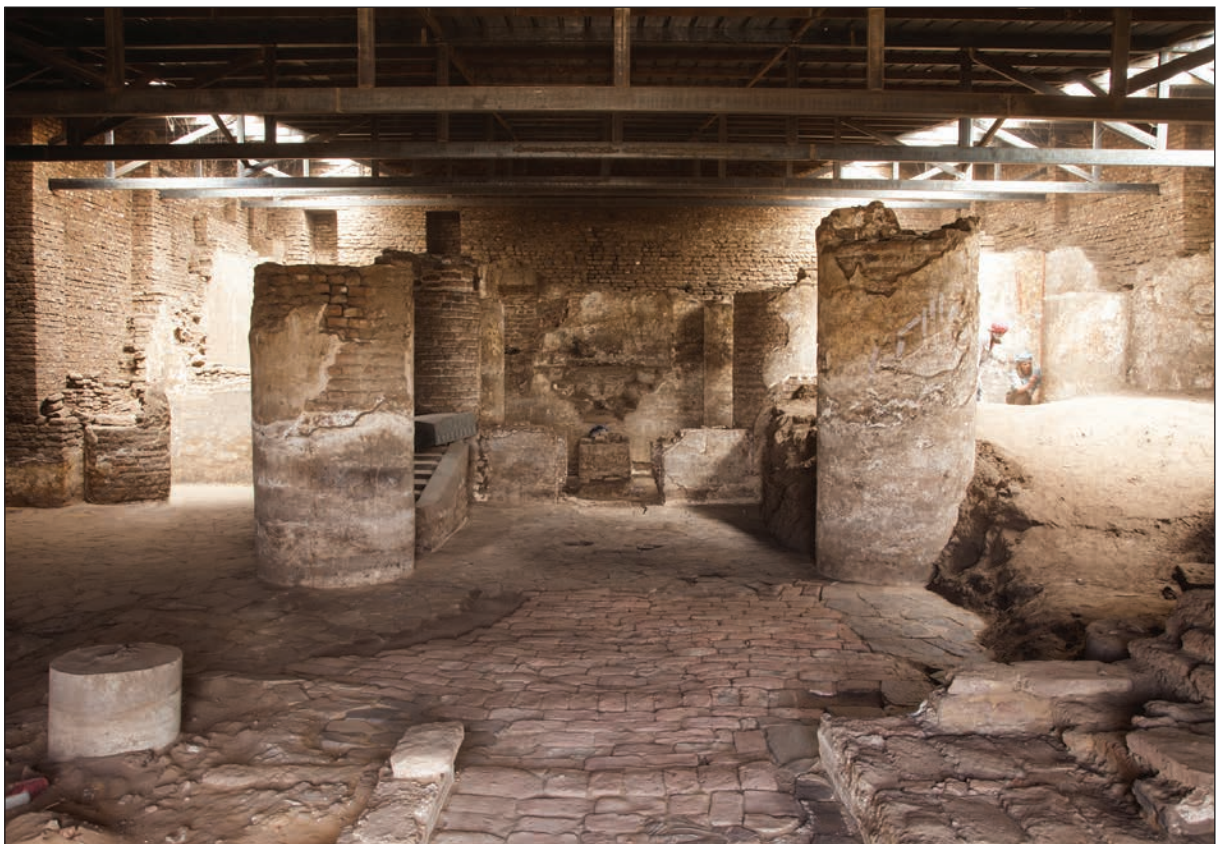
Fig. 10.5. Church naos, view from the west toward the apse

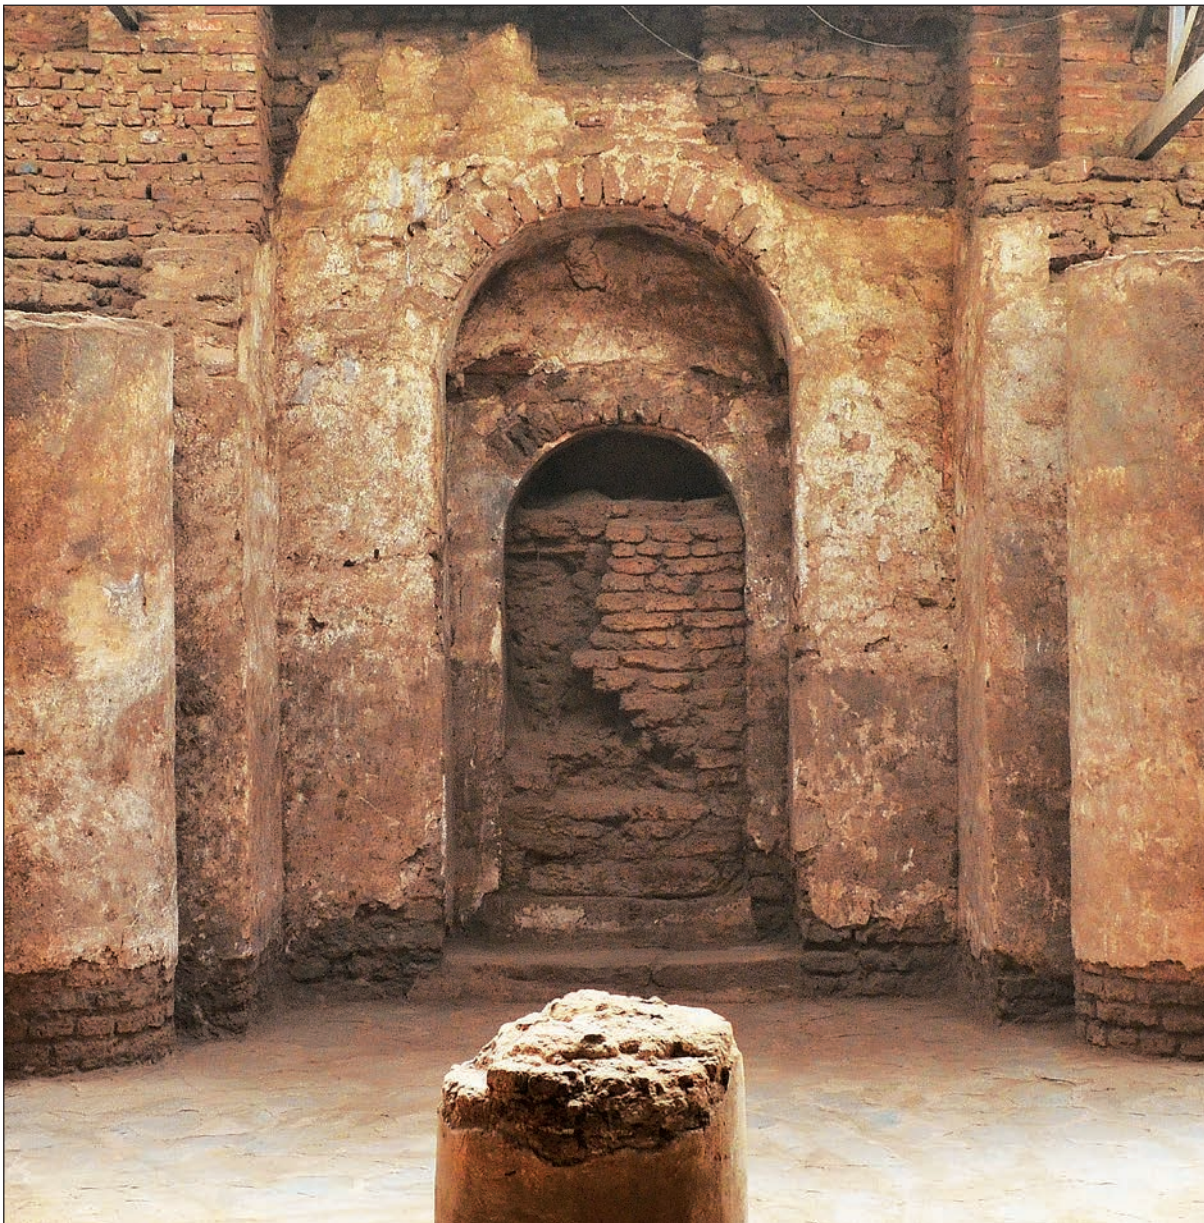
Fig. 10.7. Entrance to the church from the south, view from inside the naos (see Fig. 10.6)

The southern arm of the naos holds an entrance to the church [Figs 10.6, 10.7]. The doorway has been excavated only on the inside and was found partly blocked with a wall that probably dates from the late period of operation of the church.

The south wall features a recess 2.68 m wide and 0.84 m deep, flanked by two lateral engaged pillars. This bay had a vaulted ceiling, which is preserved only in the lower part, on the eastern side. In the center beneath the vault was a window preserved only to the level of the window-sill, which is 0.70 m in width. The entrance was located below the window, in the south wall of the bay. It was splayed towards the inside, where it measured 1.40 m in width and was topped with an arch 2.97 m high and 0.66 m deep. On the external side the passageway was narrower, 1.02 m, but it also had an arch, which was 1.83 m

high above the naos floor. A wooden beam was inserted 23–35 cm deep into the side walls above the external arch of the entrance.

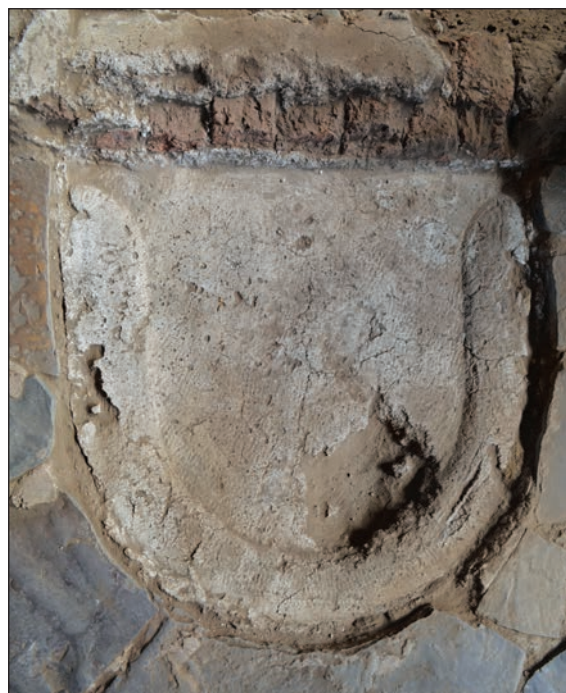
Fig. 10.8. Imprint of a semicircular slab preceding the western entrance to the sanctuary area (see Fig. 10.1)

A central entrance opened in the west screen. Its width from the naos was 1.20 m, reduced to 1.00 m on the other side. The upper part of this structure is missing. The floor in front of the entrance preserves an imprint of a semicircular slab, 0.82 m wide and 0.84 m high, with a 13-cm-wide band along its rounded edge. The impression is slightly embossed at the base [Fig. 10.8].

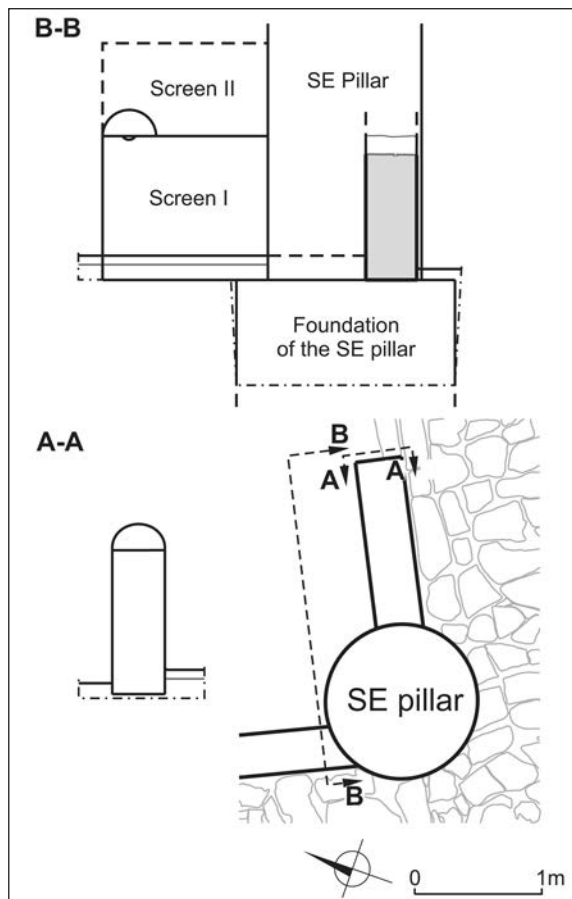
Fig. 10.9. Southern altar screen wall: sections through foundations of the southeastern pillar and the late changes to the wall

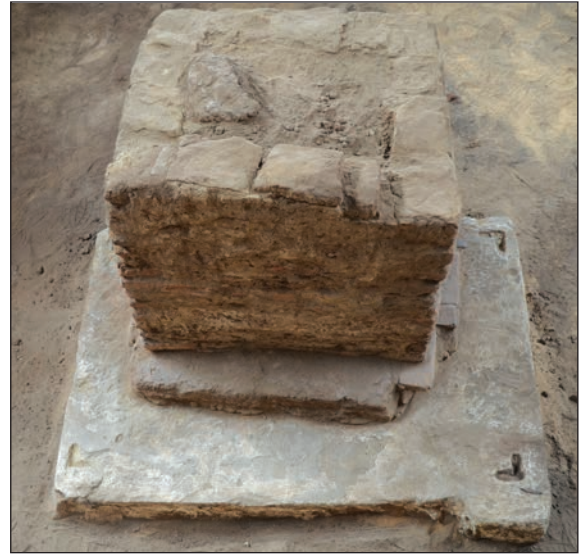
Fig. 10.10. Altar viewed from the east

The altar was placed relatively close to the front of the high *synthronon*, at a distance of 0.95 m. A relic of the original altar is a stone slab measuring 119 cm by 86 cm, on which the altar was founded. The slab's corners have holes in the shape of the letter *gamma*, probably for mounting metal joints. They delineate a rectangular area 1.09 m by 0.73 m. The slab is probably a *spolium*, but this cannot be determined without lifting the stone, which lies beneath a late altar built of baked bricks. The late altar is only partly preserved [Fig. 10.10]. It was founded on a soil deposit that had covered the slab after removal of the floor in the sanctuary. A square feature measuring 0.73 m by 0.73 m with a preserved height of +0.74 m occupied the central part of the sanctuary.

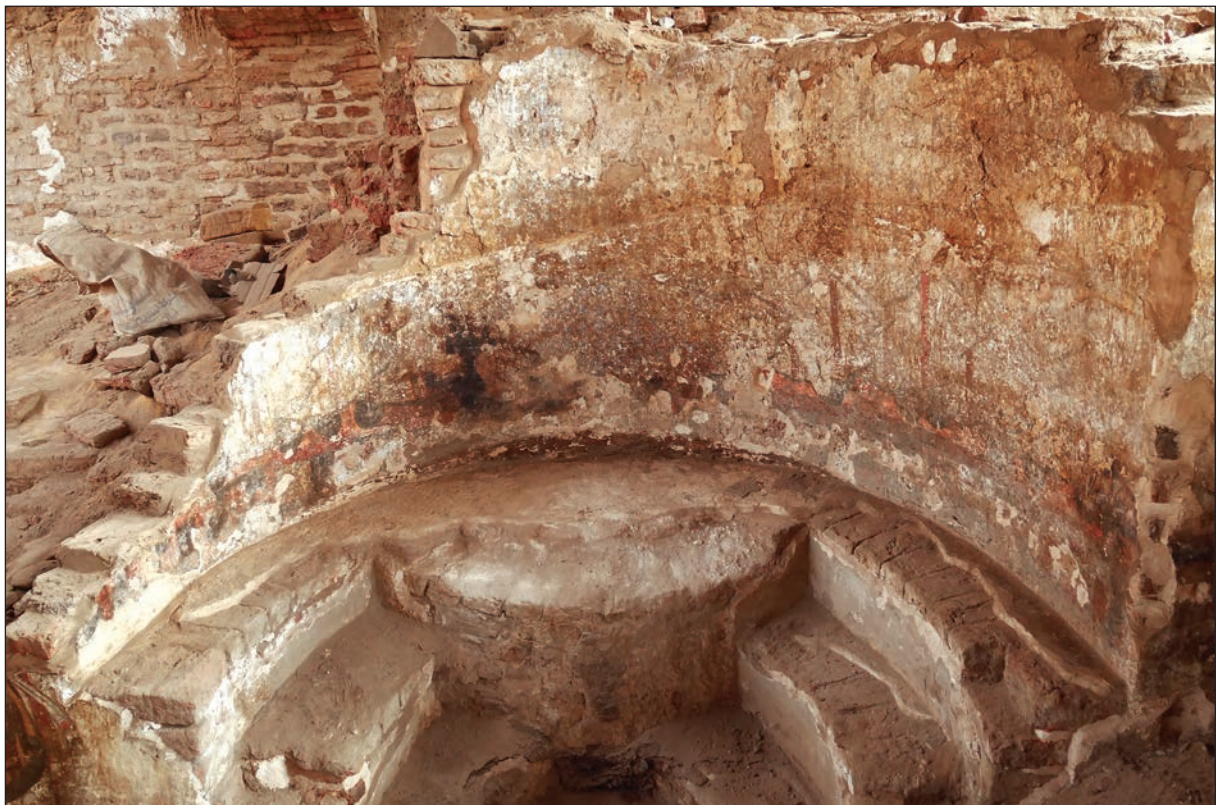
Fig. 10.11. Synthronon, frontal view from the naos

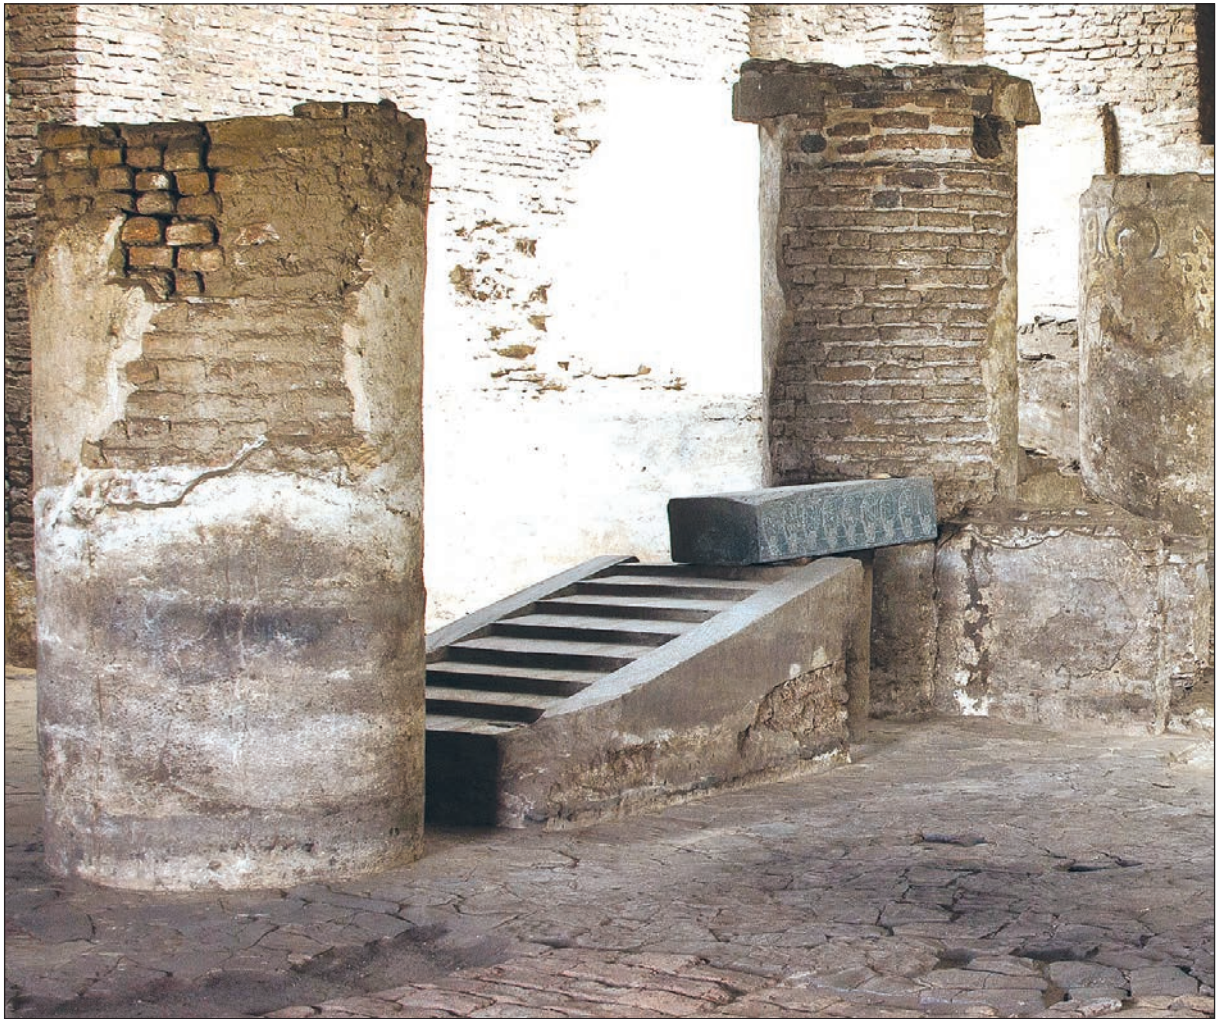
Fig. 10.12. Pulpit incorporating granite elements from a Kushite temple, view from the naos

The pulpit was situated between the northern freestanding pillars. It is a massive construction measuring 1.80 m in length and 1.27 m in width, built of baked bricks in the foundation part and incorporating granite *spolia*. The pulpit is preserved *in situ*, and it is almost complete. The missing granite slab of the platform was found near the northern entrance to the church. Granite stairs, probably from a sanctuary of a Kushite temple, stand on a rectangular base 0.50 m high. The brick base was diligently plastered.

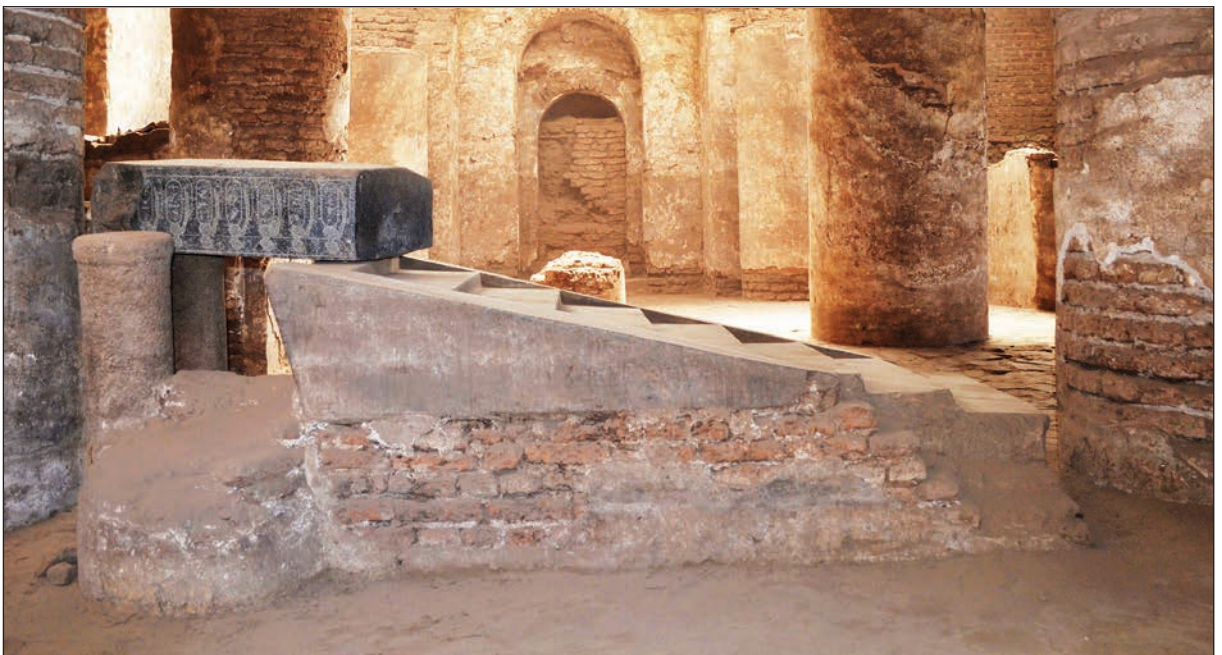
Fig. 10.13. Circular feature on the northern side of the pulpit, view from the northern aisle

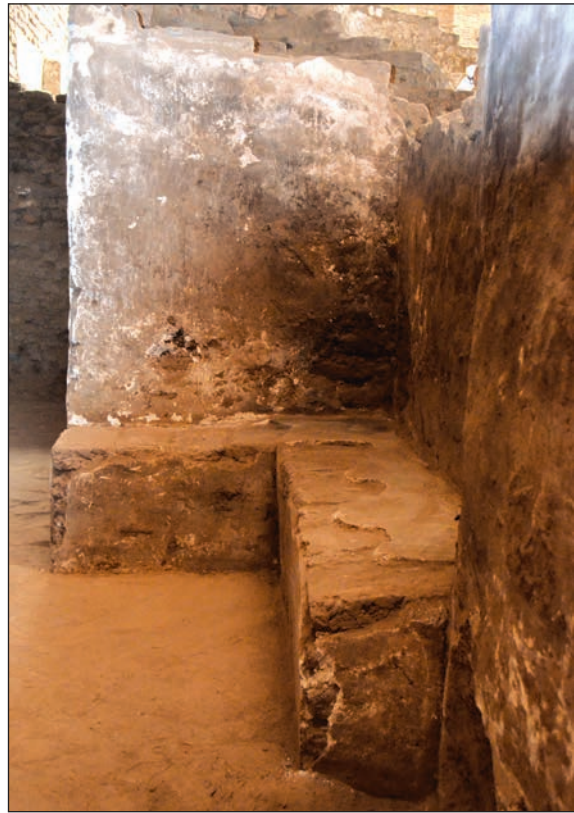
Fig. 10.14 Bench in the *prothesis*, view from the north

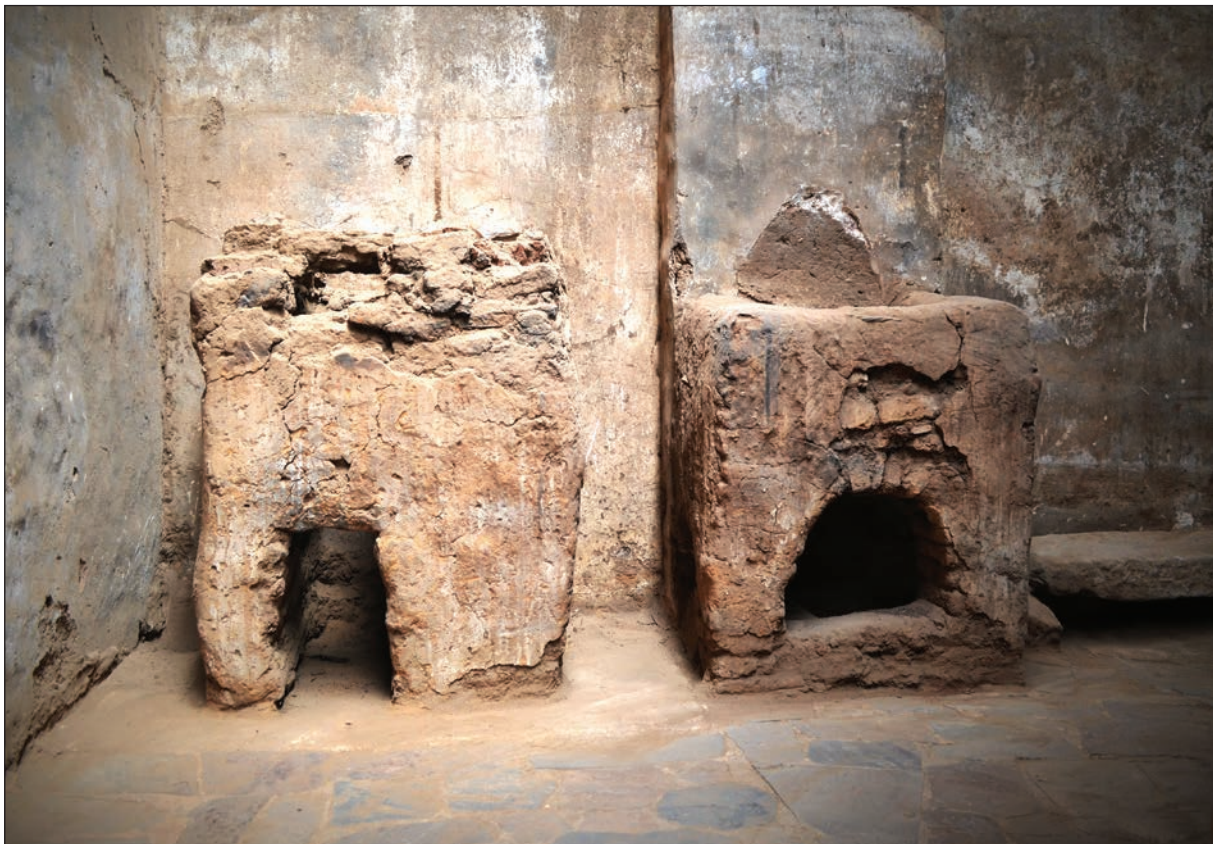
Fig. 10.15. Late altars in the *prothesis*, view from the west

Furnishings of the *prothesis* included features dating back to the original building: a bench along the wall of room 2 and a stone slab by the east wall of room 1, on which the original *prothesis* altar had once stood. In addition, two altars dating from a later phase are preserved. One of them is located next to the east wall of room 1, while the second one abuts the face of the eastern pilaster [Fig. 10.15]. Stone elements of the bench

They were located 0.82 m above the floor. The walls are one-brick thick and measure 0.12 m in width. The feature measured 0.82 m by 0.72 m and reached a height of 1.11 m. The interior is empty and the walls lack plaster or wash. Mud plaster was hastily laid only on the external walls. A small hole measuring 24 cm in width and 44 cm in height was found at the edge of the north wall. The upper surface of the feature was built of large bricks laid on small beams. In its flat surface there was a rectangular hollow by the wall, measuring 20 cm by 25 cm. The upper part is damaged and some elements of it are missing [see *Fig. 10.15*].

The southern altar stands on the stone floor against the eastern pilaster. The feature, built of baked bricks of different sizes, was shaped to resemble a four-legged table. It measured 0.75 m by 0.48 m and is preserved to a height of 0.95 m. Three holes were discovered in the lower parts of its side walls. They were probably identical in shape, but the best-preserved one is in the front. This front opening is 33 cm high and 40 cm wide at the base, and it is topped with a small arch. The arches of the lateral openings are damaged. The interior of the feature is empty. The altar top rested on a base, which measured 0.44 m by 0.35 m and abutted the face of the pilaster [see *Fig. 10.15*].

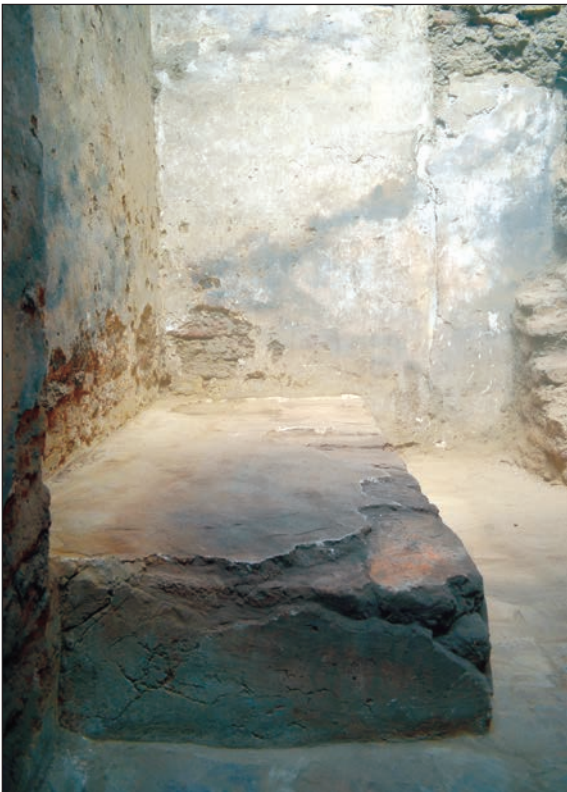
Fig. 10.17. Bench in the diakonikon, view from the south

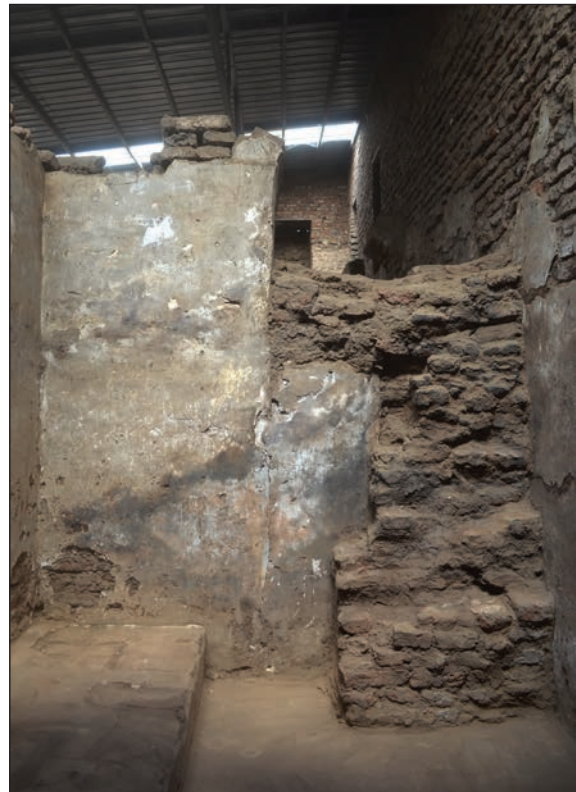
Fig. 10.18. Blocked entrance from the diakonikon to the eastern corridor

bricks in the lower part and mud bricks in the upper part. The blocking wall measures 0.95 m by 0.55 m at the base and has fairly even faces. In the upper part it appears to have been built to abut the fill inside the *diakonikon* [Fig. 10.18].

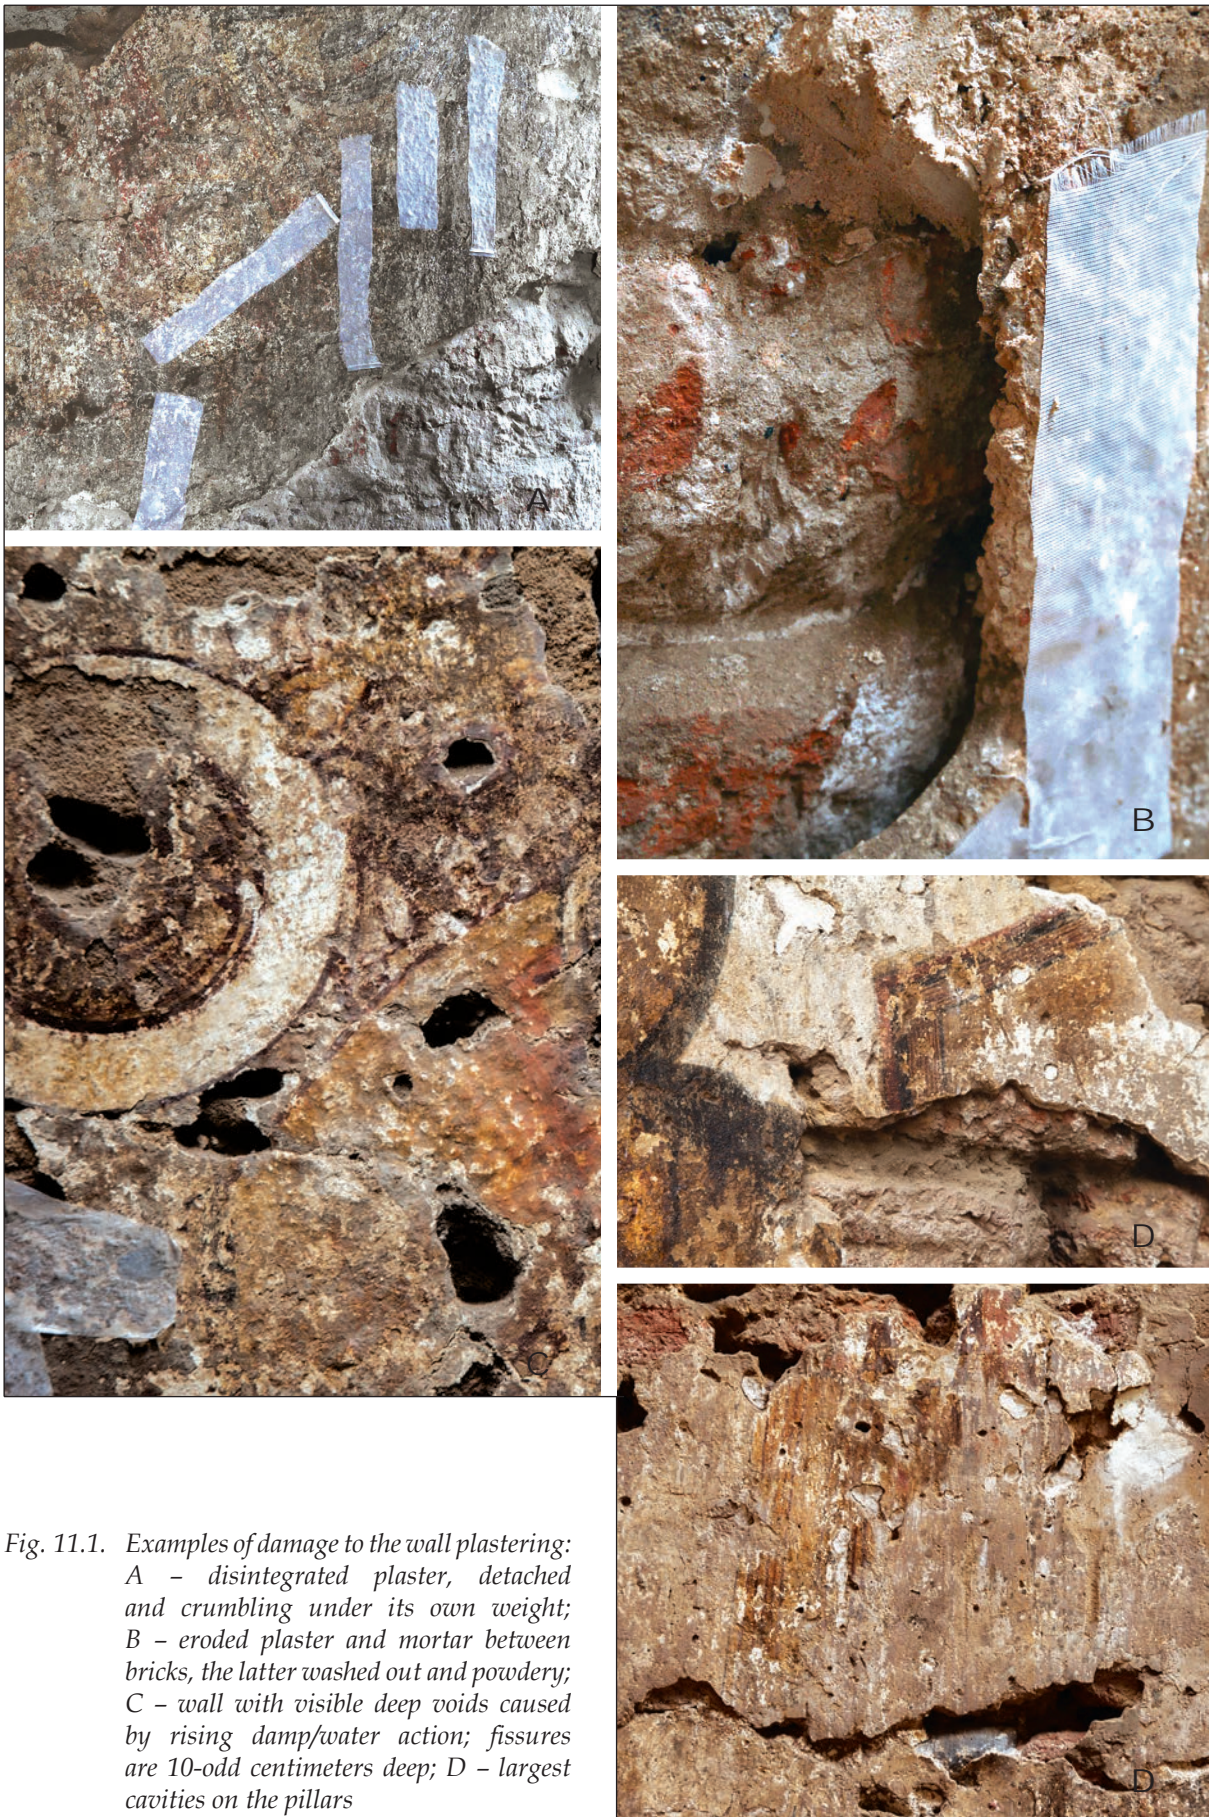
Fig. 11.1. Examples of damage to the wall plastering:
 A – disintegrated plaster, detached and crumbling under its own weight;
 B – eroded plaster and mortar between bricks, the latter washed out and powdery;
 C – wall with visible deep voids caused by rising damp/water action; fissures are 10-odd centimeters deep;
 D – largest cavities on the pillars

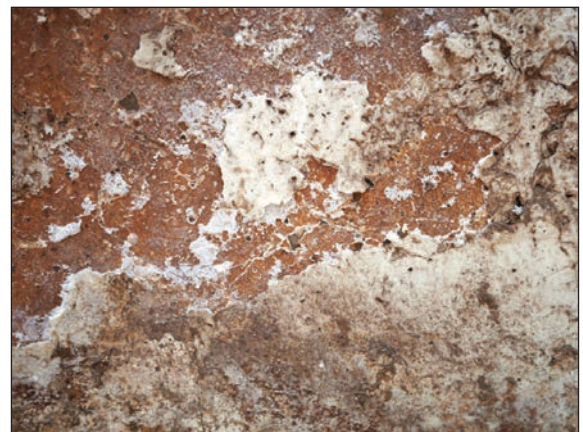
Fig. 11.2. Example of salt efflorescence

Shortly after removing the fill, salt efflorescence appeared on the surface and in cracks and pores in the plaster next to the entrance to the *diakonikon* (part of a painted representation of the Apostles). Salt crystals pushed out plaster fragments of different sizes in that area and caused their detachment [Fig. 11.2]. The process came to a halt after the walls had dried, the crystals were mechanically removed in a delicate manner, and as a result the accumulation of salts ceased to progress. Currently, the conditions inside the church are stable enough to be considered safe for the paintings.

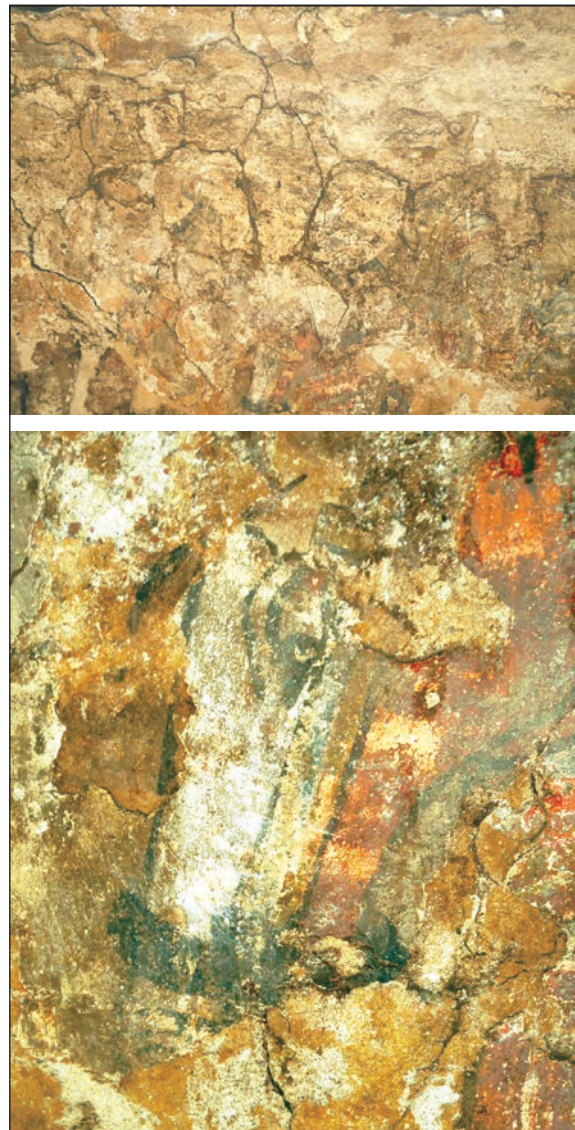
Fig. 11.4. St Menas: top, detail before cleaning and, bottom, during cleaning

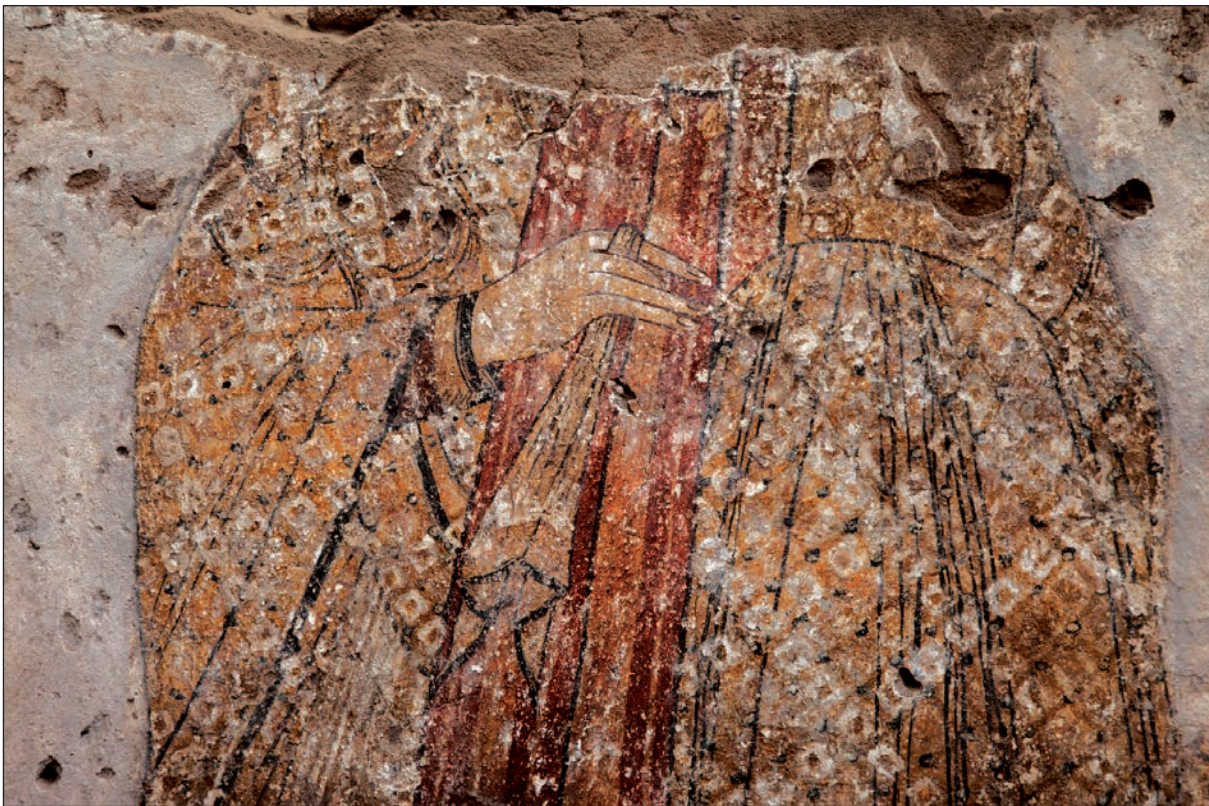
Fig. 11.6. Mural of a saint on a pilaster on the east wall of the diakonicon, cleaned and secured with KLUCEL G

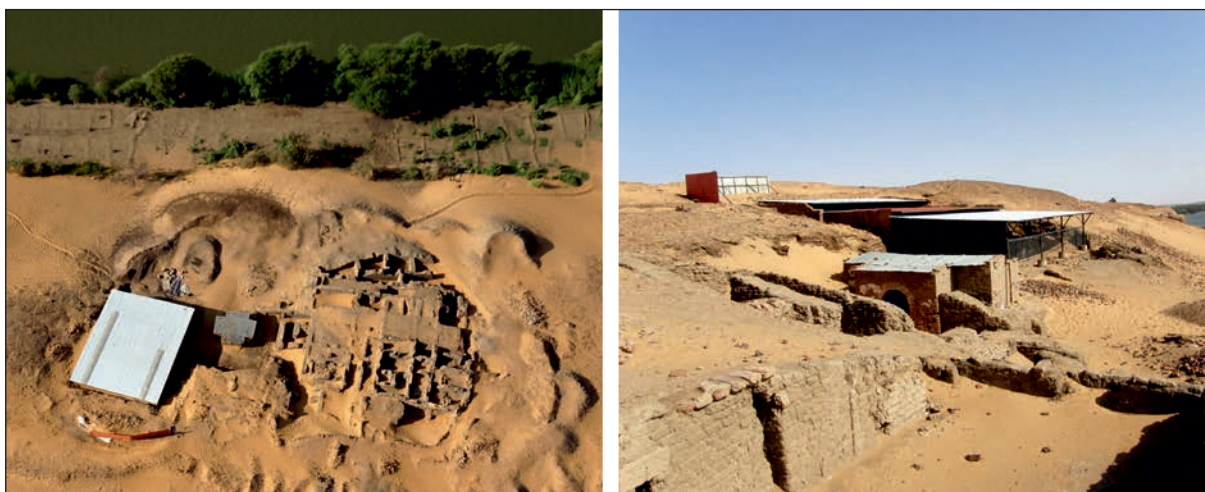
Fig. 12.1. Location of the Church of Archangel Raphael (SWN.B.V) on a steep cliff overlooking the Nile: left, bird's eye view; right, side view

The Church of Archangel Raphael (SWN.B.V) is located within the walls of the Citadel, near the Palace of Ioannes (SWN.B.I) and the Commemorative Building (SWN.B.III). These structures form a coherent complex located on the high, rocky bank of the Nile [Fig. 12.1].

church to protect the interior against unauthorized access [see Fig. 12.1 right].

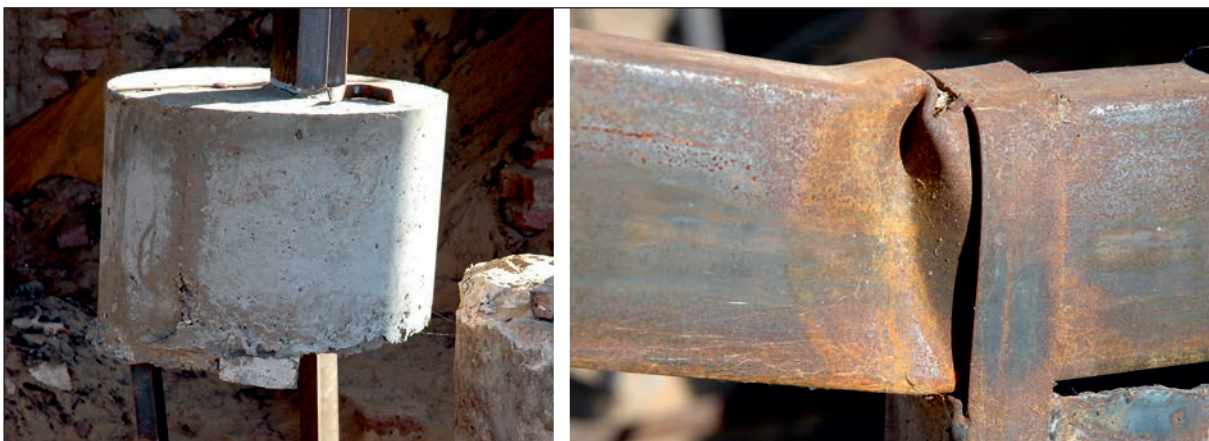
Fig. 12.2. Damage to the first protective structure: left, displacement of the concrete anchor block; right, destruction of the thin-walled section steel member

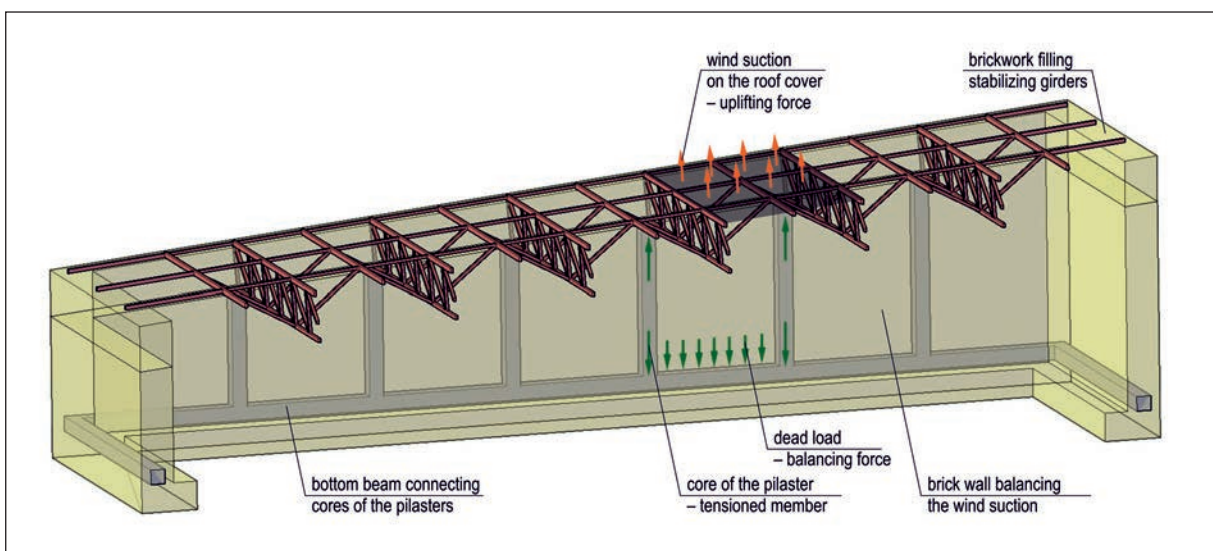
Fig. 12.3. General principle of balancing the wind load with self-weight of building walls

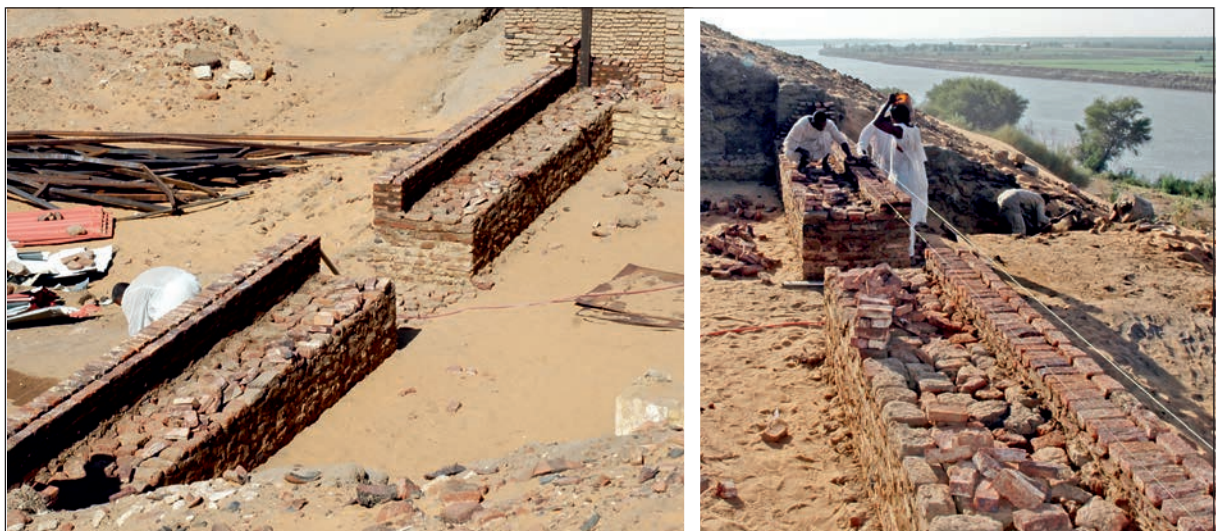
Fig. 12.6. West wall: bricklaying of the bottom part

The work started with construction of the walls to the level of the bottom reinforced concrete beam. New walls exactly followed the outline of the remains of the original walls [Fig. 12.6]. Next, a trough of bricks was built to serve as lost formwork for the beam [Fig. 12.7 left]. Once the reinforcement was placed in this formwork together with the pilaster starters [Fig. 12.7 center], the beam was concreted [Fig. 12.7 right].

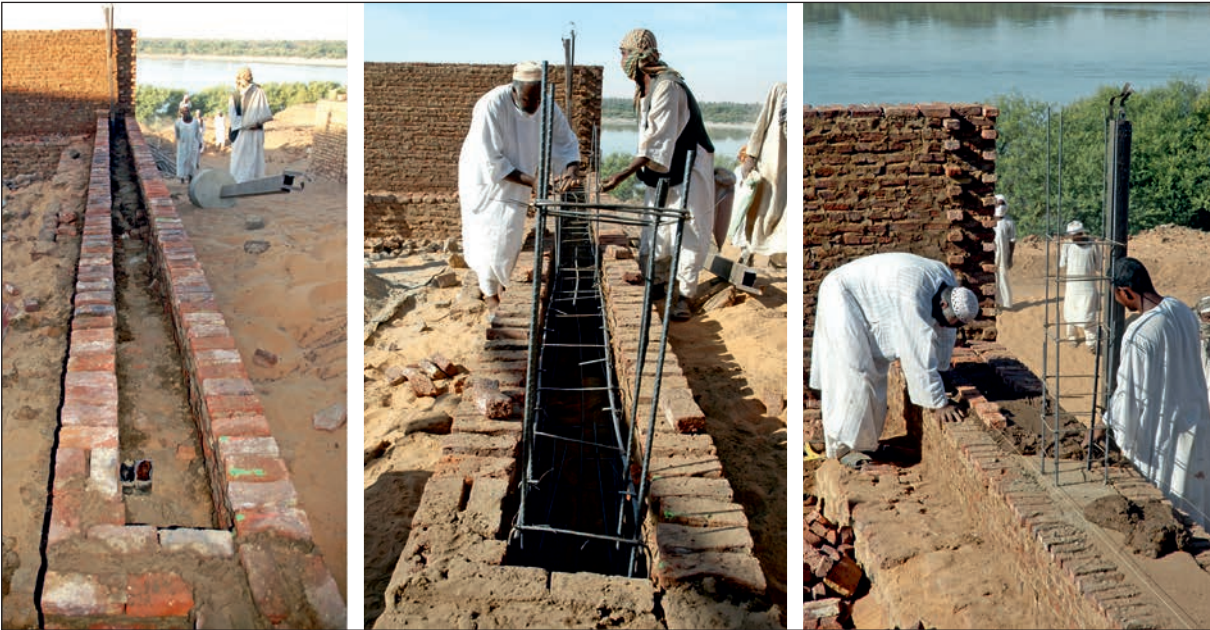
Fig. 12.7. Construction of the lower beam: left, lost formwork made of bricks, center, installation of the reinforcement and, right, pouring the concrete

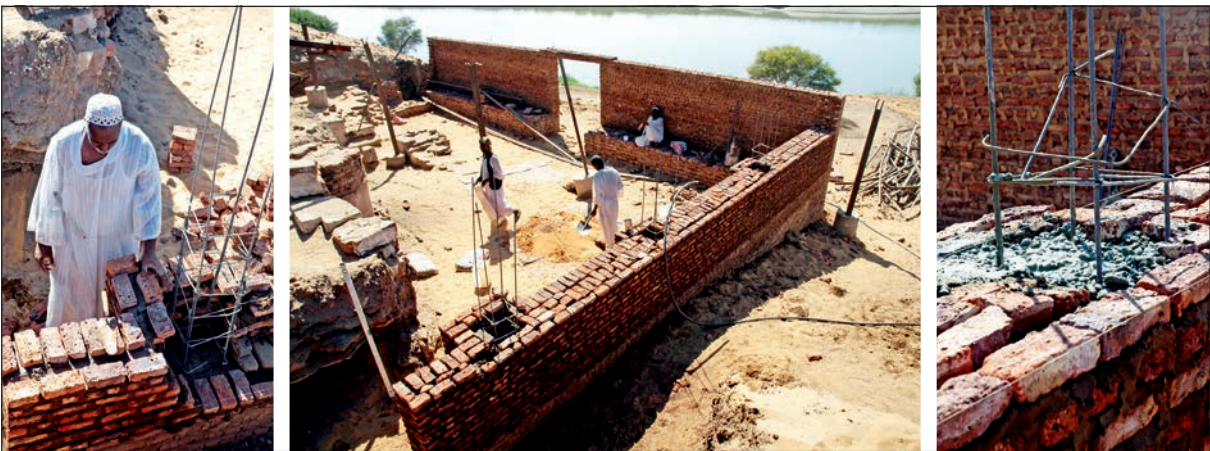
Fig. 12.8. Construction of the walls above the bottom beam: left, bricklaying of wall and pilasters, center, installation of the reinforcement in the cores of the pilasters; right, concreting the cores

Bricklaying on the western side did not meet with the same constraints, since the original wall only survived to the level of the floor and had to be reconstructed to its full height [Fig. 12.8 center]. The north and south walls were partly preserved above the floor level. The height of the preserved relics increased towards the east, i.e., into the slope. Particularly the south wall had better-preserved segments, and it was necessary to adjust the lower beam and the arrangement of the pilasters, as well as the height of the reconstructed walls, to the height of its extant relics [Fig. 12.9].
