DONGOLA

FIELDWORK
CONSERVATION
AND SITE MANAGEMENT

PCMA Excavation Series 5

QATAR-SUDAN ARCHAEOLOGICAL PROJECT (QSAP)
NUBIAN ARCHAEOLOGICAL DEVELOPMENT ORGANIZATION

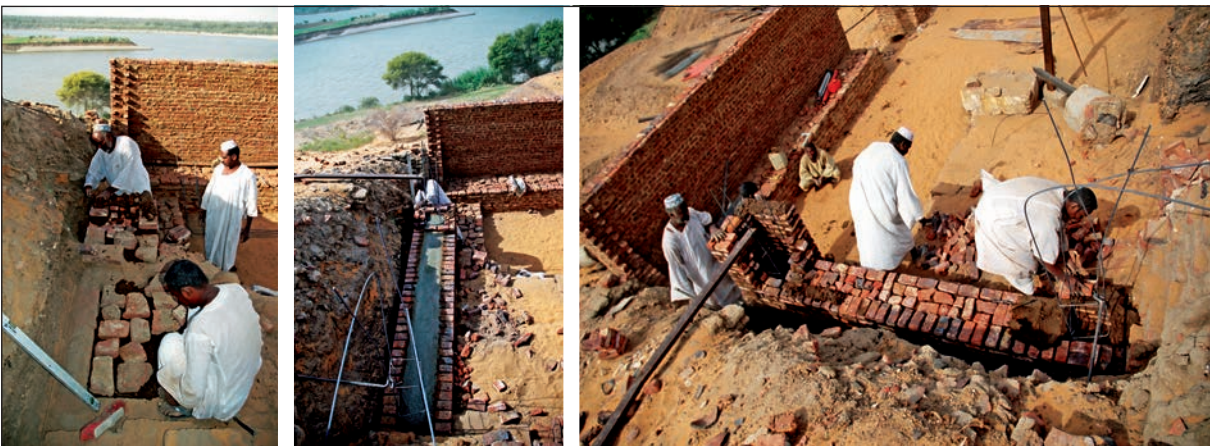
Fig. 12.9. South wall: adjusting the layout of the new elements to the preserved remains of the original wall

Bricklaying on the western side did not meet with the same constraints, since the original wall only survived to the level of the floor and had to be reconstructed to its full height [Fig. 12.8 center]. The north and south walls were partly preserved above the floor level. The height of the preserved relics increased towards the east, i.e., into the slope. Particularly the south wall had better-preserved segments, and it was necessary to adjust the lower beam and the arrangement of the pilasters, as well as the height of the reconstructed walls, to the height of its extant relics [Fig. 12.9].

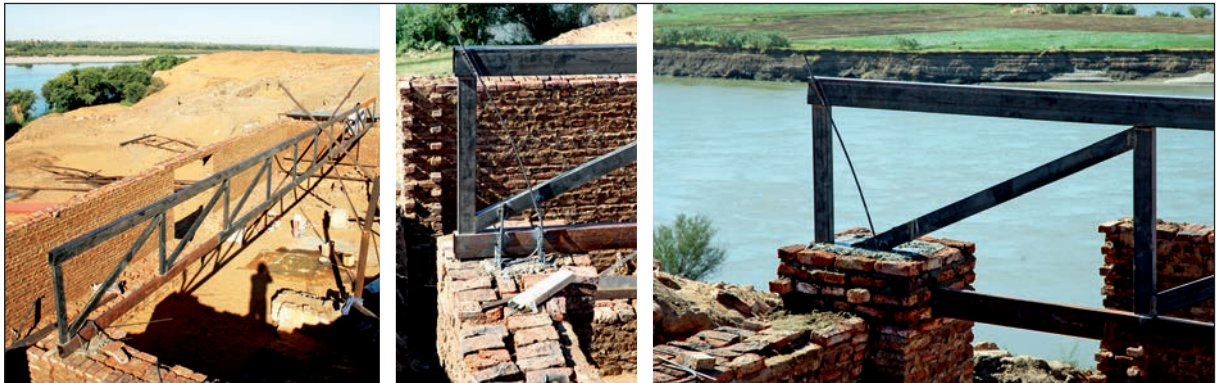
Fig. 12.10. Installation of the roof girder: left, placing the girder on the pilaster; center, connection of the pilaster reinforcement to the lower chord by welding; right, fixing the girder in a socket in the wall

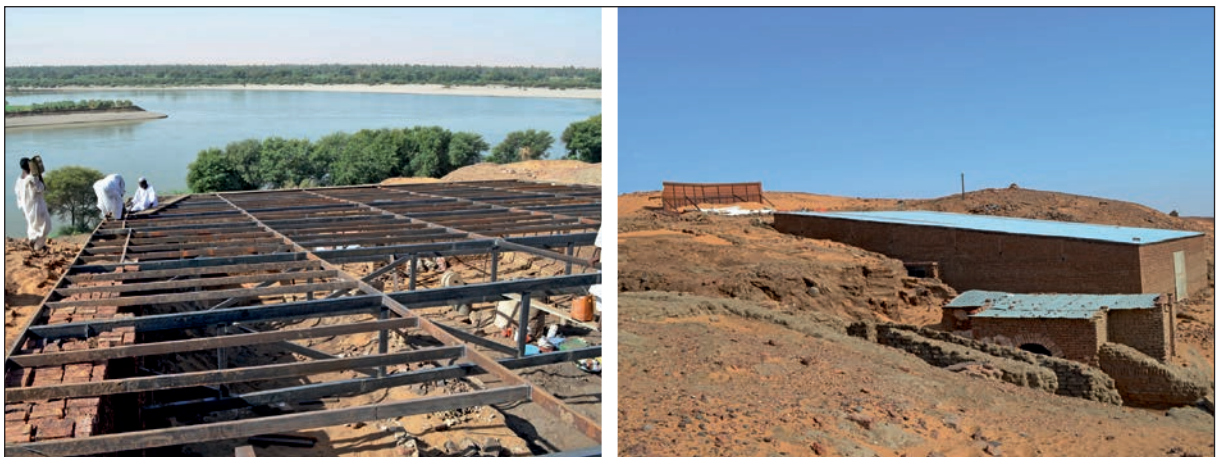
Fig. 12.11. Installation of the roof cover: left, assembly of purlins; right, general view from the river side

After installation of the girders, roof purlins were installed. They were made of steel profiles similar to the profiles used for the chords of the girder. Purlins were welded to the side surface of the chords of the girder to protect it against lateral-torsional buckling [Fig. 12.11 left]. Low-profile folded sheets were laid on the purlins [Fig. 12.11 right].

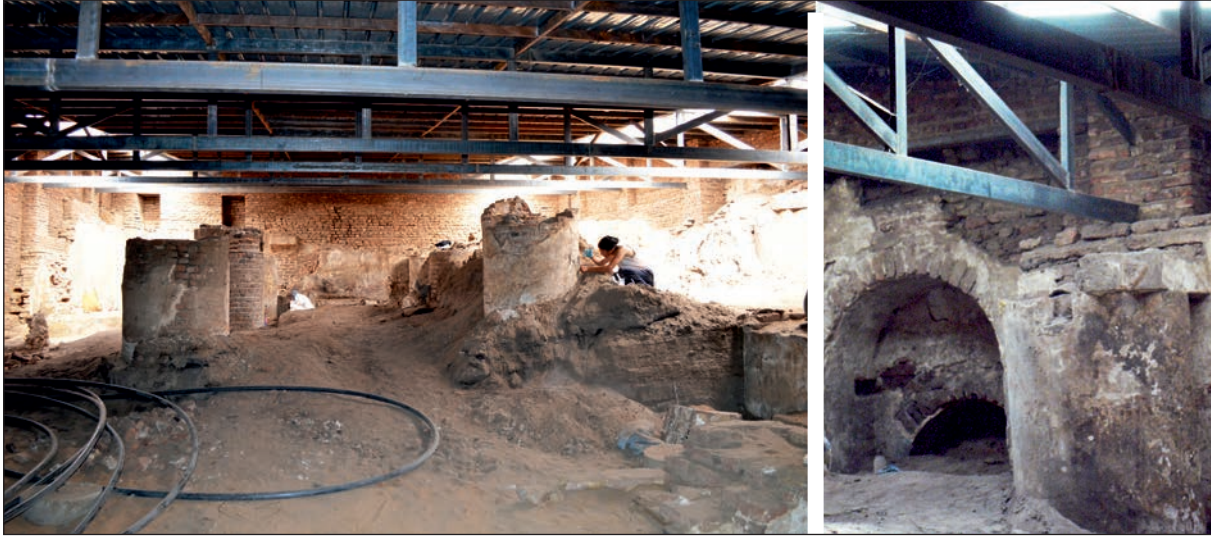
Fig. 12.12. Interior of the building after completion of works: left, general view; right, view of the girder mounted in the wall

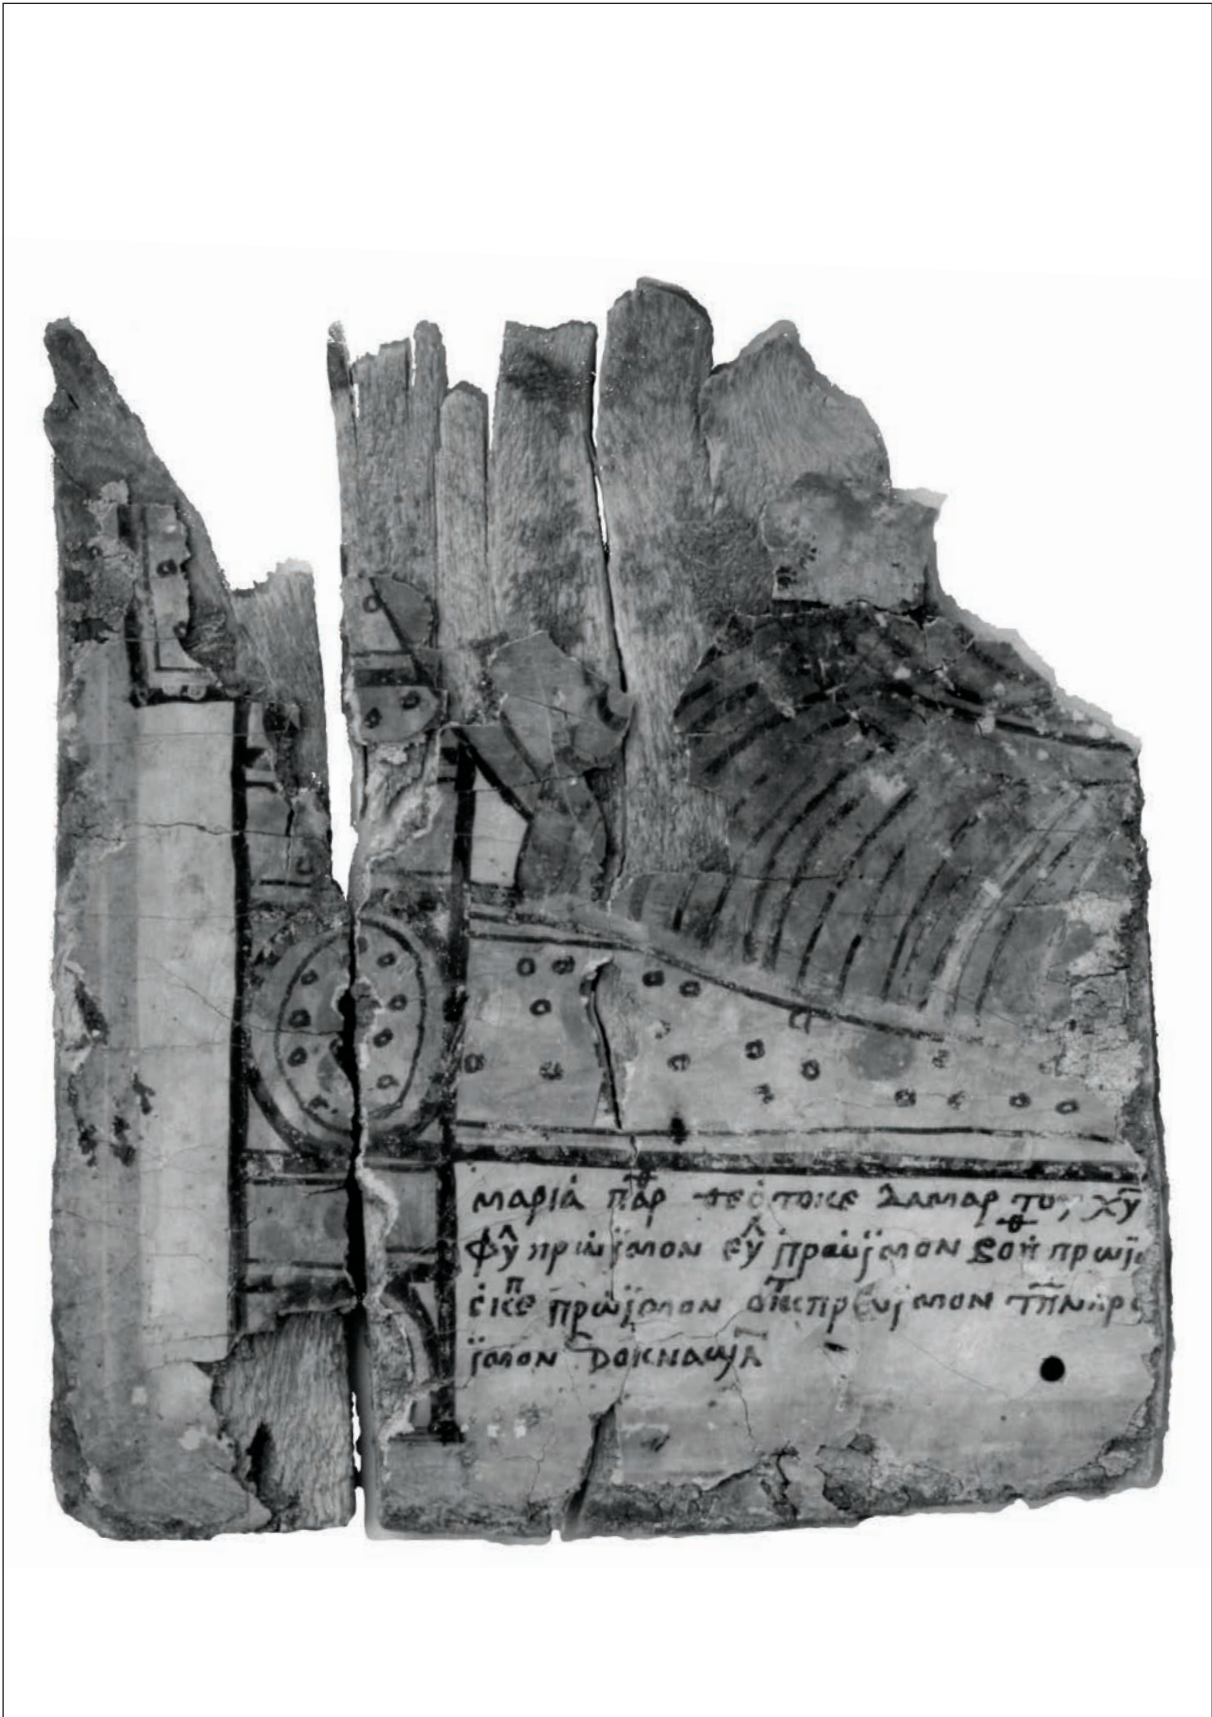
Fig. 13.1. Two sides of a wooden icon from the Church of Archangel Raphael (SWN.B.V) in infrared photography: top, front side; opposite page, back side

The lower part of the composition on the other side (reverse) most likely shows two figures standing side by side. The one on the right may be an angel protecting the more centrally located figure [*Fig. 13.1* top right]. Judging by the robes, we may tentatively identify the protected individual as a layman, but this is merely a suggestion based on the title recorded in an inscription underneath the image, which reads „Proimos joknashil” (see below). It is most likely a representation of Proimos under the protection of an angel. Thus, the double-sided icon resembles painted representations in sacral spaces, where one finds an official, an archangel, and an inscription containing a plea for protection in a single composition. The only more frequent inscription type accompanies painted representations of Mary, Christ, or a saint whose protection the writer is seeking (Jakobielski 1974: 297–300). The walls of the naos of the Church of Archangel Raphael on the Citadel of Dongola carry several such representations of officials under the protection of archangels [see above, *Fig. 10.19*].

The piece under conservation was a palm wood plank measuring about 0.8 cm in thickness, painted on both sides most likely in the tempera grassa technique. The object was incomplete [Fig. 13.1]; the preserved part was broken into three larger fragments, and several detached pieces of the ground with the paint layer were also found. The piece was uncovered in a deposit that ensured a constant humidity level until removal from the soil; despite seasoning, the object dried rapidly, which resulted in the appearance of numerous cracks and in detachment (flaking) of the paint and ground, particularly around the cracks in the wood. The paint layer also bore white efflorescence and stains of organic origin, which made the composition difficult to read.

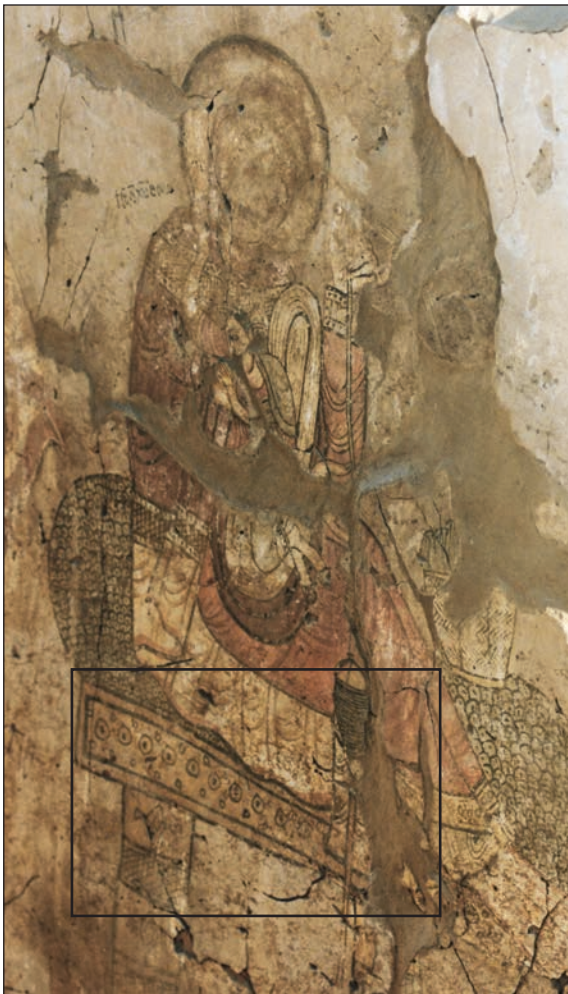
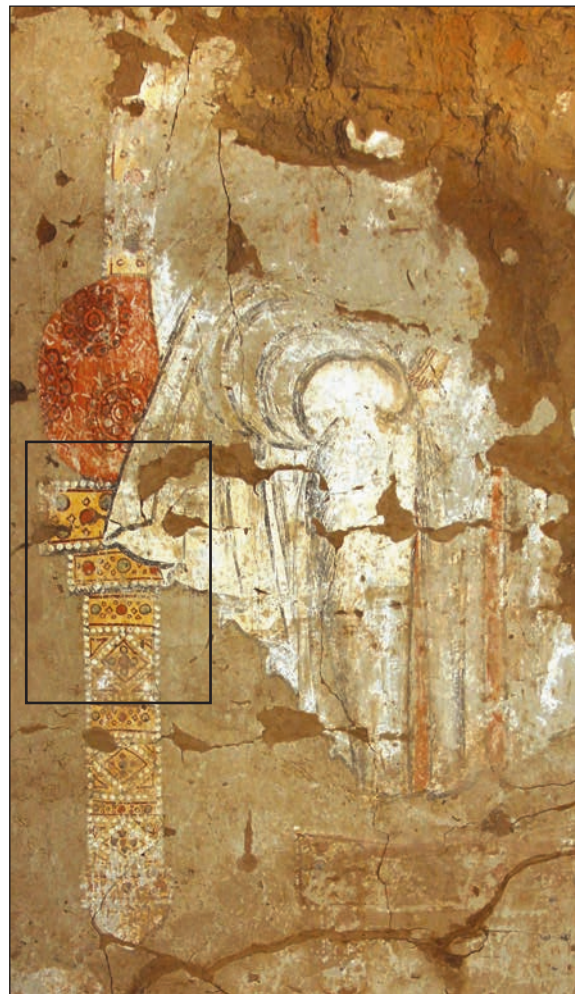
Fig. 13.2. Two representations of the Enthroned Virgin and Child from the Southwest Annex of the monastery on Kom H in Dongola; boxes mark analogous renderings of the throne

the 13th–14th century on the basis of iconographic and stylistic parallels found in wall paintings. The manner in which the enthroned Mary was depicted and the decoration of the throne resemble paintings in the so-called Southwest Annex by the gate to the monastery in Dongola (Martens-Czarnecka 2011: 272–273, Cat. No. 86) [Fig. 13.2].

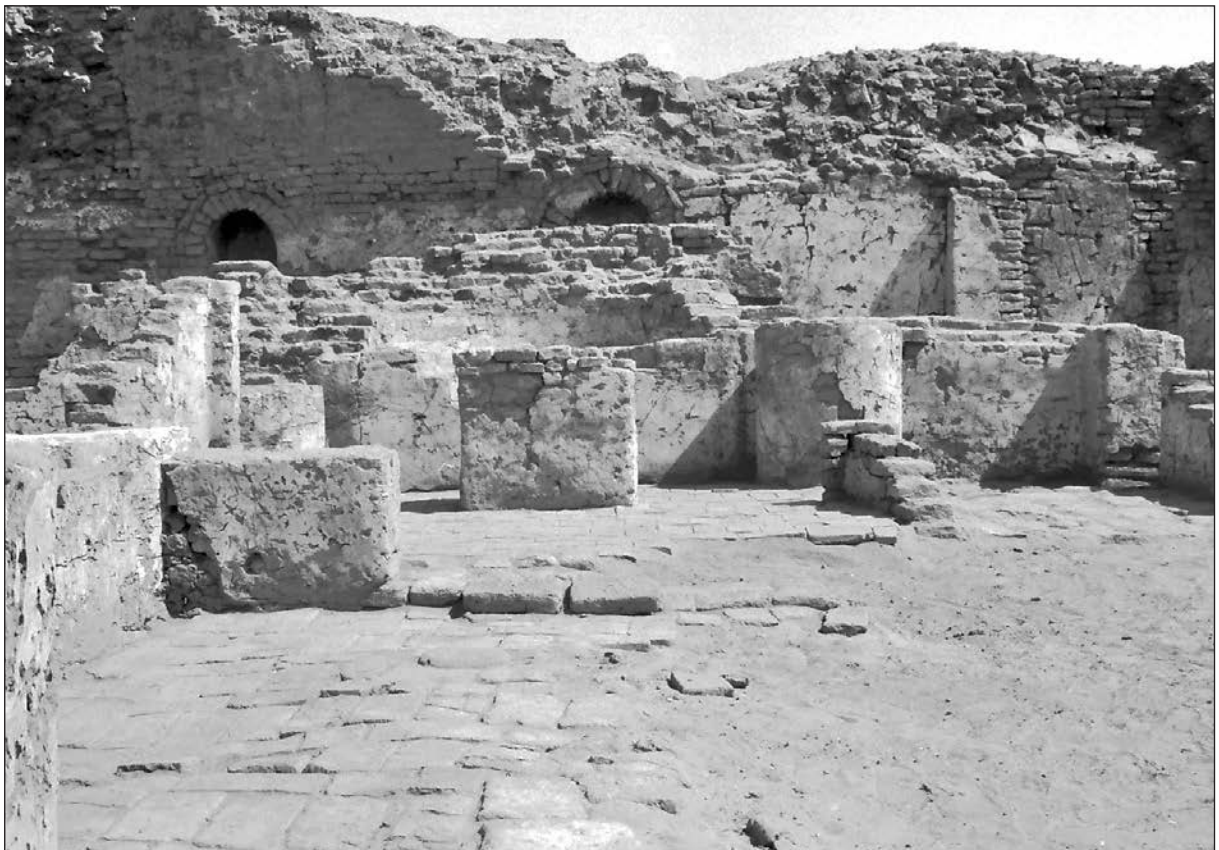
Fig. 14.4. Eastern part of the Pillar Church

The walls of the church are preserved to the highest level in the eastern part of the building [Fig. 14.4]. On average, they rise 2.50 m above the floor of the church, but their maximum height is 4.00 m. The walls are best preserved in the east, and their height gradually decreases towards the west, where they ultimately disappear. Inside the naos, the northwestern pillar is preserved at a low level, and only scarce remains of the southwestern pillar are extant. No trace remains of the western engaged pillars or the floor in the southwest part of the naos.

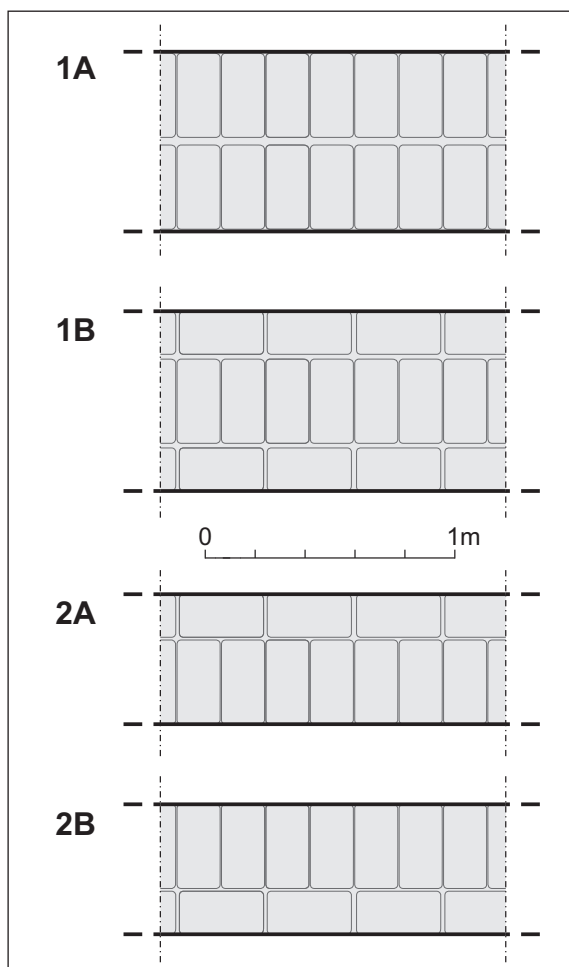
Fig. 14.5. Brick bondwork in alternating courses of the walls of the Pillar Church: 1 A,B – outer walls; 2 A,B – inner walls

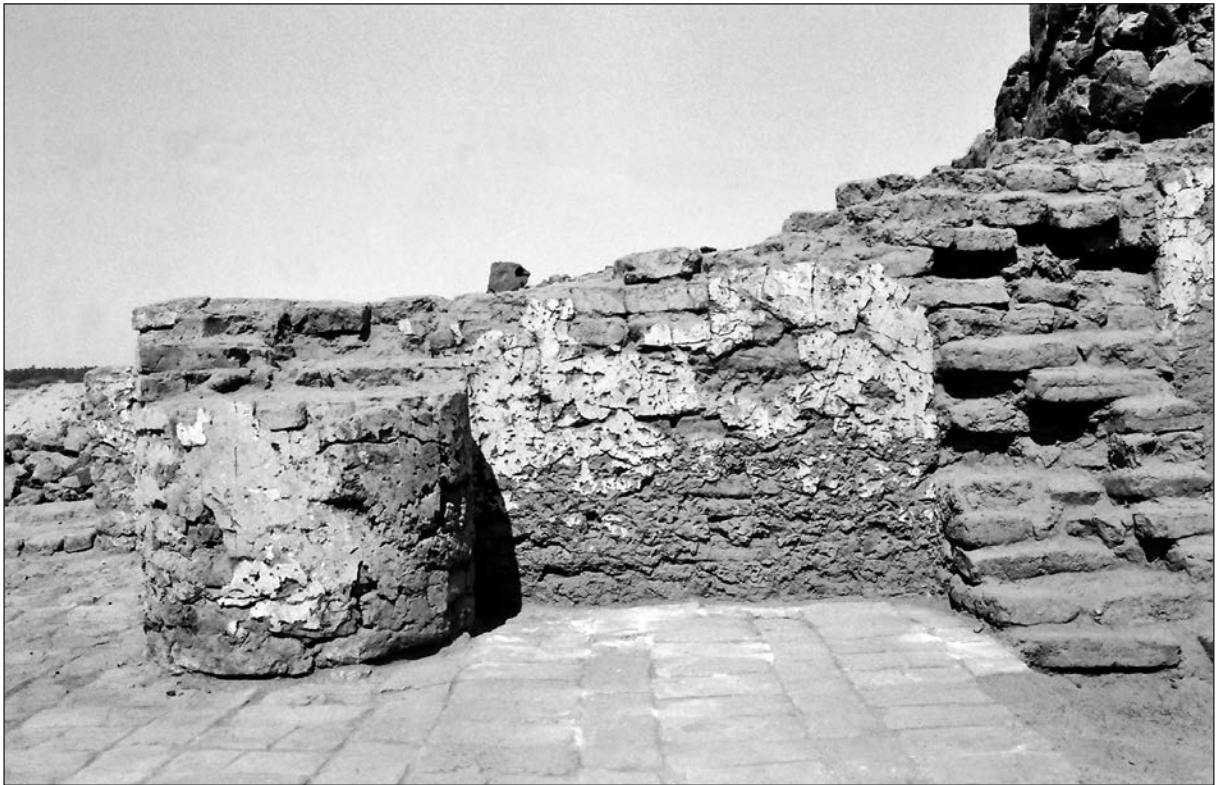
Fig. 14.7. North wall of the Pillar Church, view from the south

The preserved stretch of the north wall of the Pillar Church is 15 m in length. Its height by the face of the curtain wall is 2.90 m, and it decreases until its disappearance in the west [Figs 14.6, 14.7].

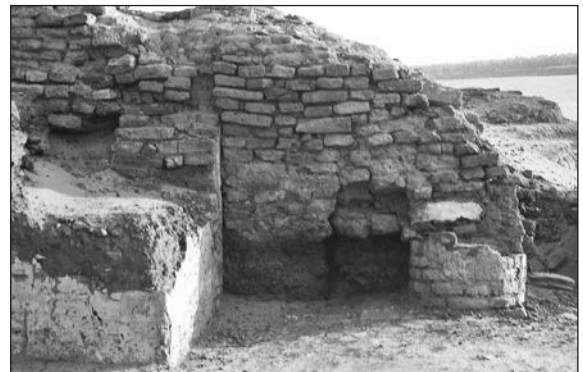
Fig. 14.8. South wall of the Pillar Church between the west wall of the diakonikon and the south entrance

a doorway there [Fig. 14.8]. There is no data for a reconstruction of the southern part of the building except for an assumption of symmetry with the northern part.

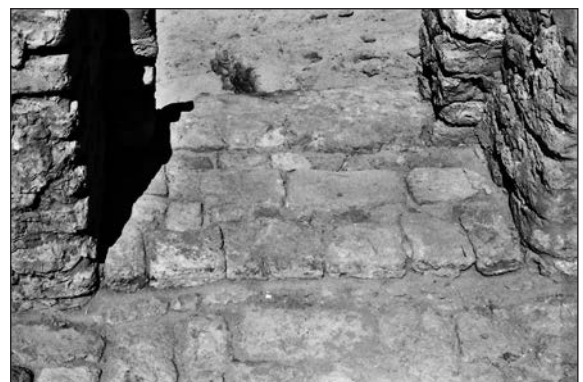
Fig. 14.9. North entrance to the Pillar Church

Of the two or more original doors to the church, only the one in the northern bay has been preserved. It was splayed [Fig. 14.9], with jambs 0.82 m apart on the inside and 1.05 m on the outside. A stone threshold of yellowish sandstone, 0.34 m wide, was placed between the outer jambs. On the inner side, the entrance was paved with a brick floor, 5 cm lower with regard to the threshold. A brick with a circular depression, 6 cm in diameter, formed part of the threshold in the inner western corner. It may have been placed there to mount the door pivot.

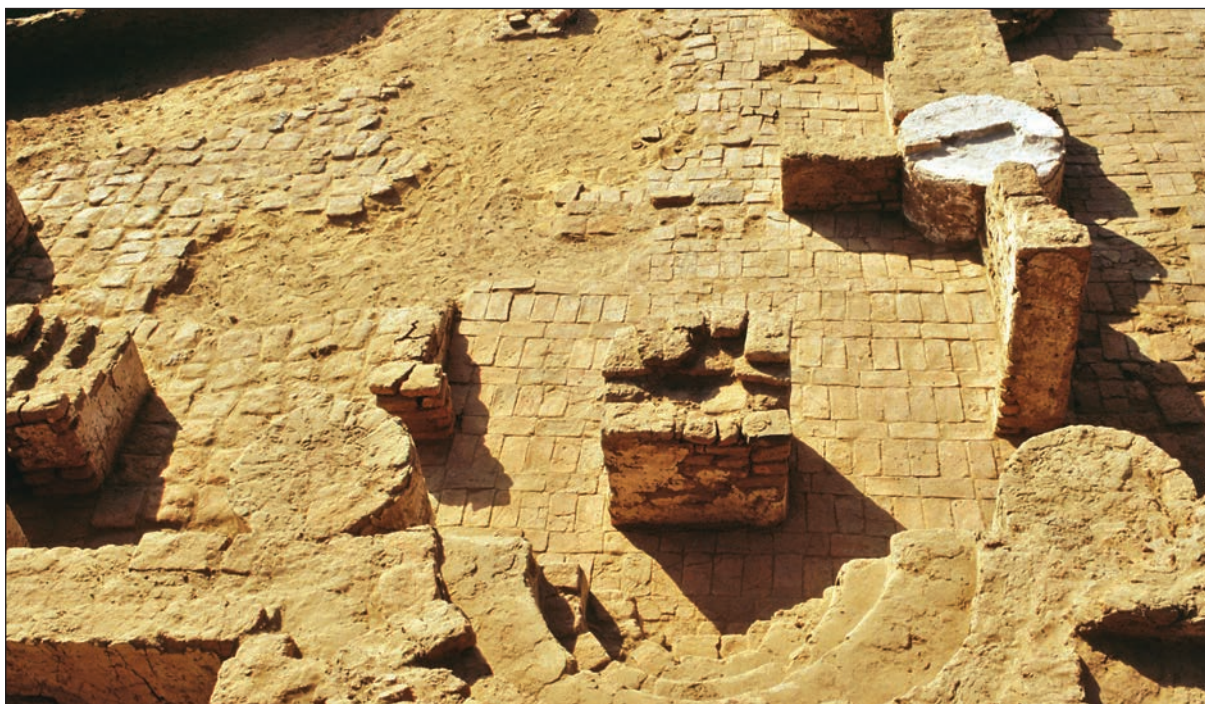
Fig. 14.11. Sanctuary of the Pillar Church with the preserved northeastern pillar, view from the east

The northeastern pillar with a diameter of 1.00 m is preserved up to a height of 0.50 m above the floor. It was built of rounded baked bricks bonded in lime mortar [*Fig. 14.11*].

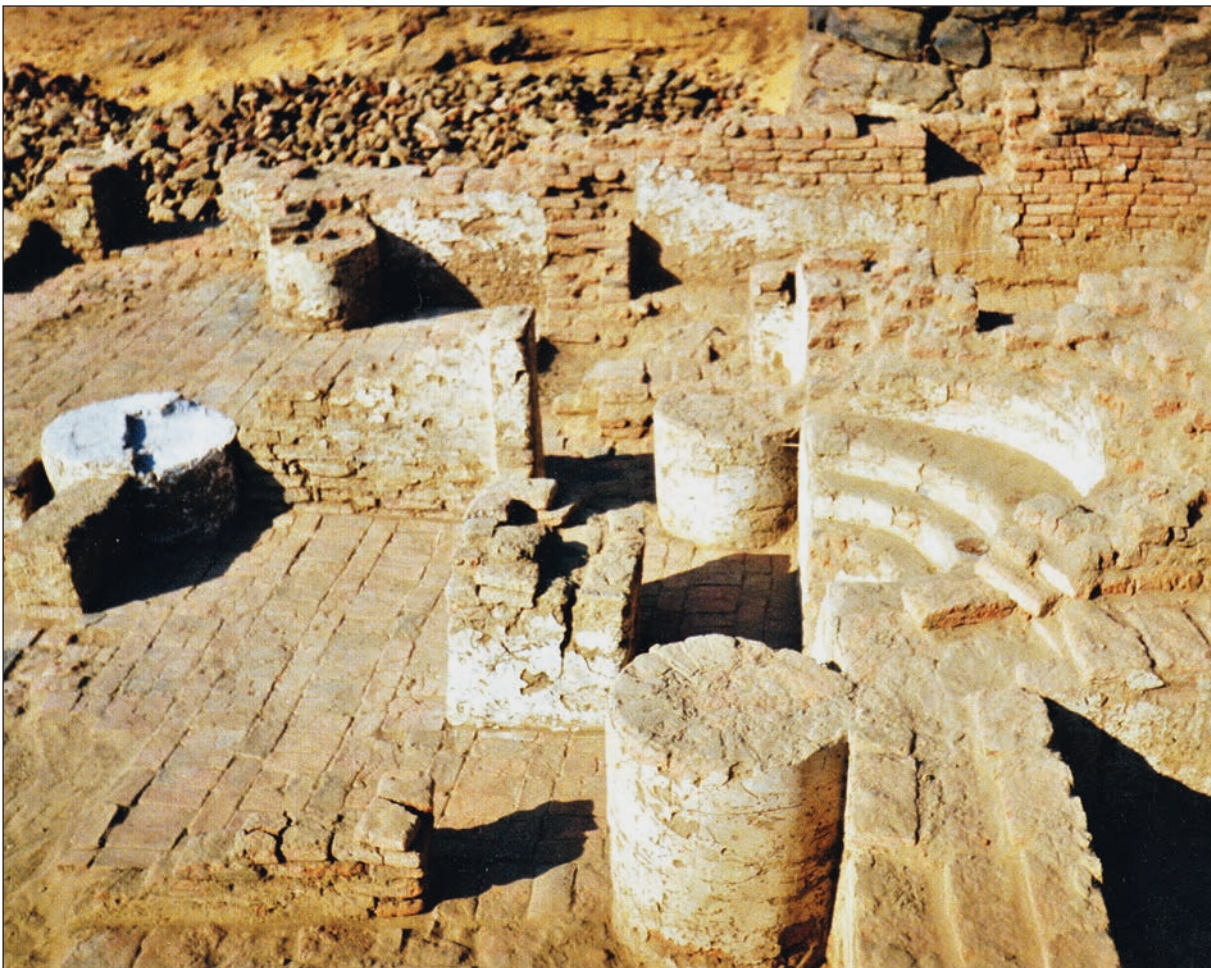
Fig. 14.12. Sanctuary of the Pillar Church: view from the south

[Fig. 14.12]. The space between the eastern free-standing pillars and the engaged pillars flanking the entrance to the apse measured 3.11 m by 3.44 m and was sectioned off with screen walls built of baked bricks. In the screen walls there were three entrances: the main one from the west, and two lateral ones near the eastern engaged pillars [Fig. 14.12]. The screens are only partly extant.

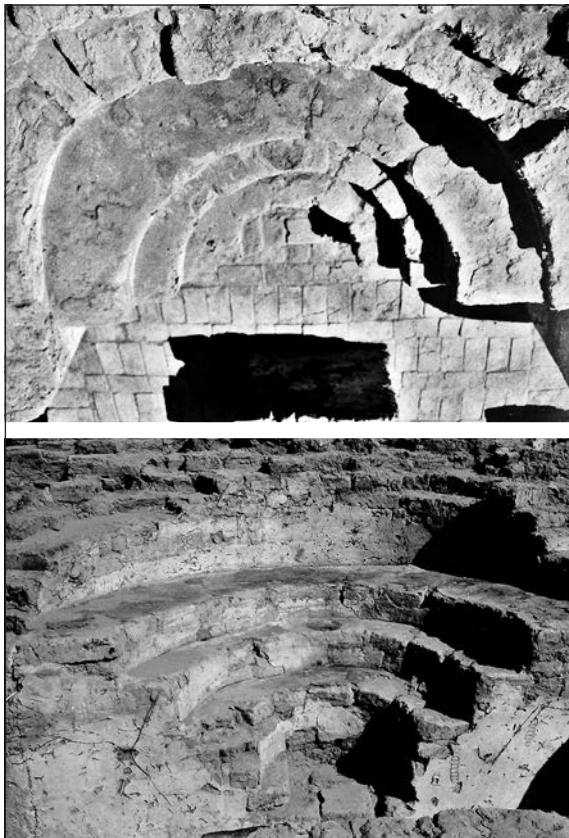
Fig. 14.13. Synthronon: from above and from the west

The apse, 2.15 m wide and 1.20 m deep, was completely filled with a brick *synthronon*, which was built after paving the floor and plastering the walls [Fig. 14.13 bottom].

The *synthronon*, typically Makurian in form, consisted of four semicircular, concentric steps that were 0.87 m high. The feature is largely intact except for the first step, partly damaged in the northern corner. There was no central dais on the uppermost step that was 40 cm wide. The lowermost step was 36 cm wide and 28 cm high. The other steps were about 16–25 cm high and varied in width from 20 to 23 cm. The dark circular stains on the plaster surface of the *synthronon* steps were left by oil lamps [Fig. 14.13 top].

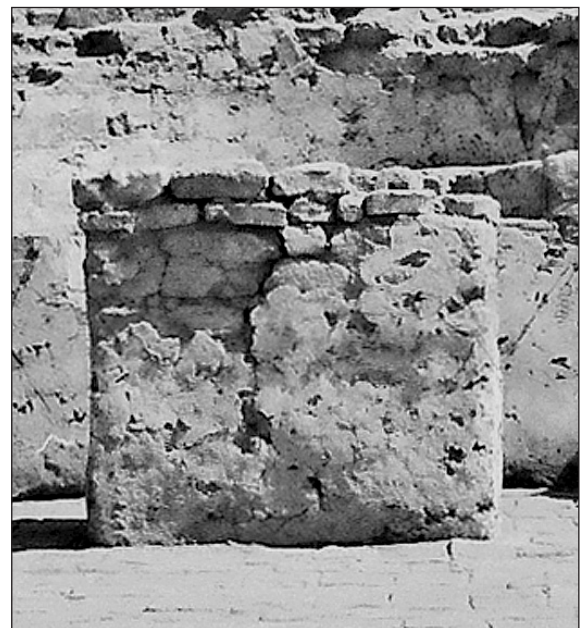
Fig. 14.14. Altar, view from the west

An altar of baked bricks was built on the floor of the sanctuary, 0.75 m from the *synthronon*. The *mensa* was not preserved. The base block measuring 0.75 m by 0.84 m is extant to a height of over 0.79 m [Fig. 14.14].

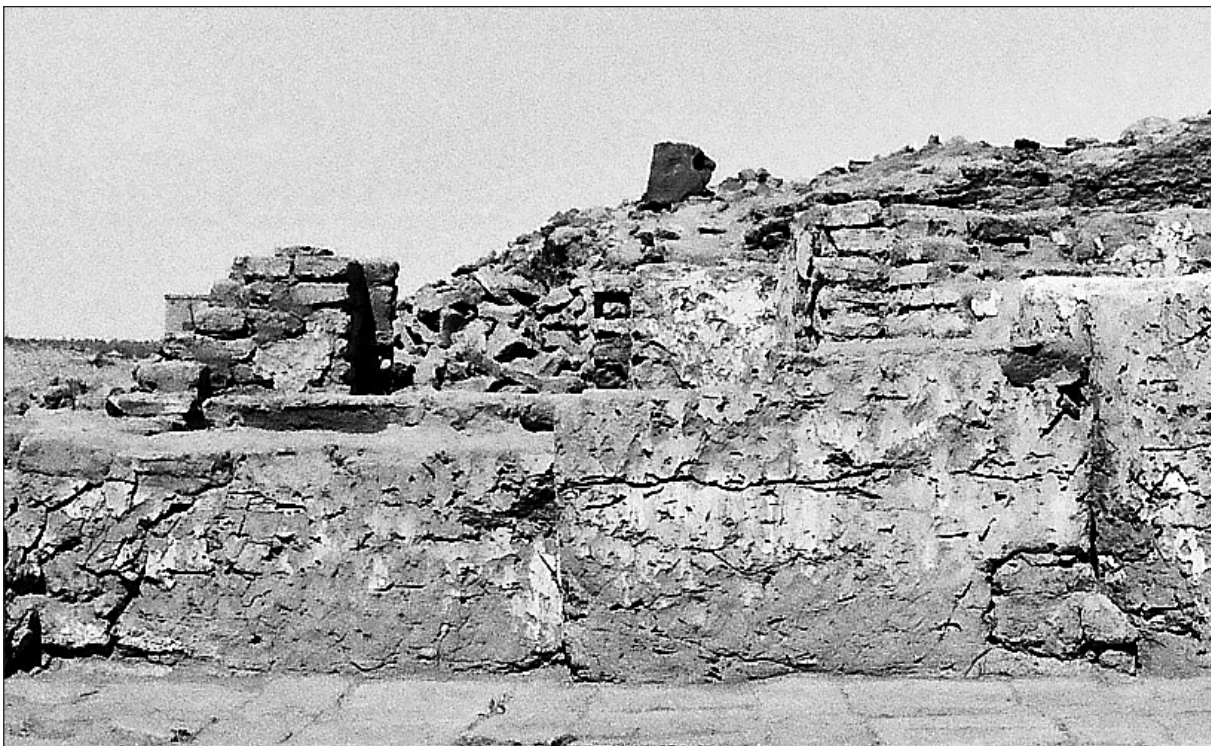
Fig. 14.15. Pulpit, view from the south

The pulpit was located to the west of the north-eastern pillar. It was built of baked bricks on the floor of the naos and is preserved only in its lower part. The entire structure is 1.98 m long and up to 0.55 m high. It consisted of two parts, a platform base measuring 1.05 m by 0.85 m in the eastern part, and in the west a base for the steps, 1.12 m long and 0.70 m wide [Fig. 14.15].

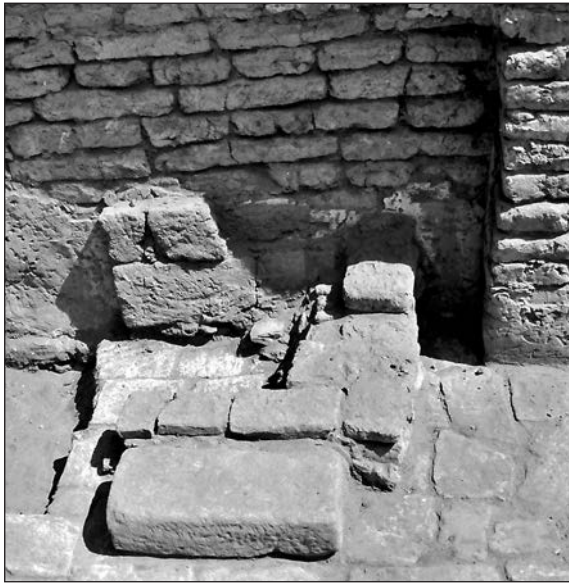
Fig. 14.16. Altar in the prothesis

An altar was constructed of baked bricks and ceramic tiles against the east wall. Only its lower parts founded on the floor of the room are preserved [Fig. 14.16]. The feature measured 0.84 m by 0.64 m at the base and it reached a height of 0.64 m. A block of sandstone with dimensions 53 cm by 21 cm by 13 cm was placed on the floor next to its western face. Amphora stoppers were found next to the altar.

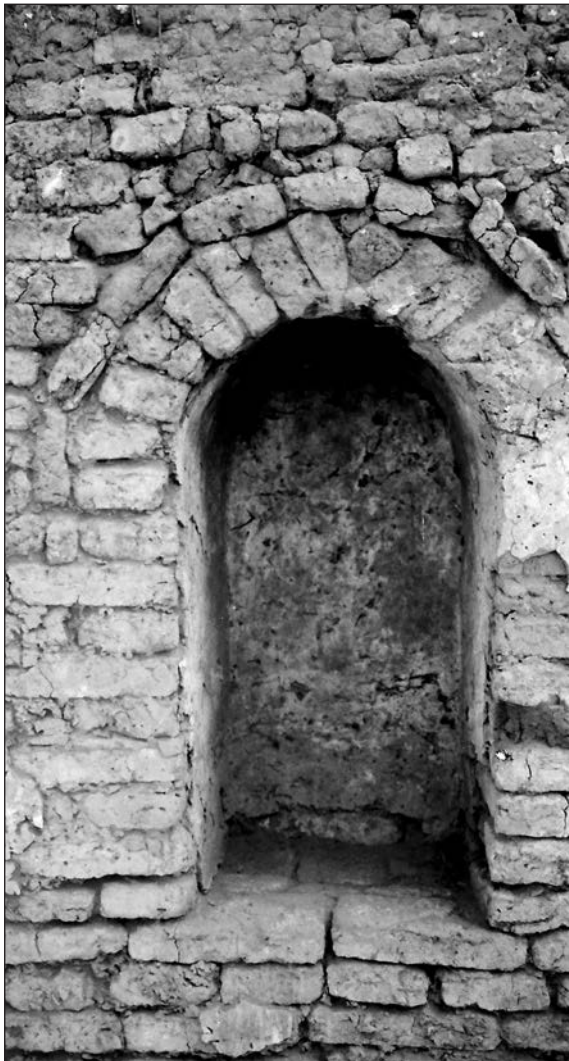
Fig. 14.17. Northern niche in the east wall of the Pillar Church

The east corridor at the back of the apse allowed communication between the pastophories. It measured 1.02–1.13 m in width and slightly narrowed towards the south. Its east wall, closer to the *diakonikon*, held a large, arched niche 1.10 m in height. Its floor (0.70 m by 0.41 m) was 0.94 m above the pavement [Fig. 14.17].

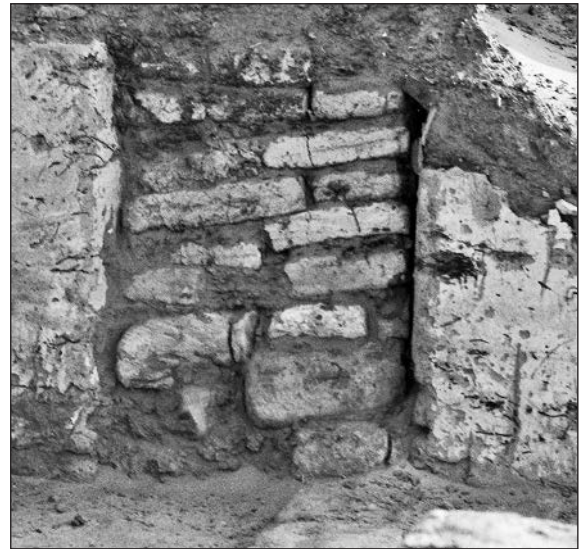
Fig. 14.18. Blocked entrance from the naos to the diakonikon

of occupation of the church, the entrance was bricked in [Fig. 14.18].

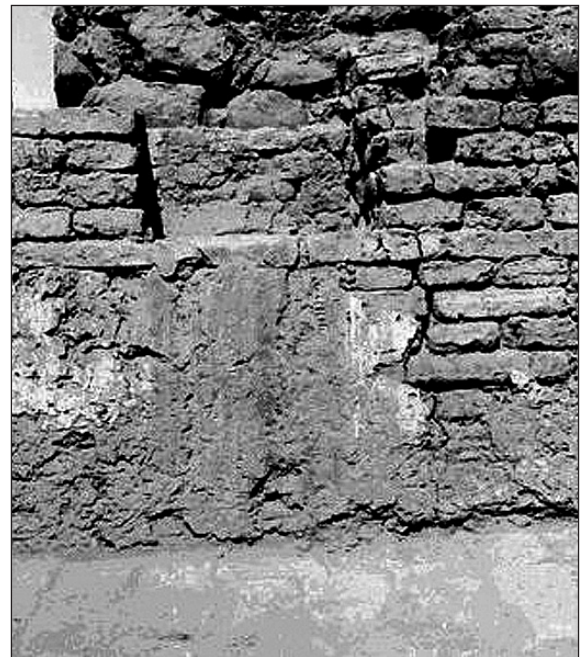
Fig. 14.19. Niche in the north wall of the diakonikon

The northern room of the *diakonikon* with dimensions 2.30 m by 1.50 m had a niche in its north wall, which was also the outer wall of the apse. The floor of the niche measured 0.50 m by 0.50 m and was situated 0.80 m above the pavement [Fig. 14.19].

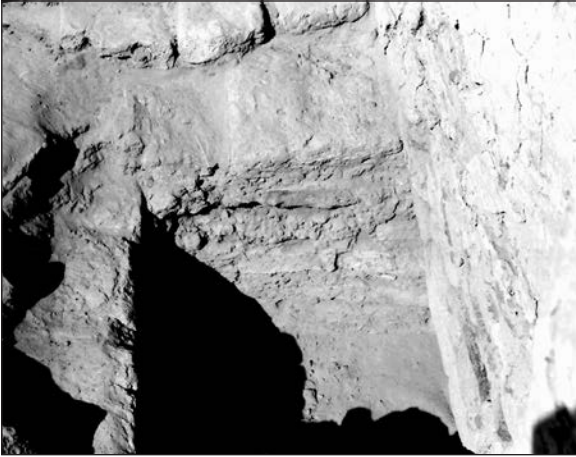
Fig. 14.20. Shaft of the crypt descending below the fortifications

By the east wall of the room, next to the pilaster, there was a shaft (internal dimensions 0.42 m by 0.49 m) with walls faced with baked bricks. The shaft led to a crypt below the foundation of the wall, which rested in this place on a sandstone slab at least 60 cm long, 29 cm wide and 11 cm thick. The chamber had an irregular shape and was carved in rock below the curtain wall. It was empty at the moment of discovery and the shaft was filled with late pottery, indicating that the crypt was penetrated in the 14th century [Fig. 14.20].

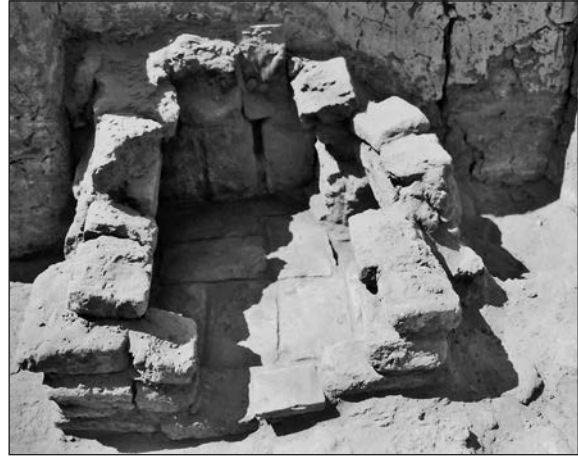
Fig. 14.21. Oven in the *diakonikon*

An oven, probably for the purpose of baking Eucharist bread, was found by the west wall, on the floor of the room [Fig. 14.21]. It was 0.90 m long by 0.94 m wide and stood 0.28 m high. Built of baked bricks, it had a tiled floor that was heavily burnt. The opening in it was 27 cm wide on the inside. Ashes were removed from it through a hole, 15 cm by 14 cm, in the north wall. A large amount of ash was found on the floor of the room between the oven and the apse wall.

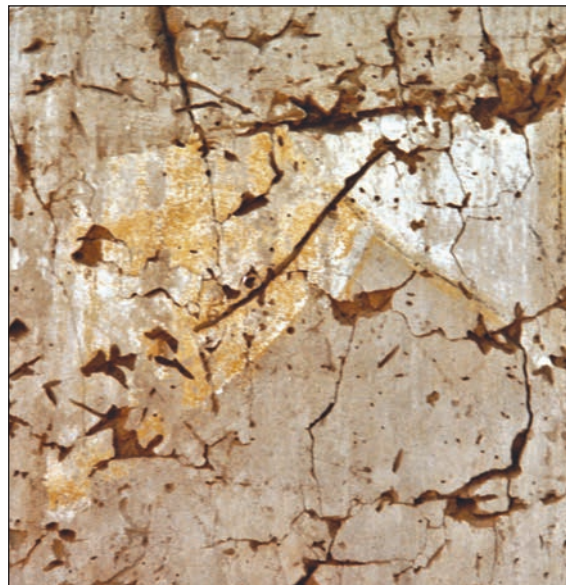
Fig. 14.23. Partly preserved wall painting in the diakonikon

the *diakonikon* [Fig. 14.23]. The sandy fill layers in the naos contained a dozen or so small fragments of painted plaster with geometric decoration against a golden background [Fig. 14.24].

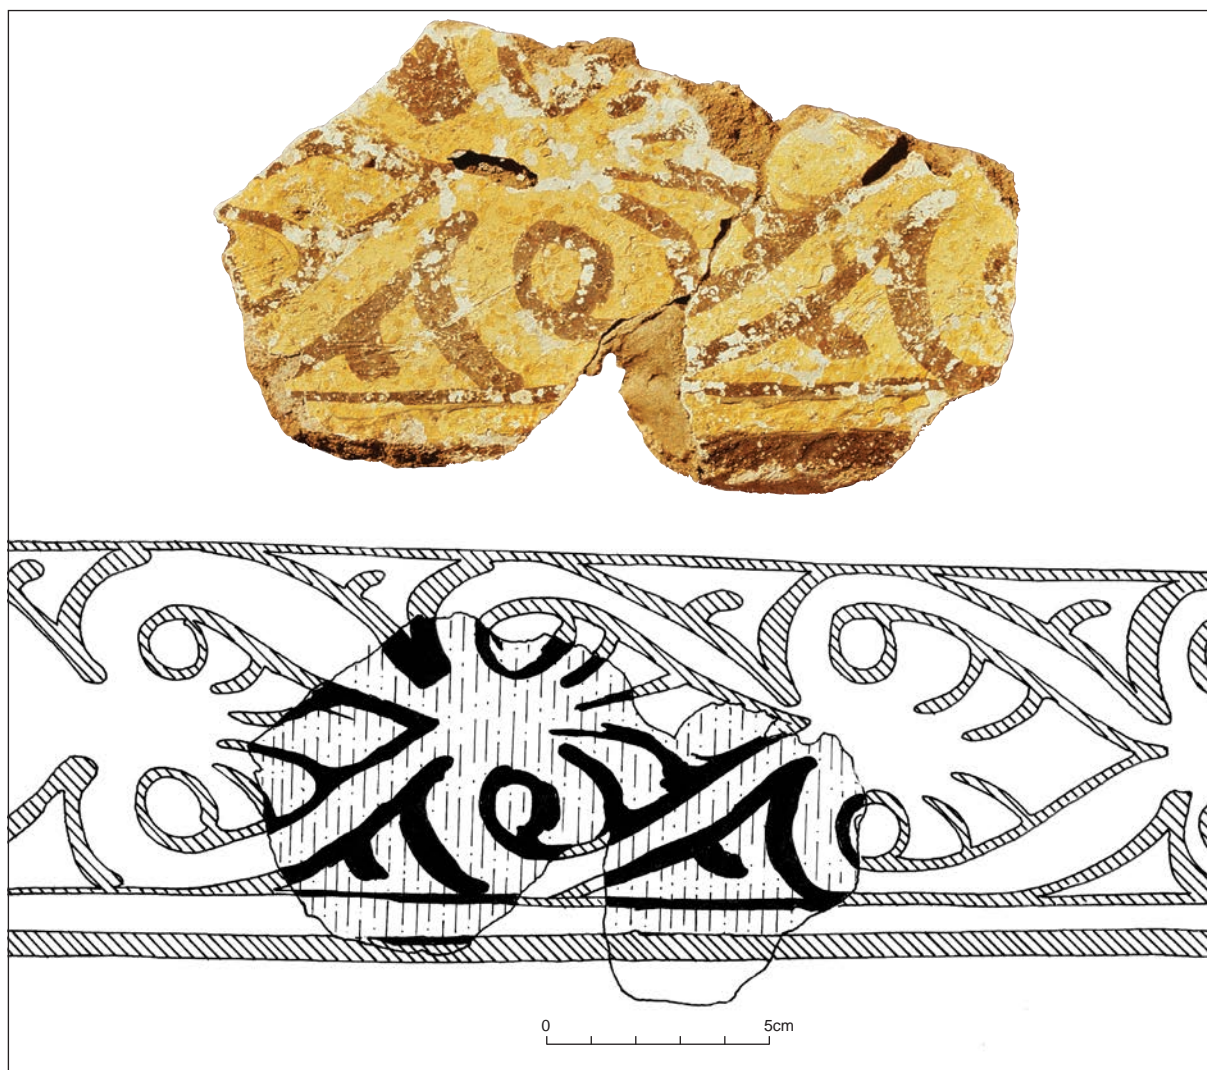
Fig. 14.24. Fragment of plaster with painted decoration; bottom, reconstruction of the pattern

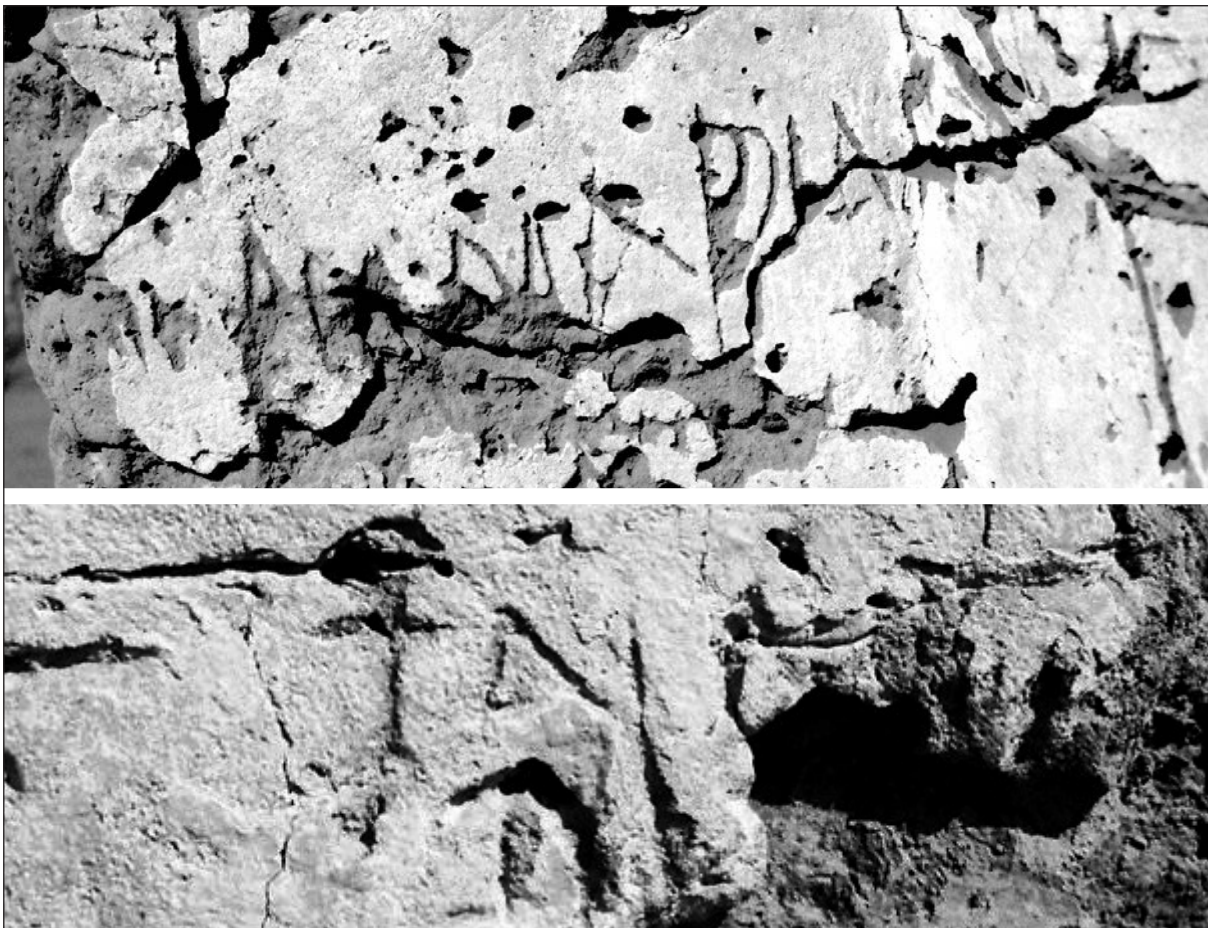
Fig. 14.25. Graffiti on the jamb of the eastern entrance into the *prothesis*: top, graffiti A; bottom, graffiti B

The graffito obviously contains the name *ΜΑΡΙΑ* repeated at least twice. In all likelihood the name refers to the mother of Jesus and not to a particular living person in Christian Nubia. Multiple repetitions of the names of the Divinity and saints is a phenomenon well attested in Christian Nubian literacy, especially in less formal texts, such as graffiti on pottery and on walls of cult places. The most telling example of this phenomenon is presented by the series of the name of Michael containing up to five elements, which accompany signatures of high ecclesiastics on pots found in the Monastery on Kom H in Dongola (Łajtar and Pluskota 2001). Another example is yielded by visitors' inscriptions in the Upper Church at Banganarti with the name of the local patron Raphael repeated twice or thrice (Łajtar forthcoming a: Nos 72 and

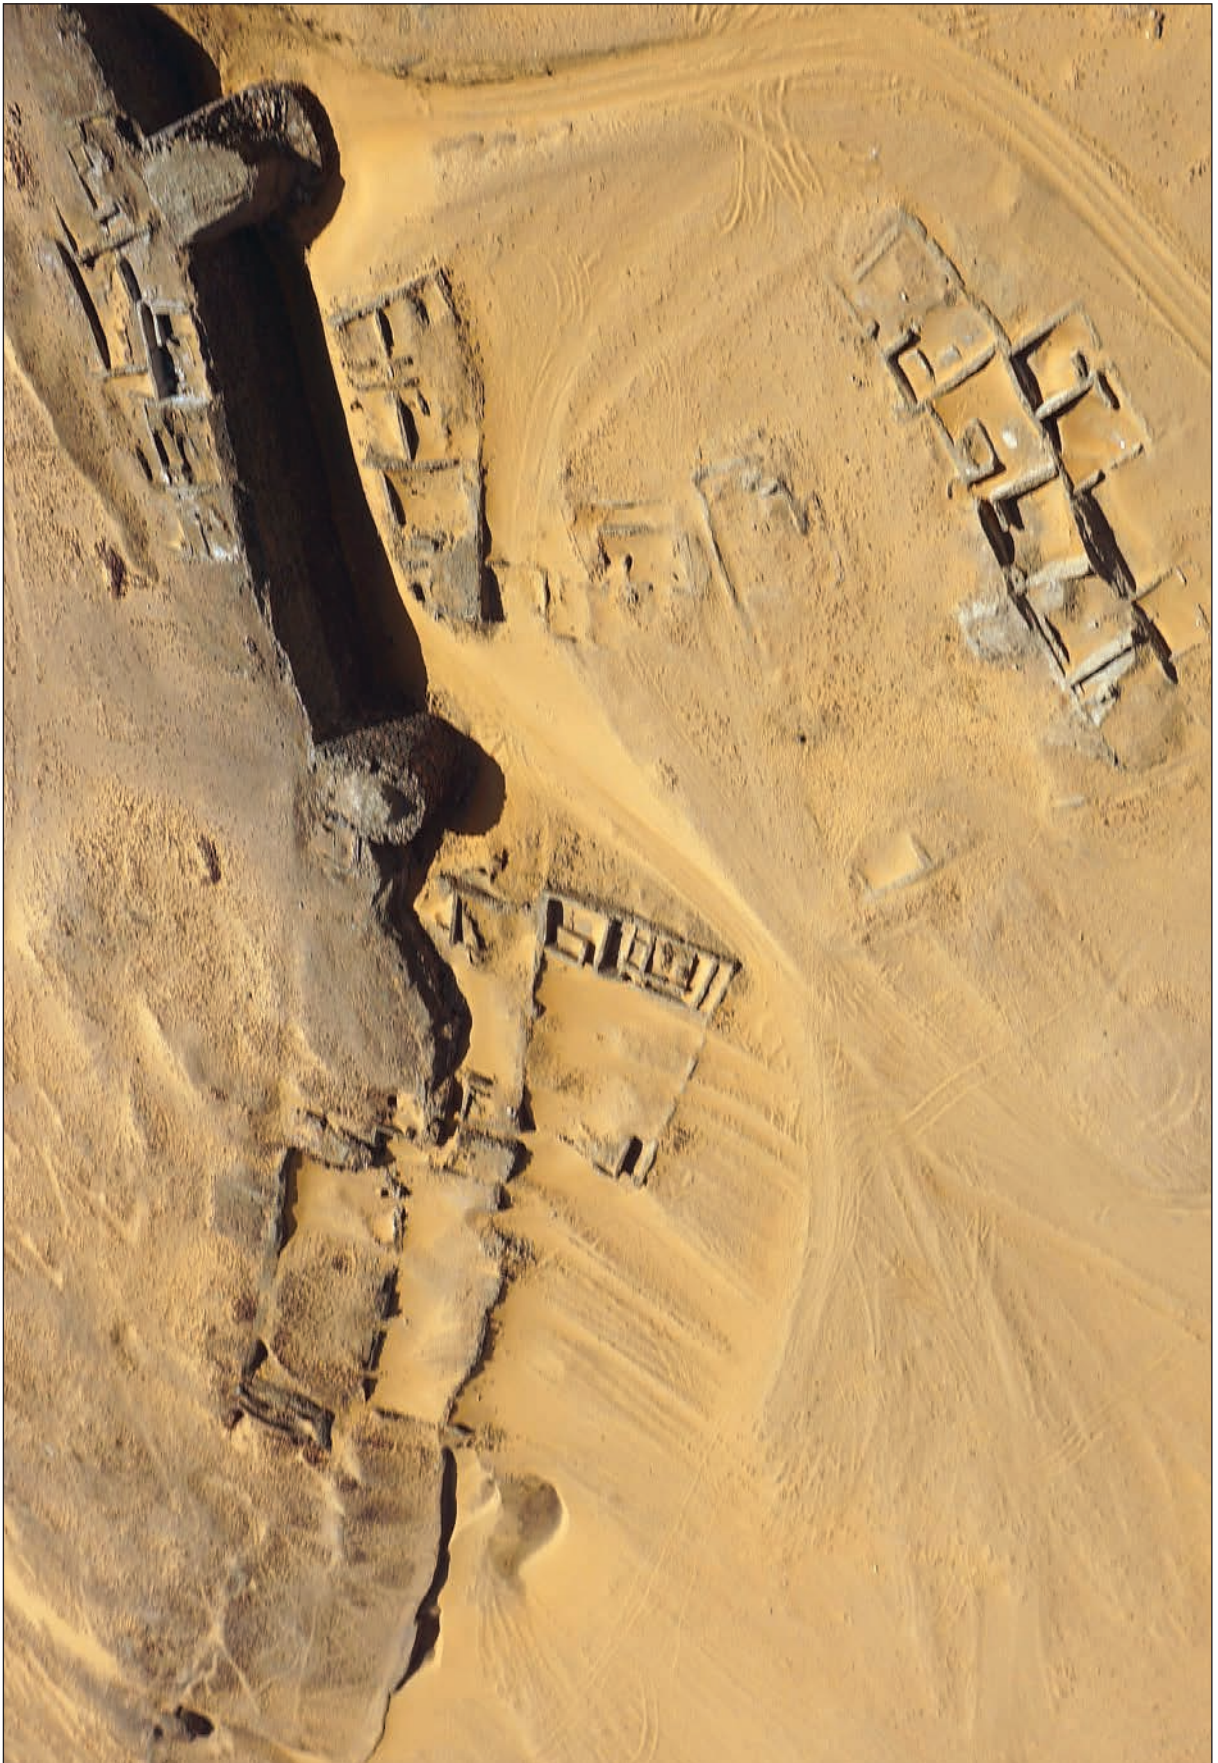
Fig. 15.2. Eastern part of the Citadel, aerial view
