DONGOLA

FIELDWORK
CONSERVATION
AND SITE MANAGEMENT

PCMA Excavation Series 5

QATAR-SUDAN ARCHAEOLOGICAL PROJECT (QSAP)
NUBIAN ARCHAEOLOGICAL DEVELOPMENT ORGANIZATION

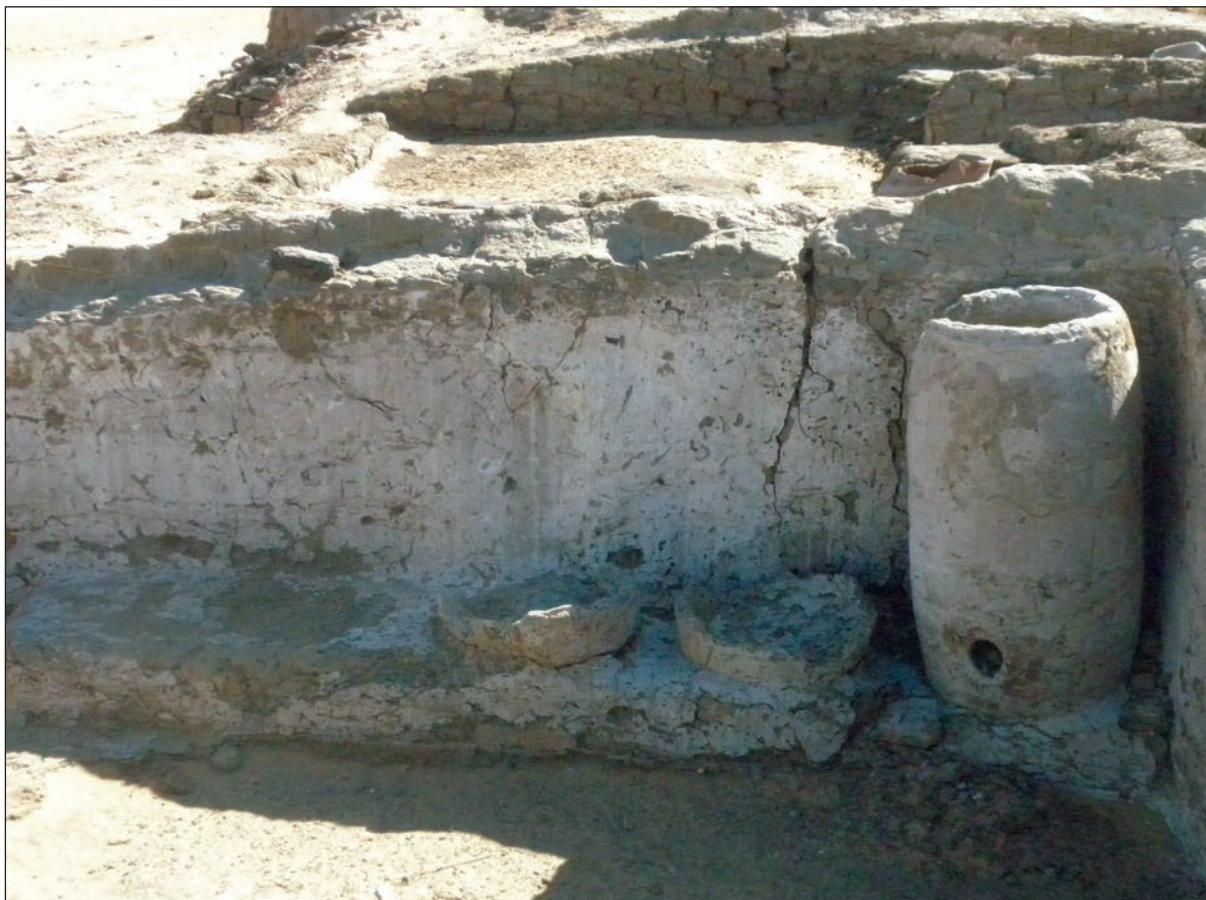
Fig. 15.4. Bench with storage bins in house C.H.303

The completely preserved bin measured 0.48 m in diameter and 1.01 m in height. Its wall was thicker in the upper part. On the western side near the bottom the bin had an opening 11 cm in diameter. Fragments of a lid of dried mud, which

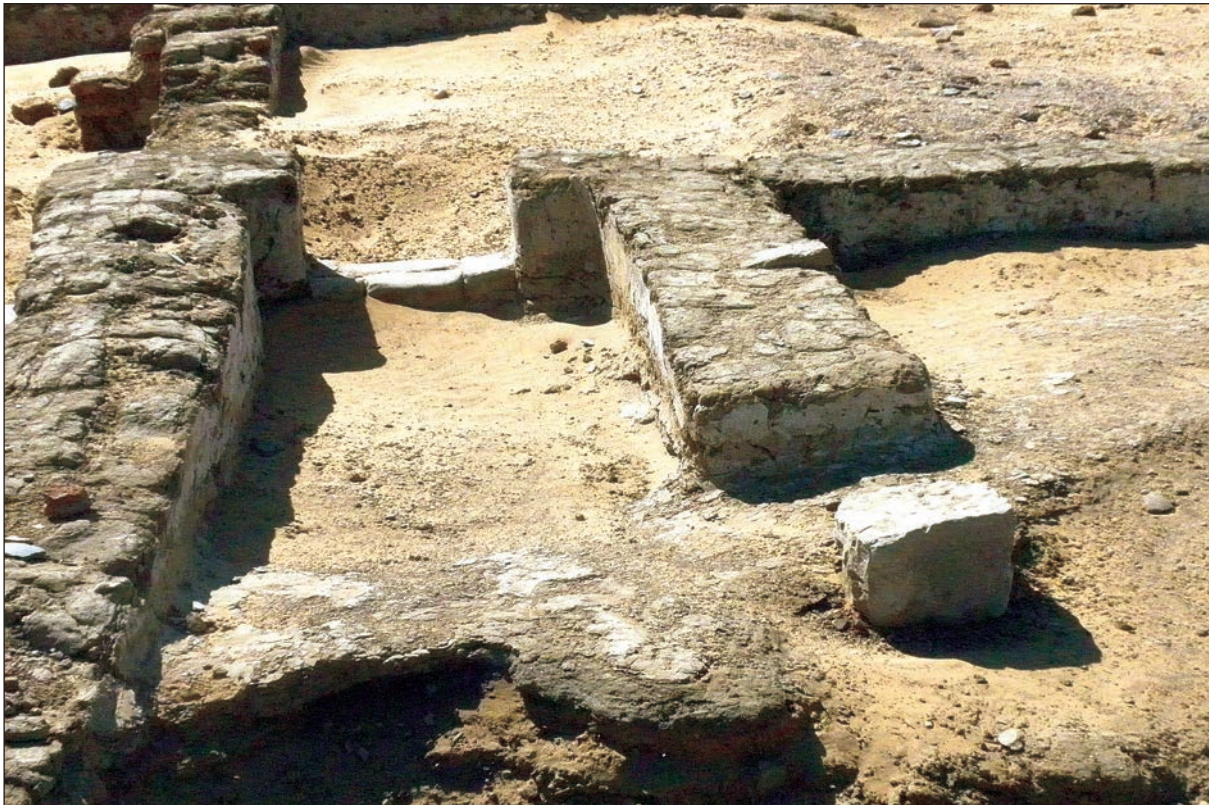
Fig. 15.5. Entrance to house C.H.306

The entrance, 0.65 m wide, had a threshold of four sandstone blocks and was flanked on the inside by a stub wall (*tuddik*) 1.60 m in length. The vestibule inside the entrance was 1.02 m wide [Fig. 15.5].

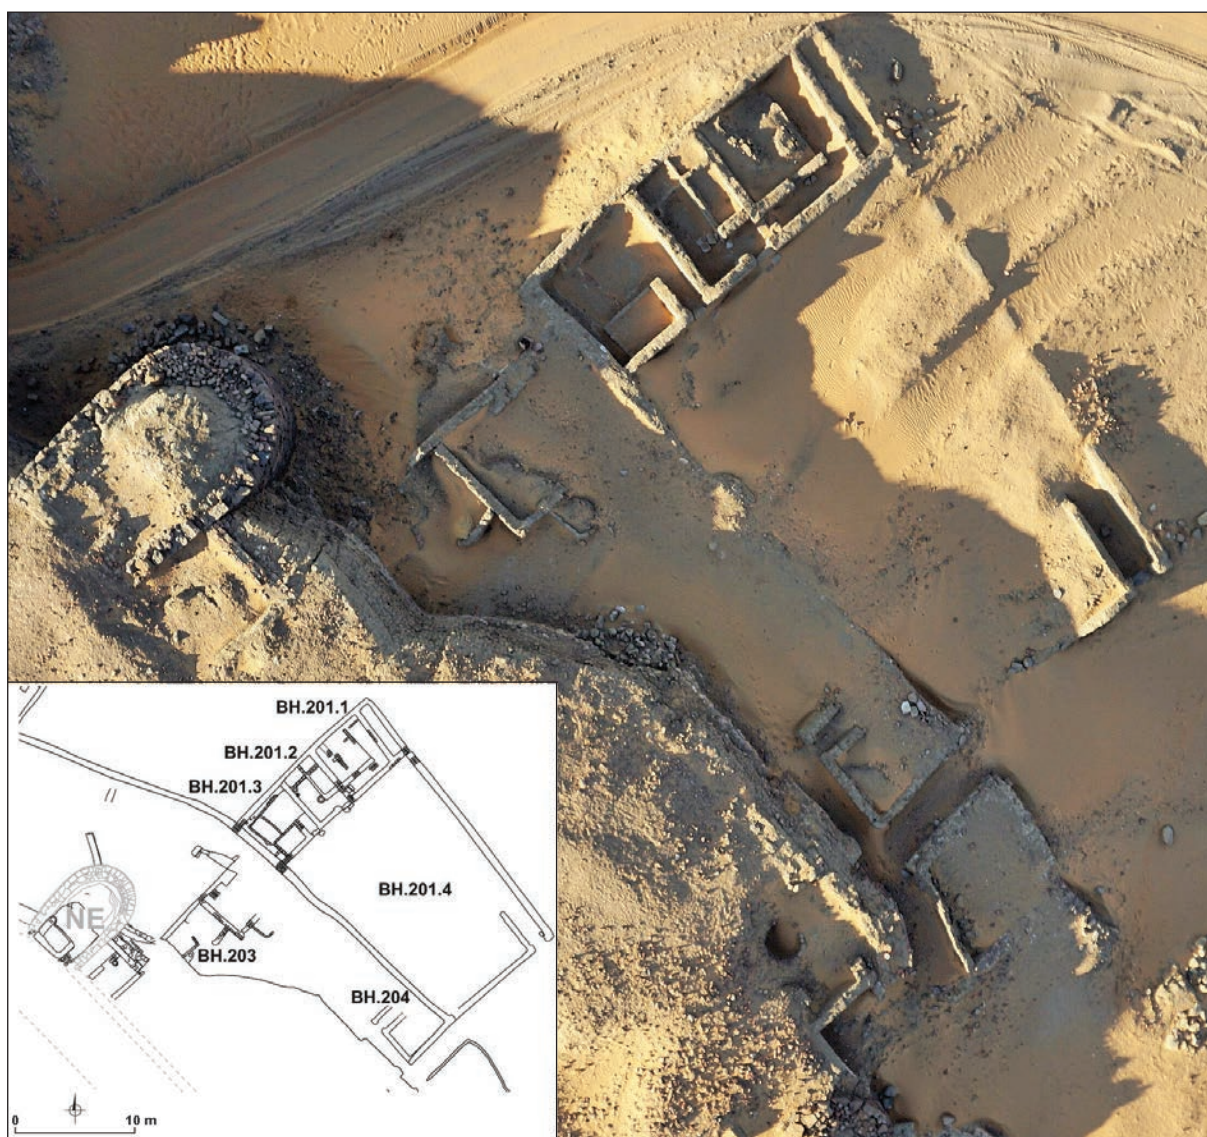
Fig. 15.6. Sector of the Citadel walls between Towers NE and E.1 and the area at the foot of the fortifications; inset, detail of the excavation plan

Between Towers NE and E.1 there is a vast extension of the fortifications referred to as the North-eastern Platform. Excavations in the 2015 season exposed only a wall surrounding this extension of the fortifications, as well as relics of buildings erected against the northern face of Tower E.1 and on top of Tower NE [Fig. 15.6].

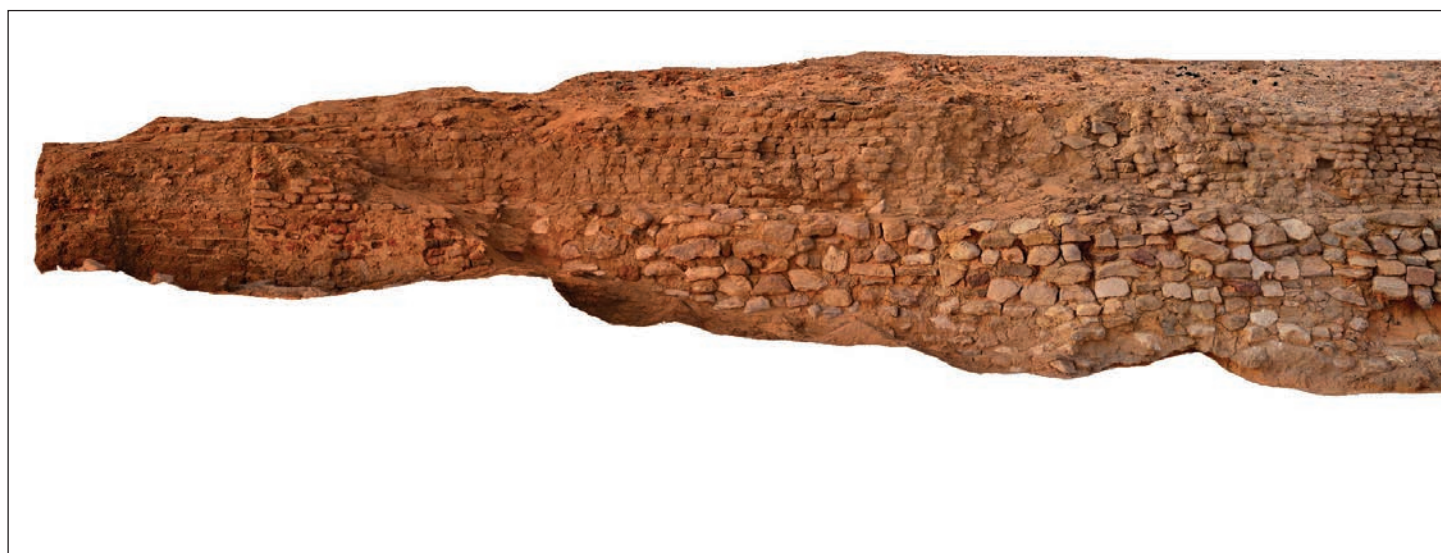
Fig. 15.7. Wall delimiting the Northeastern Platform on the east

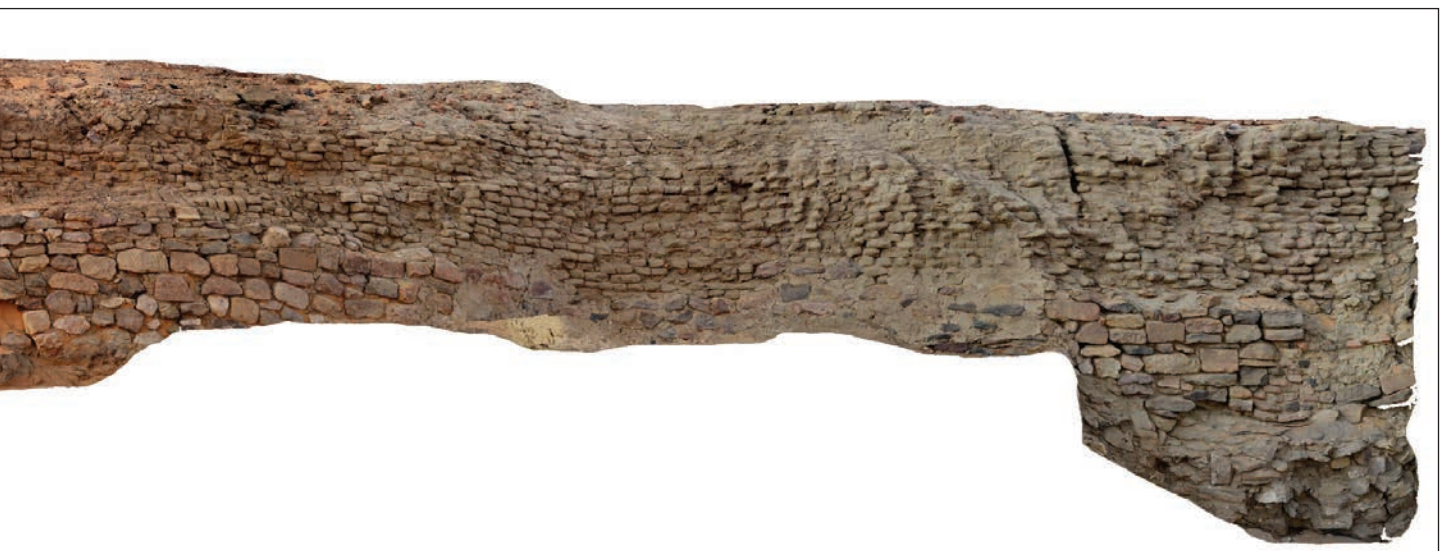
It has two extant walls on the north and the west, both built of mud bricks. The west wall, 0.46 m thick, is preserved to a height of 1.30 m. The north wall of the building, 0.45 m thick, is also preserved to a height of 1.30 m in its western part but slopes toward the east, where it is only extant to 0.60 m [Fig. 15.10 top right].

On an upper level, the entire space between the walls is filled with compacted rubble or bricks laid in layers without mortar [Fig. 15.10 bottom]. There is no evidence that its surface served as a walking level; it was rather a rubble fill intended to reinforce the Citadel fortifications in the vicinity of Tower E.1.

The partly preserved interior measuring 2.60 m by 2.80 m had neither a well-tamped floor nor furnishings. It was most likely accessed from the south or from the east, though the south-eastern corner of the structure was completely destroyed. The north wall was most likely abutted by a tall feature, as indicated by the extant level of whitewash on its plaster [Fig. 15.10 top right].

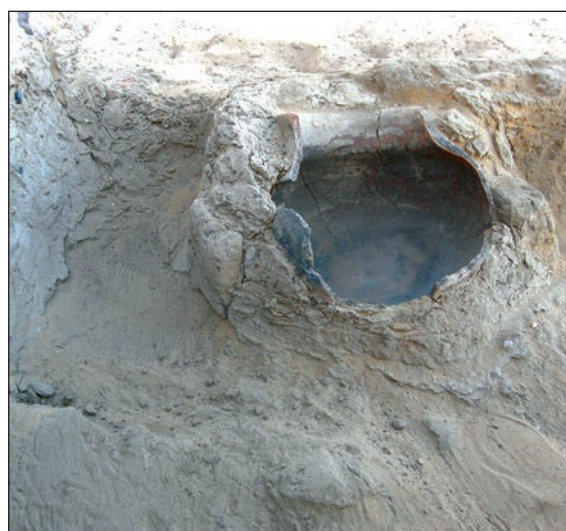
Fig. 15.12. Fireplace inside a pottery vessel in house B.H.203

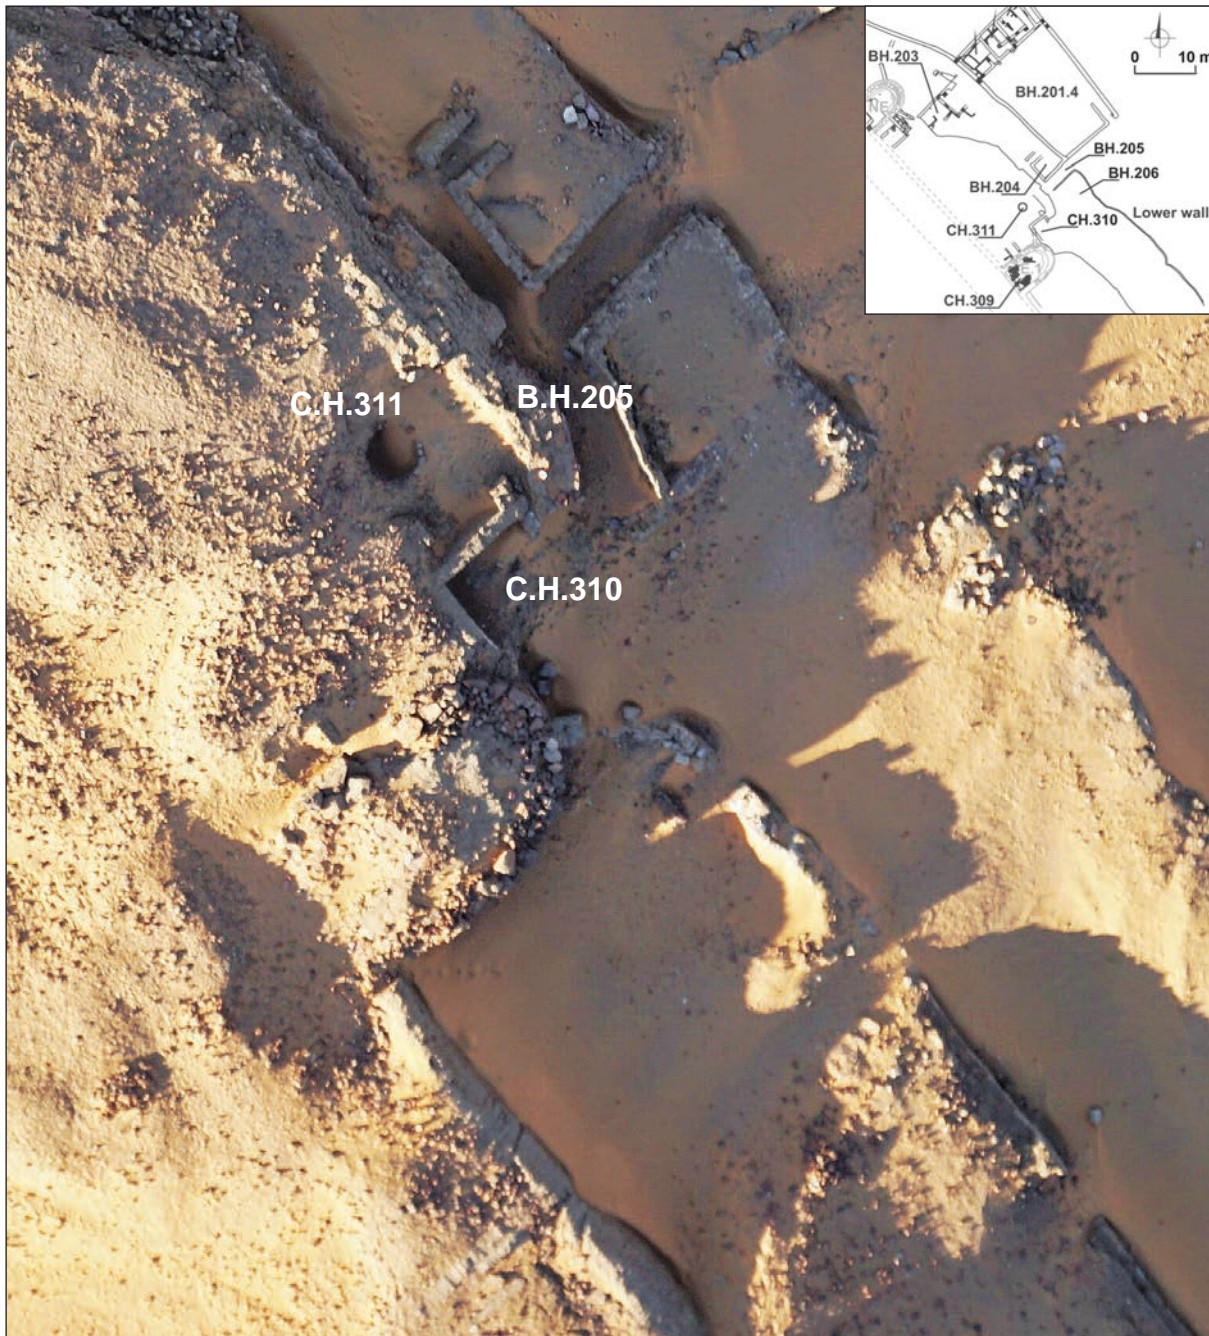
barriers with a tamped walking level below. On the eastern side of the gate, the level began at 25.18 m and rose steadily over a stretch 5.00 m long, to a level of 26.41 m in the street at the foot of the upper dune barrier wall, between houses B.H.204 and B.H.206. The side walls of the gate were built of roughly hewn stone blocks and are similar to the part of the lower dune barrier wall stretching on both sides of the gate.

The southern corner of the gate was founded on a deposit of windblown sand, at an elevation of 24.96 m; the walls tops were preserved at 26.30 m.

Fig. 15.13. Gate B.H.205(?) and adjacent buildings, including house C.H.311 with a courtyard featuring a *matmura*

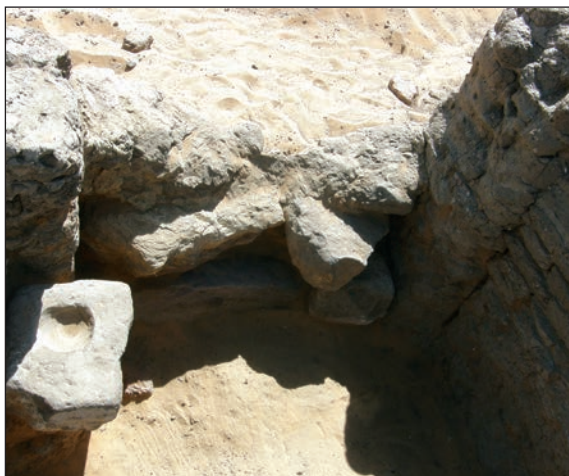
Fig. 15.14. Pivot block in the entrance to courtyard B.H.201.4

A square block located on the inner side of the eastern jamb had a circular depression in its upper surface and must have served for mounting a door pivot [Fig. 15.14]. The surface of the courtyard was not excavated, but a vast ash deposit was identified in its eastern part.

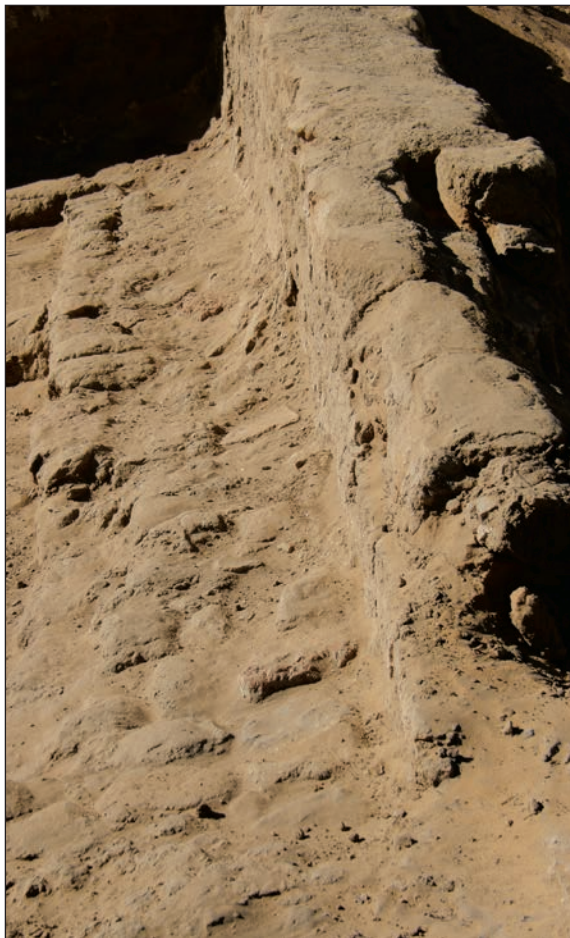
Fig. 15.16. Northern bench in room B.H.201.1: view from the northeast

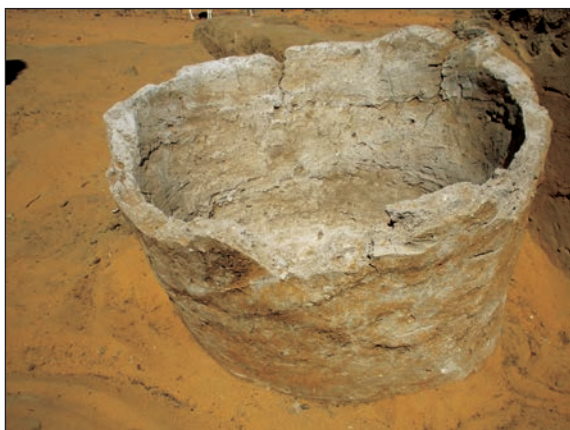
Fig. 15.17. Storage bin (gesseba) in room B.H.201.2

- ▶ Small structure consisting of an inverted pottery vessel and a brick, located next to the mastaba adjacent to the west wall of the building;
- ▶ *Gesseba*. Lower part of a bin with massive walls of desert clay (*gir*), preserved next to the large mastaba, by the stub wall flanking the entrance; dimensions: H. +0.48 m, Diam. 0.68 m. The bin was found on a layer of sand overlying the mud floor, so it was rather not in its original location [Fig. 15.17].

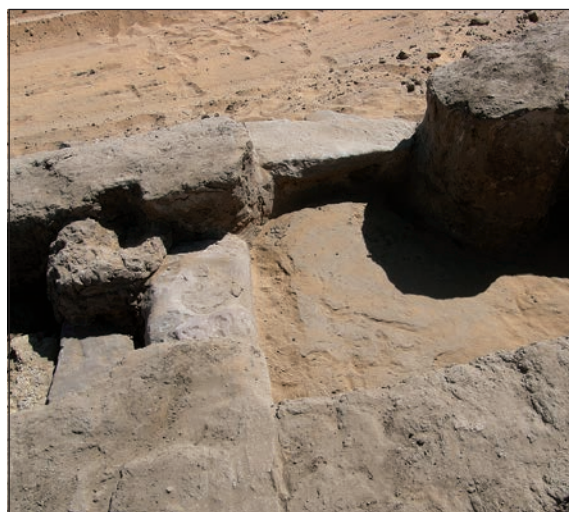
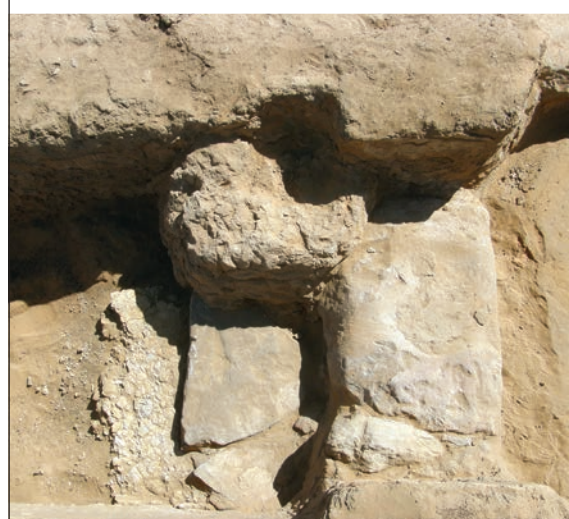
Room B.H.201.2, with inner dimensions 4.70 m by 3.00 m, was entered from the south through a passageway 0.80 m wide, flanked by straight jambs and a narrow stub wall on the eastern side (L. 0.52 m; W. 0.12 m) [*Fig. 15.18*

in turn, was the doorway to neighboring room B.H.201.3 [Fig. 15.18 bottom].

Fig. 15.18. House B.H.201.2–3: top, entrance to the house viewed from the inside; on left, passage to the interconnected room; bottom, top view of the doorway to room B.H.201.3

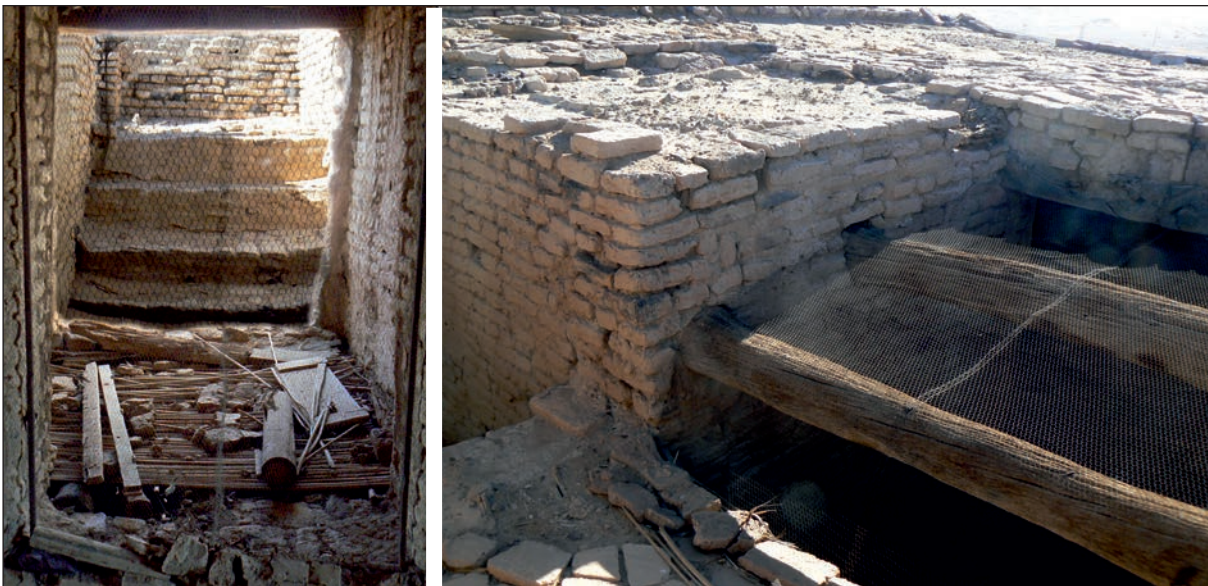
The preserved timber structure supported a part of the lower landing, the lower part of the flight of steps, and the intermediate landing [Fig. 21.1]. In the part of the lower landing, the

structure survived but in a state that precluded its use as a formwork—there was no pugging, and the timber beams were substantially weakened [Fig. 21.2]. The upper part of the flight of steps and the upper landing were not preserved. In the void where the upper section of the flight of steps used to be, only two timber beams remained – they served as a support for a steel mesh protecting the building against bats [Fig. 21.1].

Fig. 21.1. Initial state of the stairs leading from the first floor to the roof: left, bottom landing and bottom flight of steps; right, intermediate landing and void in the place of the upper flight

The upper part of the staircase was not extant. In its place was a void covered only with a metal mesh [Fig. 21.1 right]. The vertical distance between the to-be-reconstructed upper flight of stairs from the first floor to the roof and the flight of stairs connecting the ground floor with the first floor was so large that construction of an adequate scaffolding and formwork for a monolithic structure proved impossible with the available technical means. For this reason, it was decided to again use prefabricated concrete elements.

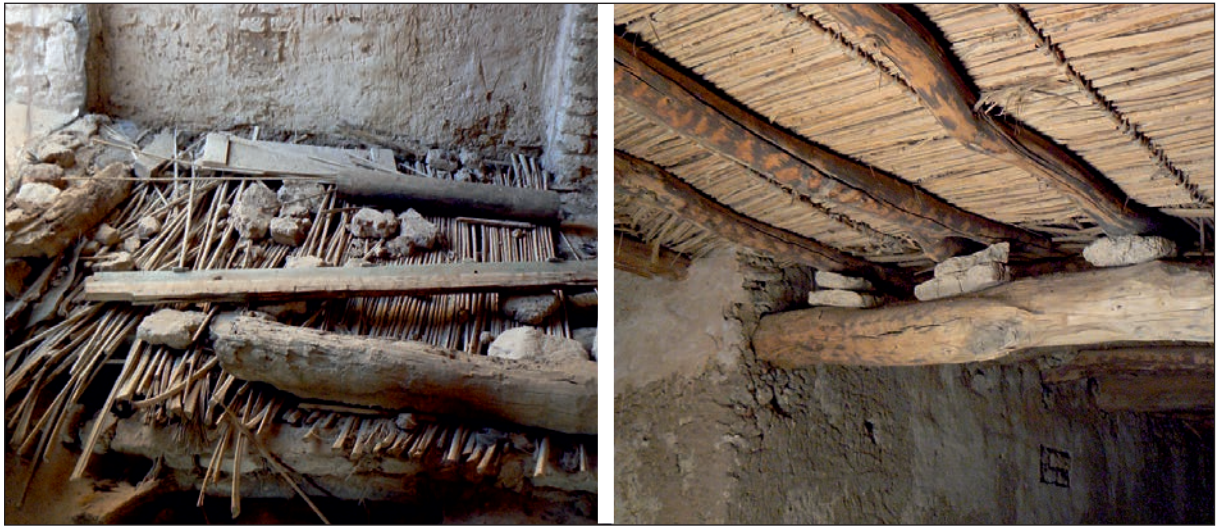
Fig. 21.2. Bottom landing of the stairs leading to the roof from the first floor: left, view from the top and right, from the bottom

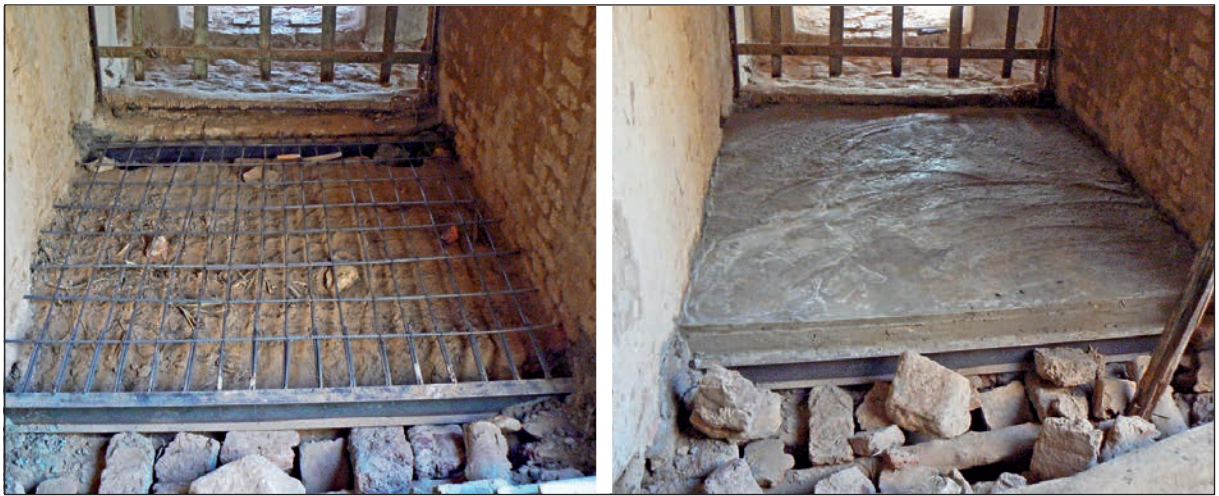
Fig. 21.3. Reconstruction of the less damaged part of the lower landing: left, steel beams and reinforcement and right, a ready reinforced concrete slab

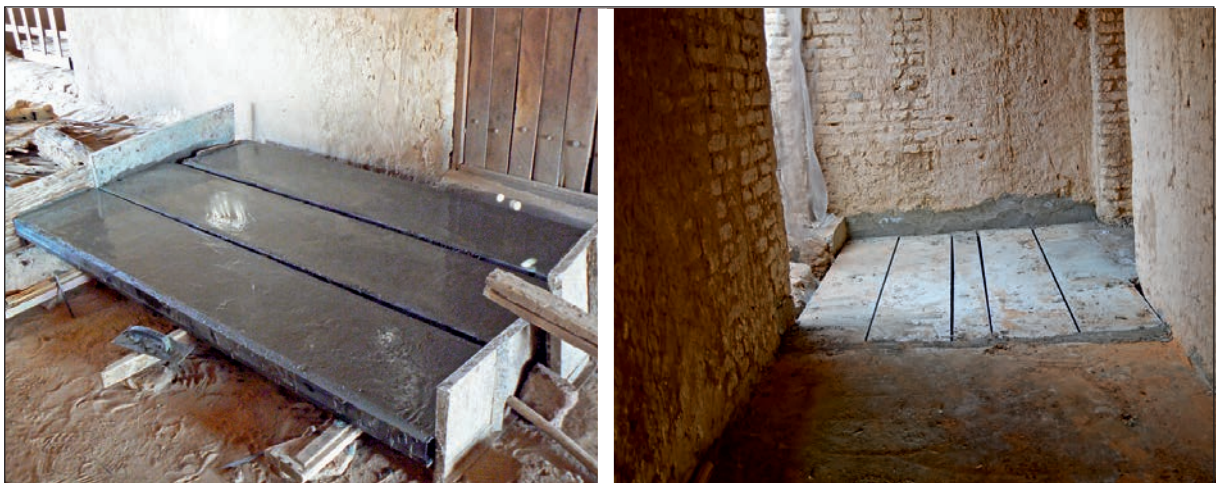
Fig. 21.4. Reconstruction of the more damaged part of the lower landing: left, prefabrication site for casting reinforced concrete slabs and right, precast elements after assembly

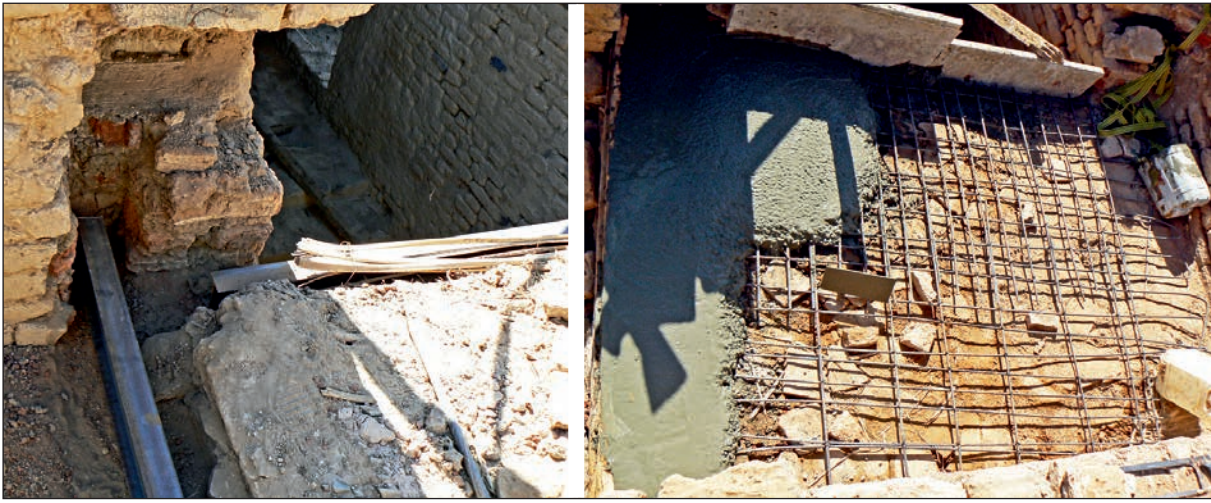
Fig. 21.5. Reconstruction of the intermediate landing: left, assembly of steel beams; right, reinforcing and concreting of a monolithic concrete slab

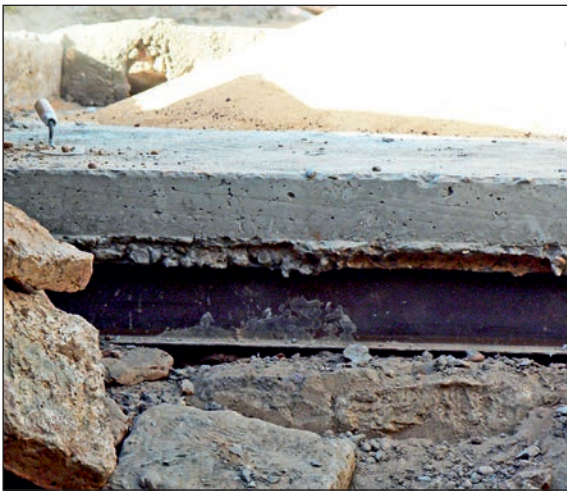
Fig. 21.6. Detail of the finished reinforced concrete slab of the intermediate landing supported on a steel beam

from the landing, and subsequently the main reinforcement (# 10 mm @ 10 cm rebars) and the distribution reinforcement (# 10 mm @ 20 cm bars) were placed [Fig. 21.5 right]. After the pouring and setting of concrete, a good-quality reinforced concrete slab was obtained [Fig. 21.6]. Its thickness varied, ranging from 8 cm to 12 cm, due to surface irregularities in the existing landing used as a formwork.

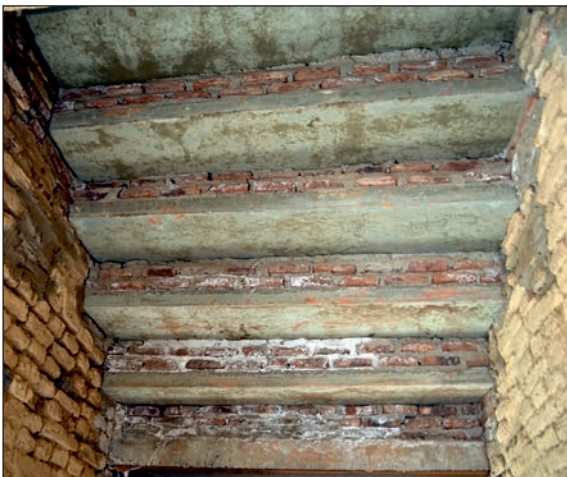
Fig. 21.7. Upper flight of stairs leading from the first floor to the roof; view of the underside

The precast elements were produced in molds previously prepared for the prefabrication of elements for the lower landing. In order to adjust the length of the prefabs to the width of the flight of stairs, the mold length was reduced using inserts. The prefabricated elements were assembled sequentially, starting from the first step above the intermediate landing. After assembly, the step became the working surface for mounting the next step. The work was carried out sequentially up to the level of the roof, where the precast elements were laid up to form the upper landing. This method of installation allowed the complete avoidance of scaffolding and formwork in the construction of the upper flight of stairs. The risers were made of bricks placed between precast elements. The completed

stairs are visually neutral in regard to the preserved walls of the historic building [Fig. 21.7].

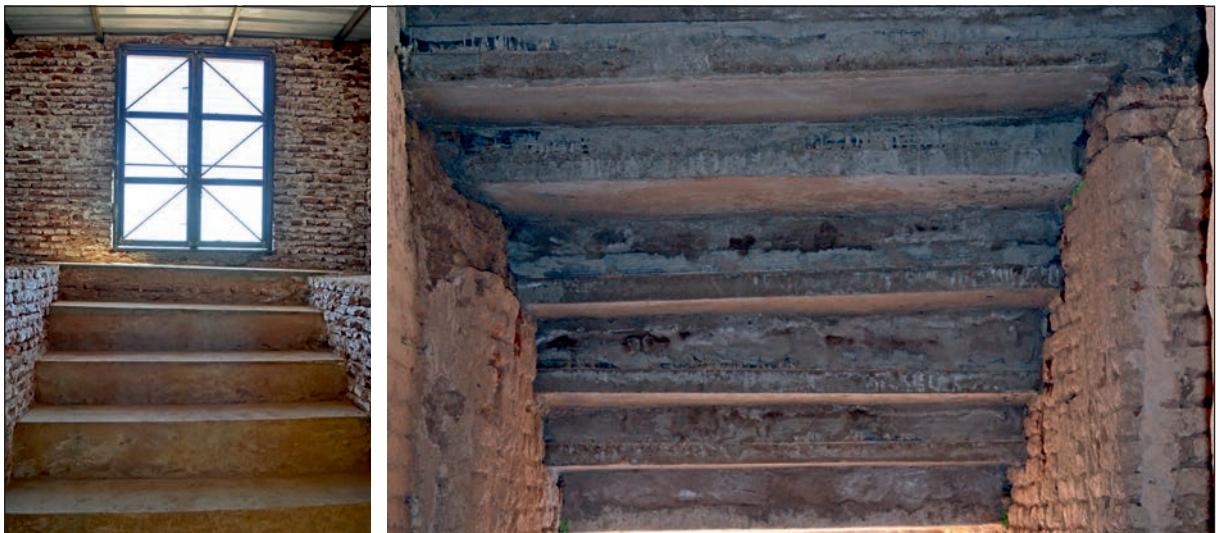
Fig. 21.9. Reconstructed flight of stairs leading from the first floor to the roof: left, upper part and right, lower part

The reconstructed stairs had a load capacity enabling their use by a group of visitors, as well as a uniform character over their entire length while remaining a relatively neutral element in the structure of the building.

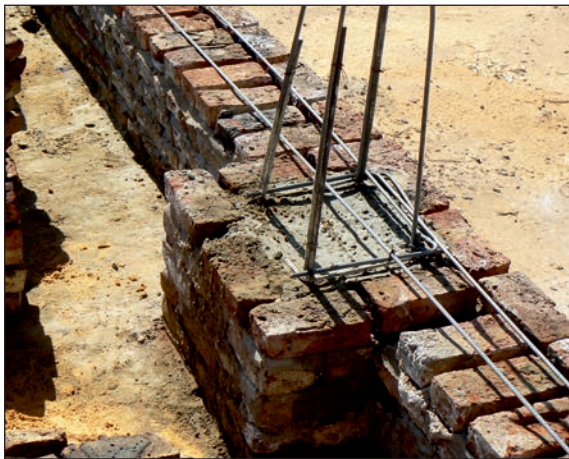
Fig. 21.12. Rim on the outer wall with an additional compensatory layer of bricks and starters of the balustrade wall pilasters

The construction of a rim designed to increase the stability of the walls began with a cleaning

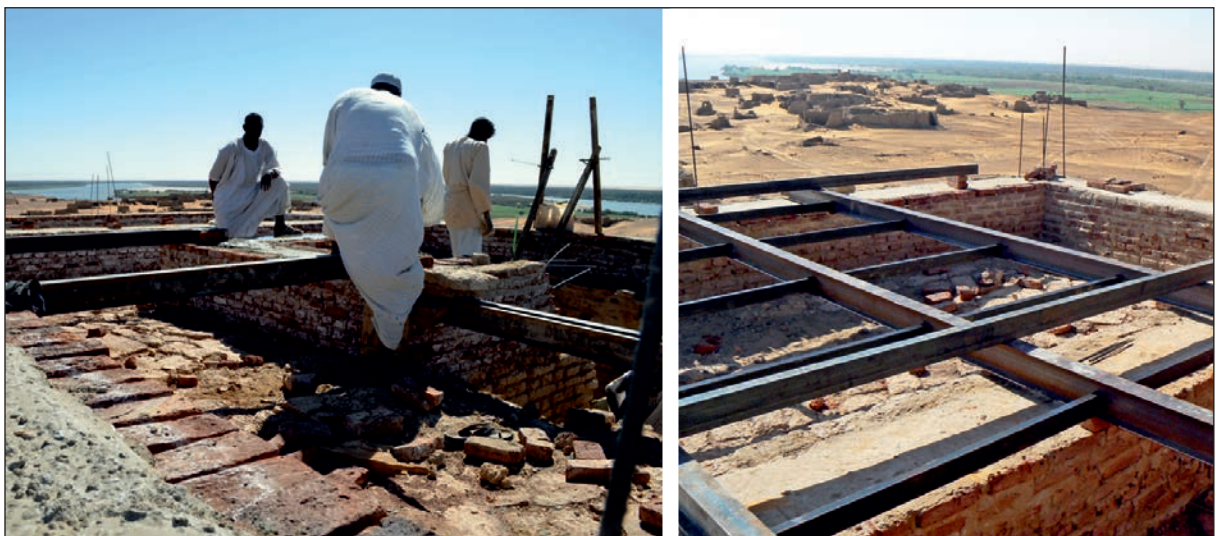
Fig. 21.13 Installation of the steel beams of the roof structure: left, for the staircase enclosure and right, for the observation deck

The scheme followed in the works is shown on the drawing [Fig. 21.10]. Successive stages included the construction of a rim on the walls to increase their stability, an enclosure over the reconstructed staircase to protect the interior against atmospheric conditions, an observation deck, and a parapet wall which doubles as a balustrade of the deck. A detailed arrangement of the components is shown in the plan of the roof [Fig. 21.11].

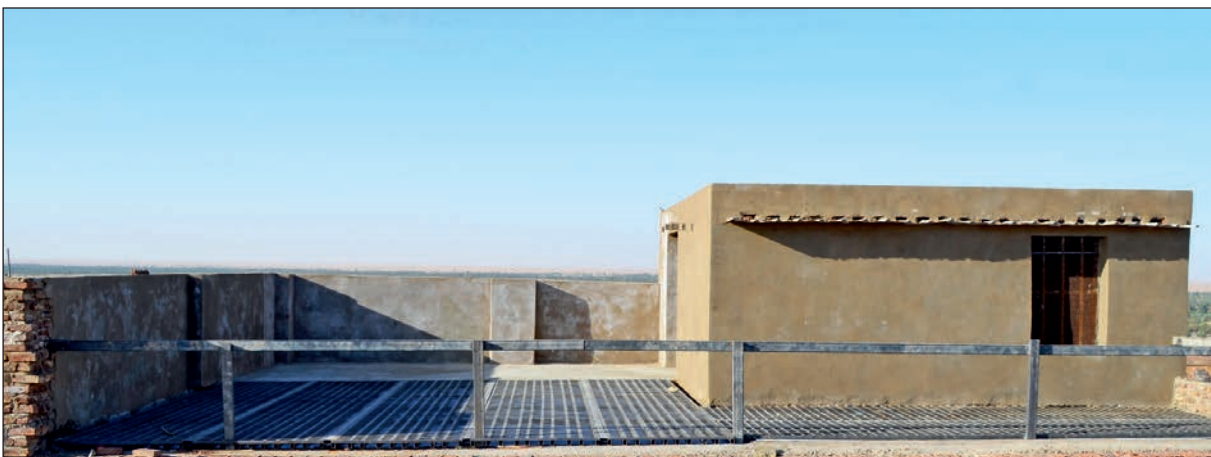
Fig. 21.17. Observation deck with parapet and enclosure of the staircase viewed from the east

The observation deck was closed on the eastern side with a lightweight RSH profile railing. This handrail can easily be dismantled to allow for future work on the remaining part of the roof [Fig. 21.17]. The platform will ultimately be surrounded by a brick wall analogous to the parapet wall.
